Published in: Composite Structures

## Strain and damage monitoring in CFRP fuselage panels using fiber Bragg grating sensors. Part I: Design, manufacturing and impact testing

This is the first paper of a two-paper series describing design, implementation and validation of a strain and damage monitoring system for CFRP fuselage stiffened panels based on fiber optic Bragg grating sensors. The monitoring system was developed and tested on the basis of three load-scenarios: compression to failure of the undamaged panel, compression to failure of the impacted panel and compression to failure of the impacted and fatigued panel. This paper focuses on the design of the fuselage panel, the design of the monitoring system, the embedment of fiber sensors in the panel during manufacturing and the impact testing. The network of the sensors was designed based on a numerical buckling analysis from which the strain field of the panel was computed as a function of the applied compressive load. Embedment of fiber sensors in the panel was done so as to minimize risk of fiber breaking during manufacturing and impact testing and to effectively capture strains that are representative of damage develop

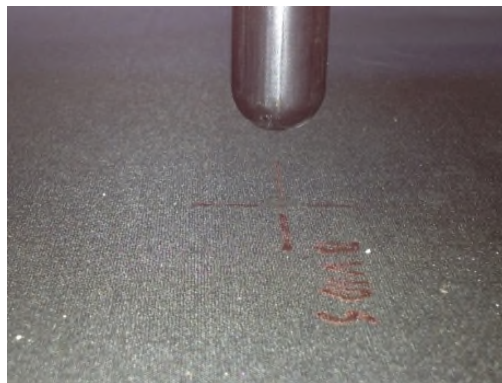
**Fig.15**

- Fig.15: Photo of the impactor above BVID5 location.
- Fig.16: Photo of the panel supported by the metallic device just before subjected to impact testing.

Impact damage was created in panel\_2 and panel\_3 using an INSTRON Dynatup 9250 HV drop tower. Several experiments were conducted to create BVID and VID sites at the specified locations indicated in Fig.6 using a semi-circular impactor with a diameter of 16 mm (Fig.15). During testing force and energy versus time and deflection were recorded. A full lateral support at the large sides of the panels was applied during impact. To apply these boundary conditions, the special metallic device shown in Fig.16 was built.
