## Further investigations into alloy induced acidic fluxing

### ABSTRACT

Gas turbine materials often feature precipitates containing refractory metals to enhance their mechanical strength. This can make them susceptible to alloy-induced acidic fluxing whereby refractory elements increase the acidity of salt deposits. It is not clear to what degree degradation around alloy precipitates is caused by alloy-induced hot corrosion mechanisms, or the inability to develop a protective scale where precipitates are located. The effect of alloy-induced hot corrosion was isolated from the disruption of the protective-scale formation by adding particles of molybdenum to the 80/20 (Na/K)<sub>2</sub>SO<sub>4</sub> deposit for a 'deposit re-coat' style hot corrosion test. The resulting morphologies were compared to samples exposed without the addition of molybdenum. Morphology changes were investigated using scanning electron microscopy with energy-dispersive X-ray mapping. Results show a mix of sulphidation and pitting. The effects of molybdenum additions appear more severe for MarM 509 compared to PWA 1483.

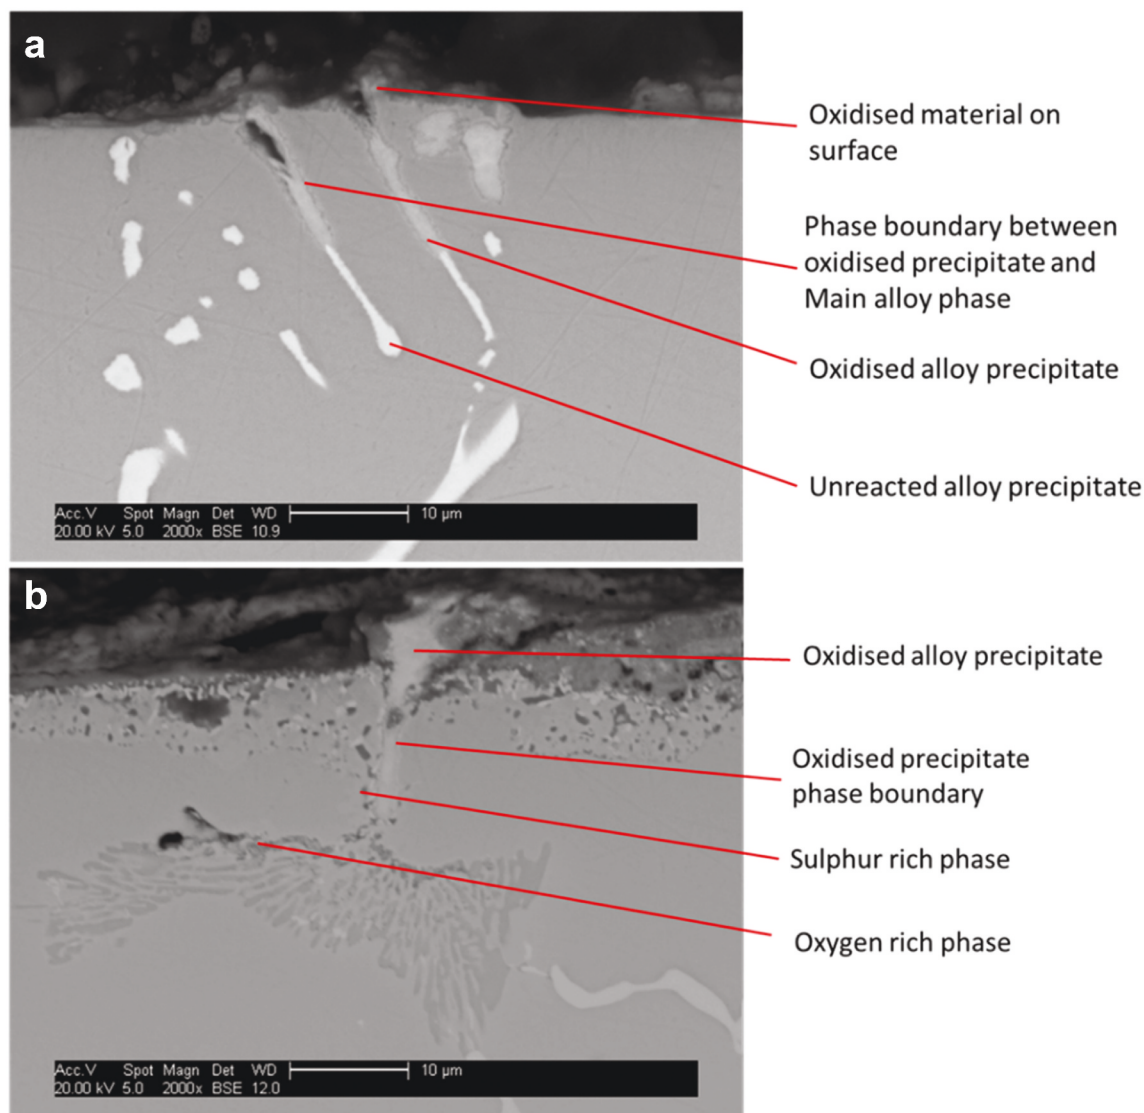
**Figure 1.** (a) MarM 509 exposed at 700 °C in air for 100 hours with no deposit. (b) MarM 509 exposed at 700 °C for 100 hours in 8.5 vol.% O<sub>2</sub>, 10.5 vol.% CO<sub>2</sub>, 5 vol.% H<sub>2</sub>O and 90 ppm SO<sub>x</sub> with 80/20 Na<sub>2</sub>SO<sub>4</sub>/K<sub>2</sub>SO<sub>4</sub> at 1.5 µg/cm<sup>2</sup>/h [4].

precipitate would accelerate the onset of propagation around the precipitate. In addition to this, the phase boundary between the oxidised precipitate and bulk alloy matrix may provide a route for the inwards ingress of deleterious species deeper into the alloy. Examples of these morphologies are shown in Figure 1.

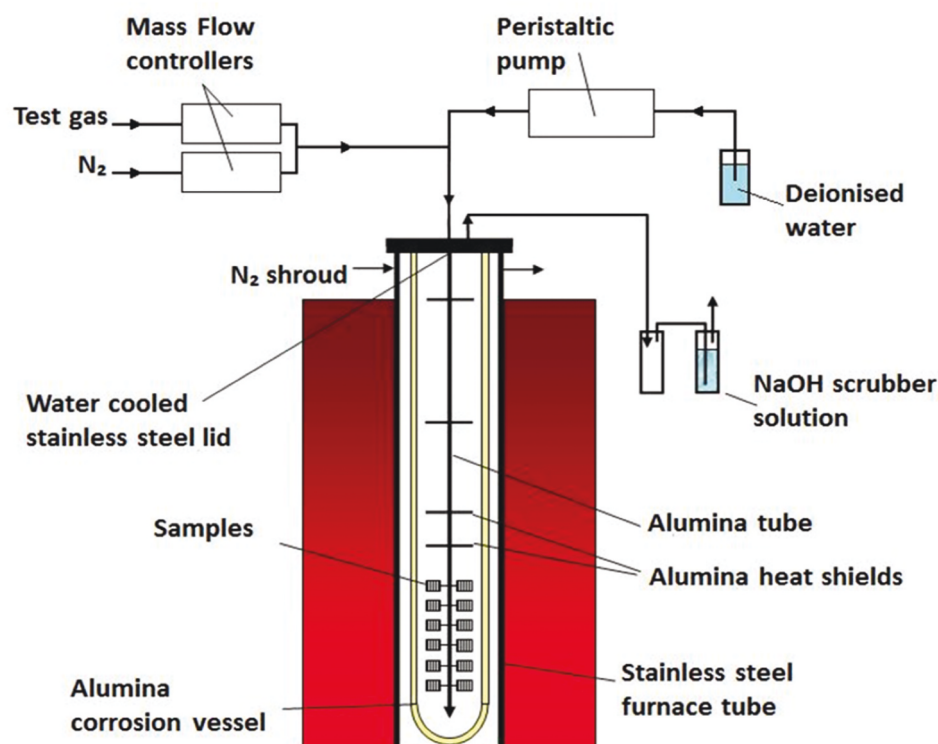
**Figure 2.** Test furnace apparatus [8].

Deposit recoat hot corrosion tests were performed in a vertically orientated tube furnace outfitted with an alumina lined corrosion vessel. Samples were held within alumina crucibles positioned on an alumina carousel in the furnace hot zone of 700°C (±5°C). The test gas of 300 ppm SO<sub>2</sub> in air was piped through the furnace into the bottom where it was emitted to pass back up past the samples before exhausting from the furnace's top. This gas pathway allowed time for the SO<sub>2</sub>/SO<sub>3</sub> equilibrium to establish. A schematic of the experimental set up is given in Figure 2.

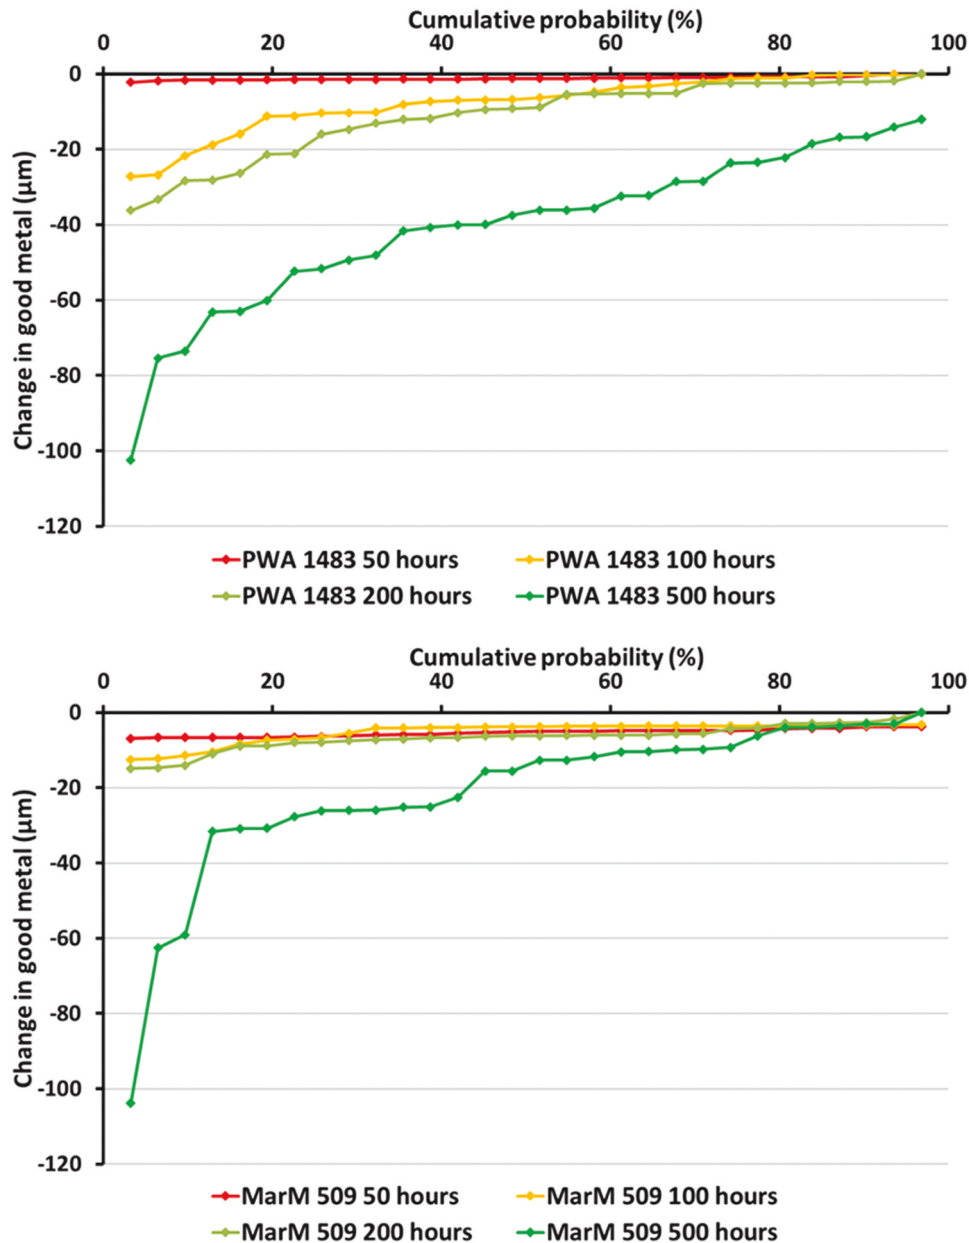
**Figure 3.** Cumulative probability of change in good metal plots for PWA 1483 (top) and MarM 509 (bottom). Exposure carried out at 700 °C in an air atmosphere with 300 ppm  $\text{SO}_2$ . The deposit flux was  $1.5 \mu\text{g}/\text{cm}^2/\text{h}$  of 80/20  $(\text{Na/K})_2\text{SO}_4$  modified with additions of  $1.5 \mu\text{g}/\text{cm}^2/\text{h}$  of Mo.

Cumulative probability curves for change in good metal are presented in Figure 3. Both PWA 1483 and MarM 509 exhibit negligible change in good metal after 50 h of exposure indicating that, at this time, they have remained in the incubation stage of hot corrosion. After 100 h of exposure approximately 55% of PWA 1483 and 15% MarM 509 show a greater degree of change in good metal. These proportions are similar after 200 h of exposure but with a greater degree of metal loss (up to  $10 \mu\text{m}$ ) where corrosion is occurring. After 500 h, the whole of PWA 1483 has entered into propagation while only 80% of

MarM 509 has done so over the same period. While a similar change in good metal (approximately 103  $\mu\text{m}$ ) is observed for both alloys at their lowest levels of probability (representing the deepest pits), the distribution of damage is more localised for MarM 509 while PWA 1483 has a more even distribution.

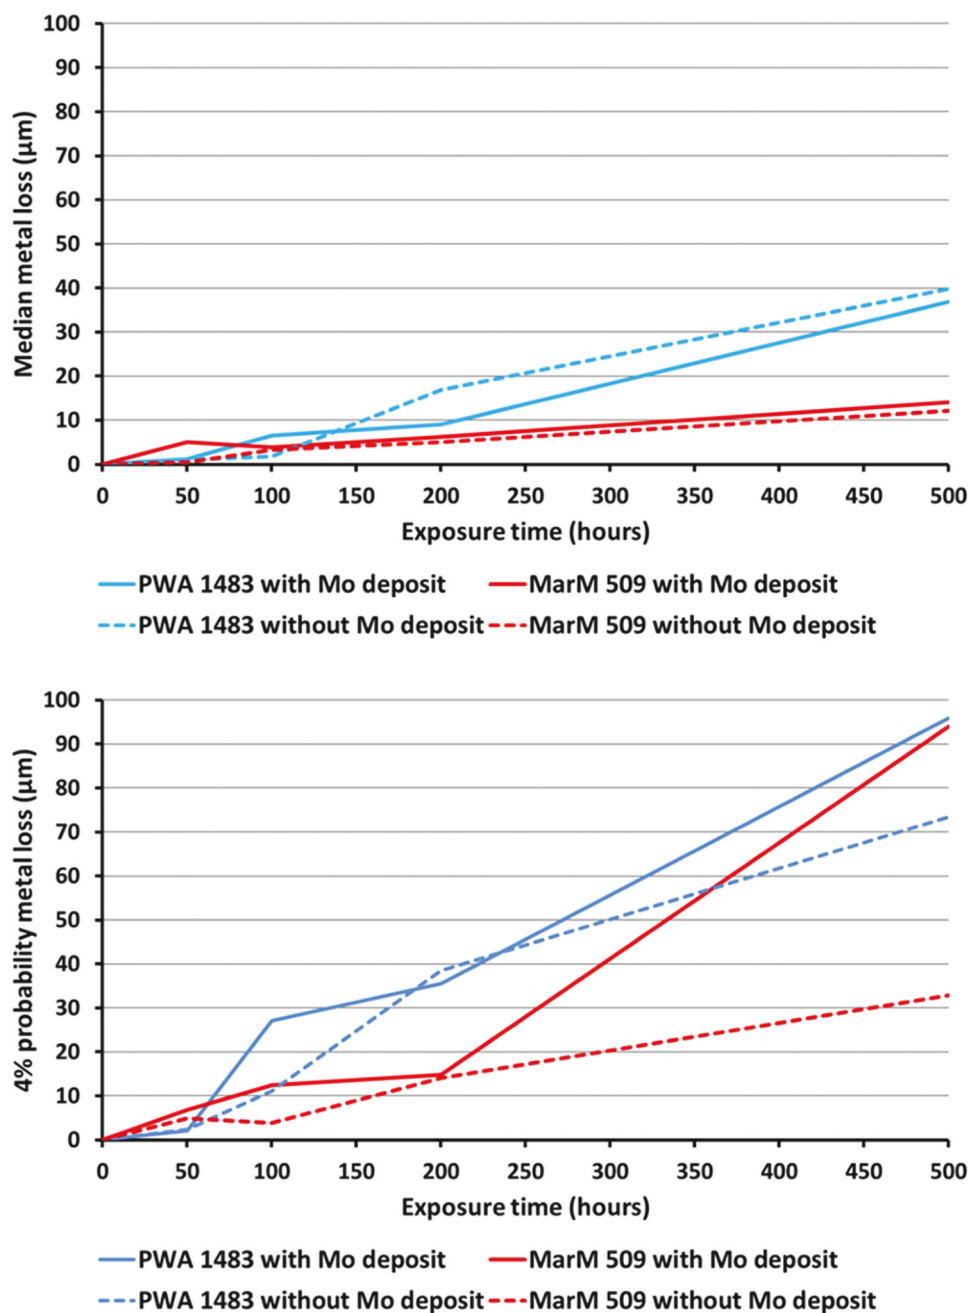
**Figure 4.** Median (top) and 4% (bottom) probability of metal loss exceedance plots. Exposure carried out at 700 °C in an air atmosphere with 300 ppm SO<sub>2</sub>. The deposit flux was 1.5 μg/cm<sup>2</sup>/h of 80/20 (Na/K)<sub>2</sub>SO<sub>4</sub> either modified with 1.5 μg/cm<sup>2</sup>/h of molybdenum or unmodified [8].

Median and 4% probability of good metal loss were used to compare the current exposures using the Mo modified deposit with previous work [8] using the same test parameters but an unmodified deposit. These data are presented in Figure 4. Median values give an average indication of corrosion damage, whereas the 4% probability data indicate the severity of corrosion pits.

Little difference between the Mo modified and unmodified deposits can be seen at the median value for all tested exposure times. However, differences are seen at the 4% probability of good metal loss. The greatest difference between the Mo modified and unmodified deposits is seen after 500 h of exposure

at the 4% probability. These were an extra 22 μm for PWA 1483 and 61 μm for MarM 509.

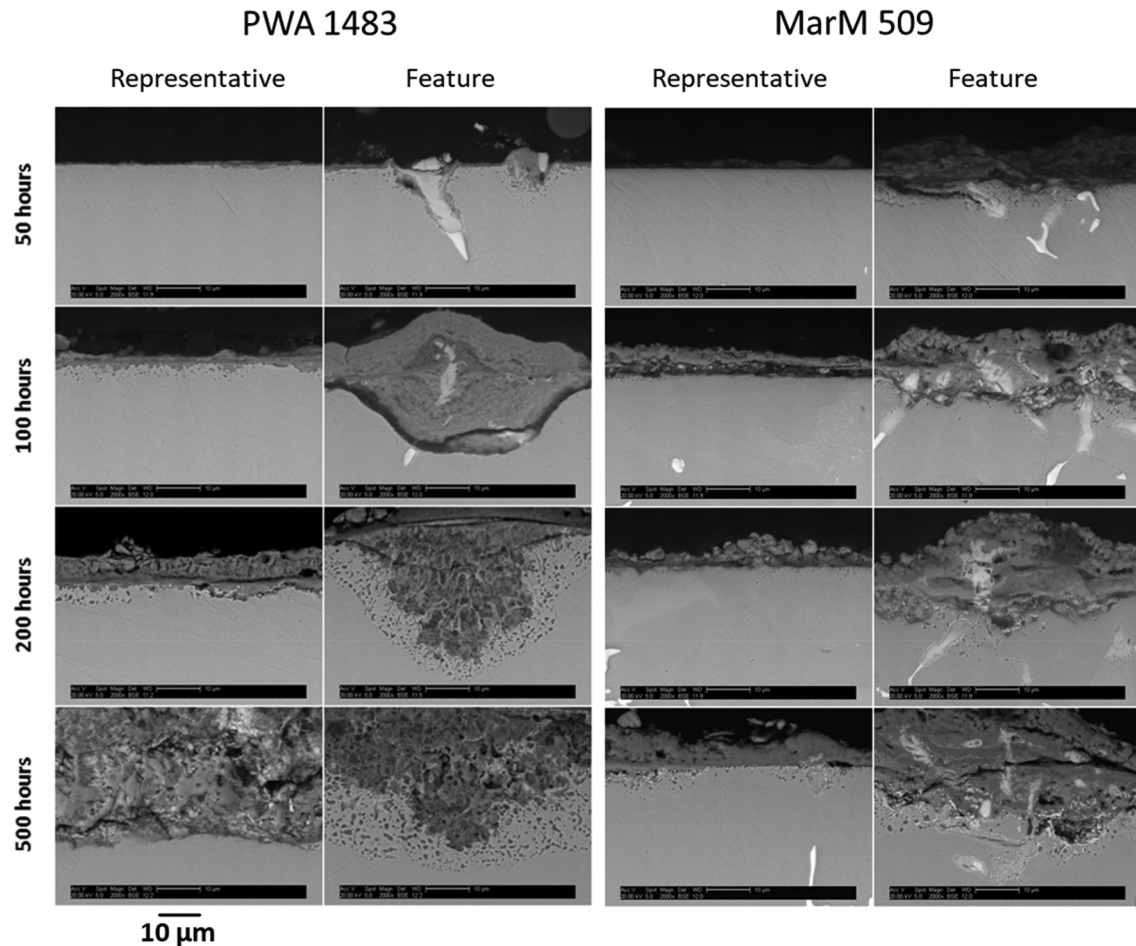
**Figure 5.** BSE images for PWA 1483 (left) and MarM 509 (right) showing areas both representative of the majority of the sample and also extreme corrosion features.

Figure 5 shows backscattered electron (BSE) SEM micrographs of PWA 1483 (left) and MarM 509 (right) after exposure with the Mo modified deposit.

Both representative and extreme ‘feature’ levels of damage are captured. For both materials, after 50 h of exposure, the image representative of the majority of the samples exhibits negligible damage which does not signify a change from incubation to propagation in the hot corrosion degradation sequence. Corrosion features are consistent with type II corrosion pits discussed in the hot corrosion literature [7,12] and are observed to have formed around alloy precipitates located at the surface. Here, internal damage can be observed adjacent to the remains of the alloy precipitates, extending up to 10 µm into the alloy.

For PWA 1483, the corrosion features formed after exposure times between 100 and 500 h show two distinct types of morphology. One type (100 h; ‘feature’ image) does not exhibit internal damage within the metal, and the corrosion product inner layer is a relatively consistent shade, indicating little compositional change. The other type (shown for 200 and 500 h; ‘feature’ images) does feature internal damage within the metal, and the corrosion product has a more mottled shade. Three possible explanations for the differences in morphology are: different corrosion mechanisms occurring; different stages of the same mechanism; or a combination of both.

For MarM 509, corrosion features encompass precipitate phases at all tested exposure times. Internal damage (shown to be sulphidation in Figure 7 based on the point analysis and the morphology in the literature for similar exposures [12–14]) can be seen in all the features, often located adjacent to precipitate phases.

The observed morphologies (shown in Figures 5, 6 and 7) can be compared with those of a previous study of the same materials using the same corrosion parameters but without Mo additions to the deposit [8]. Both sets of data show similar morphology; a mixed mode of corrosion involving pitting and sulphidation, and with corrosion features often but not exclusively forming around carbide precipitates. The difference between the tests lies in the most extreme areas of corrosion attack as reflected in the dimensional metrology (Figure 4). There was no evidence of Mo left within the corrosion features of either PWA 1483 or MarM 509 after 500 h of exposure. In addition to this, observing unreacted salt within the corrosion product indicates that molybdate species may initially drive the corrosion reaction. In the meantime, the  $\text{SO}_3$  from the deposit may be free to cause the internal sulphidation observed in Figures 5, 6 and 7.

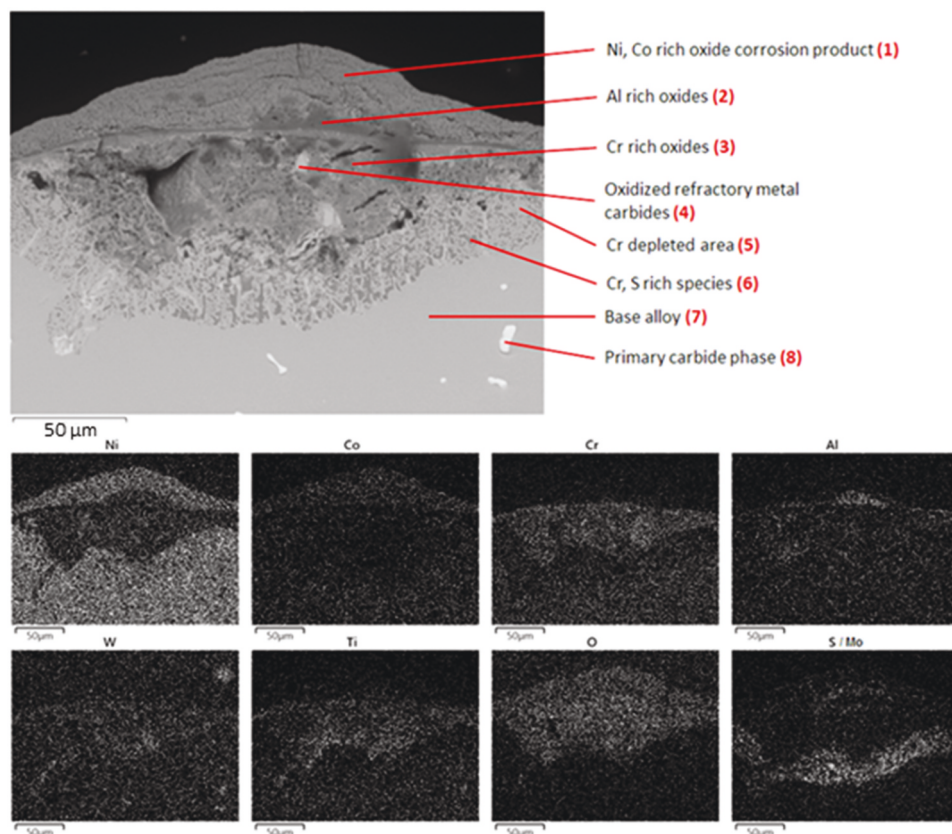
**Figure 6.** BSE image with point analysis and EDX element map of a corrosion feature on PWA 1483 after 500 hours of exposure at 700 °C in an air atmosphere with 300 ppm SO<sub>2</sub>. The deposit flux was 1.5 μg/cm<sup>2</sup>/h each of 80/20 (Na/K)<sub>2</sub>SO<sub>4</sub> and Mo..

Figure 6 shows a BSE image with EDX point analysis elemental quantification and maps. These show a mixed mode corrosion feature on PWA 1483 after 500 h of exposure. The outer-most layer of corrosion product is primarily composed of Ni- and Co-rich oxides; this layer is approximately 30 µm thick at the centre point of the feature. Beneath this Ni- and Co-rich oxide layer and central to the feature, a relatively small area of Al-rich oxide can be observed, which shows up darker than the adjacent Ni and Co oxides. The Al-rich oxide area is thicker towards the centre of the pit feature (8 µm) than at the edges of the pit (1–2 µm). An inner layer rich in Cr oxides, 60 µm thick at the centre point of the pit feature, is situated below the Al oxide layer. Within this layer, the oxidised remains of primary carbide phases rich in Ta can be observed. This kind of layering of corrosion product is a consequence of elements from the alloy dissolving

in the melt and subsequently precipitating at the gas-phase interface and is typical of type II hot corrosion.

At the interface of the remaining good metal and the corrosion product, there exists a layer composed of a Cr-rich sulphide species and Cr depleted metal. The depth of penetration of S-rich precipitates into the alloy in this region varies between 20 and 40  $\mu\text{m}$ . Where a carbide precipitate extends through this region of internal damage, deeper into the alloy (left side of the pit), so too does the penetration of S in the alloy, extending a further 20  $\mu\text{m}$ . The formation of sulphide species within the alloy adjacent to the surface is often associated with type I hot corrosion, which typically occurs approximately 200°C hotter than this exposure (i.e. approximately 900°C).

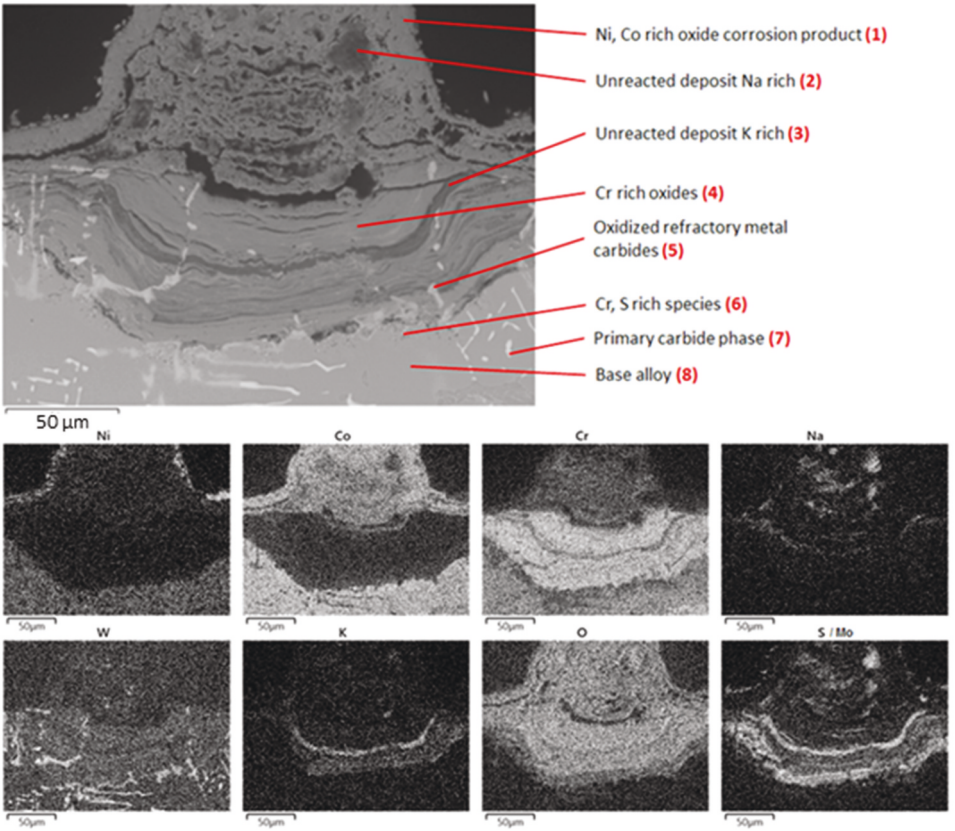
**Figure 7.** BSE image with point analysis and EDX element map of a corrosion feature on MarM 509 after 500 hours of exposure at 700 °C in an air atmosphere with 300 ppm SO<sub>2</sub>. The deposit flux was 1.5 μg/cm<sup>2</sup>/h each of 80/20 (Na/K)<sub>2</sub>SO<sub>4</sub> and Mo..

Figure 7 shows a backscattered electron image with EDX point analysis elemental quantification and maps of a broad corrosion pit feature on MarM 509 after 500 h of exposure. Although the oxidised remains of carbide precipitates are visible in the pit's corrosion product, it does not appear that this pit feature has formed around such a precipitate.

The corrosion product is comprised of multiple phases arranged in layers. The outer most layer is relatively thin (approximately 10 to 15  $\mu\text{m}$ ) and rich in both Ni and Co. Beneath this layer is a thicker (up to 100  $\mu\text{m}$ ) Co-rich layer that exists towards the centre of the pit. Within this Co-rich layer, there are regions rich in Na and S which are likely to be unreacted  $\text{Na}_2\text{SO}_4$  deposit. While Mo and S have a peak overlap in EDX, making their separation complex, this region appears with a relatively dark shade in the BSE image, indicating a lighter element, and is therefore unlikely to contain Mo, which is heavier than S and so would appear brighter.

Situated below the Co-rich layers are two Cr-rich layers bisected by a thin layer (10  $\mu\text{m}$ ) rich in K and S (likely unreacted  $\text{K}_2\text{SO}_4$  from the deposit). K and S are also shown in the element map to be present in the lower Cr-rich layer. The corrosion product adjacent to the metal surface is rich in either S or Mo. As this layer shows up brighter than the S containing species, it is likely unspent Mo originating from the deposit.

The metal at the surface of the alloy adjacent to the corrosion front features internal damage, up to 15  $\mu\text{m}$  of depth into the alloy, with an irregular distribution. EDX element mapping shows that the metal in this region is lean in Cr.

Although the corrosion feature shown in Figure 7 has evidence of mixed mode corrosion, the depth of the pit and the thickness of the oxide corrosion product layers indicate the hot corrosion mechanism may have been dominated by acidic fluxing prior to the end of the test. This type of feature does not appear on MarM 509 samples exposed in the same conditions without Mo in the deposit [8]; it is therefore likely that
