# Non-destructive evaluation of localised heat damage occurring in carbon composites using thermography and thermal diffusivity measurement

Sri Addepalli \*, Yifan Zhao, Rajkumar Roy, Wathsala Galhenege, Marine Colle, Jingjing Yu, Aziz Ucur

Through-life Engineering Services Centre, Cranfield Manufacturing, Cranfield University, Cranfield MK43 0AL, United Kingdom

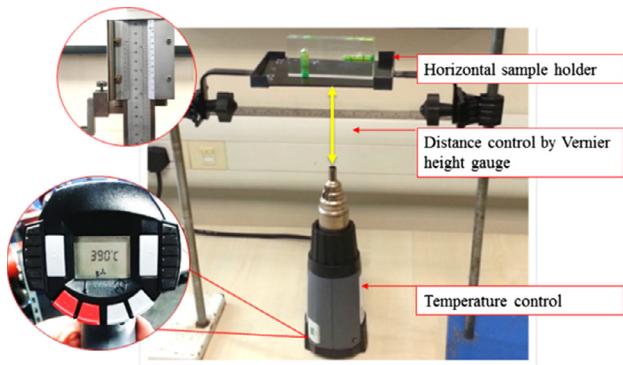
**Fig. 1.** Heat exposure test rig.

In order to maintain repeated presentation of the part, the rig was setup as seen in Fig. 1. The setup consisted of a heat gun with electronic temperature controller; two custom made holders set on the stand, the height of which was set using a Vernier height gauge with an accuracy of  $\pm 0.02$  mm. The holder was designed to match the precise location of the sample and maintain repeatability. For the selection of a suitable heat source a range of heat sources were explored during the research and included systems that used laser, infrared and resistive heating methods. With an approach to represent an in-field scenario, a hot air gun was finalised as the heat source.

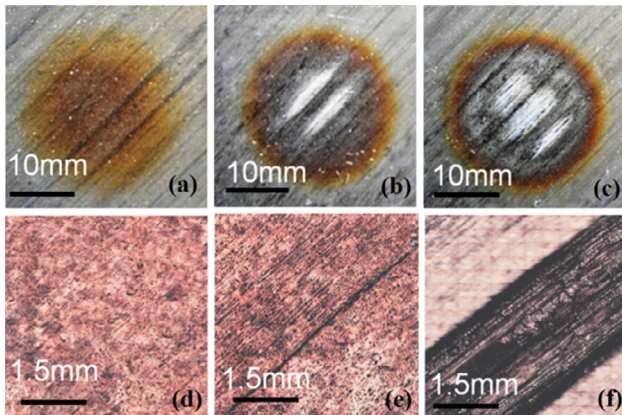
Fig. 2. Visual inspection results for laminates exposed to medium heat exposure; Digital and microscopic images: (a) (d) M2, (b) (e) M5, and (c) (f) M30.

As describe previously, the samples were exposed to two different sets of experiments. The set one had a set medium temperature of 386.2 °C with exposure durations set to 2, 5 and 30 min and set two was exposed to low and high heat conditions. The visual and microscopic indications obtained from set one are presented in Fig. 2.

As the heat gun exhaust was circular, the damage formed in this case was circular and were measured at 24 mm, 26 mm and 26 mm diameter respectively. It was observed that a 5-minute exposure caused the initial crack and a 30 min exposure produced extended cracks and blisters. As heating the laminate to the initial crack was characterised by discolouration first, a 2-minute exposure was set to capture initial discolouration to represent incipient damage. The microscopic evaluation confirmed the observed features as seen in Fig. 2, where (d) showed no significant difference; (e) the initial crack and (f) showing the full-grown damage.

Fig. 4 clearly picked up the damage caused due to heat exposure, which is also visible from a normalised line profile plot. However, it did not reveal the circular pattern as seen in the digital image (Fig. 2(c)). Also, the sample M2 showed discolouration visually and did not show any thermal response to the discolouration as presented by Fig. 5.

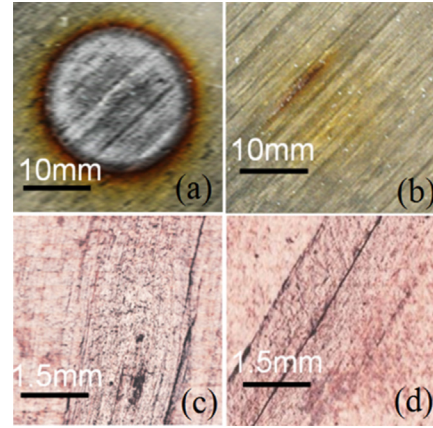
Fig. 3. Visual inspection results for laminates exposed to varying heat exposure; Digital and microscopic images: (a) (c) L220, (b) (d) H1.

It can be observed from Fig. 3 that the sample with low heat exposure (L220) showed the strongest discolouration around the periphery of the damage, whereas the laminate with high heat exposure (H1) showed only limited signs of discolouration evidenced by Fig. 3, suggesting that the discolouration is time dependant. Further, it was observed that the high heat exposure did not allow much discolouration to occur as the damage formation was instantaneous, in this case at 0.25 min due to the high exposure

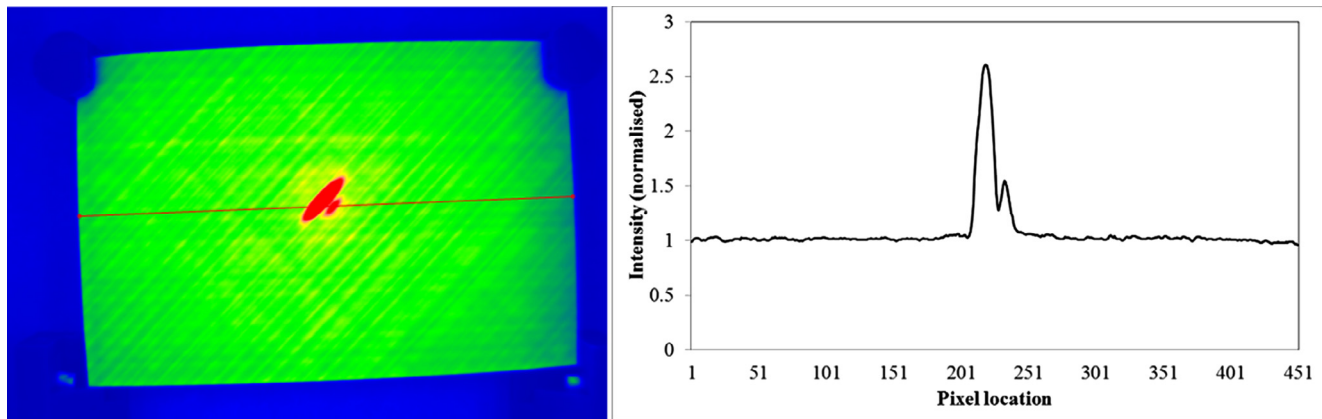
Fig. 4. RAW thermal image of the laminate M30 sampled at 0.28 s (left) and the normalised thermal line profile plot (right).

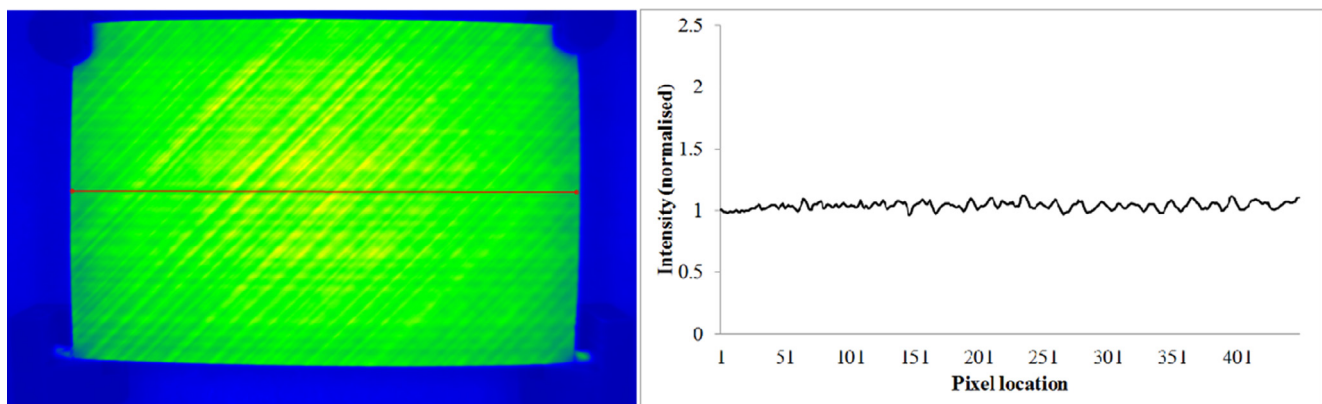
Fig. 5. RAW thermal image of the laminate exposed to medium heat for 2 min; and sampled at 0.28 s (left) and the normalised line profile plot (right).

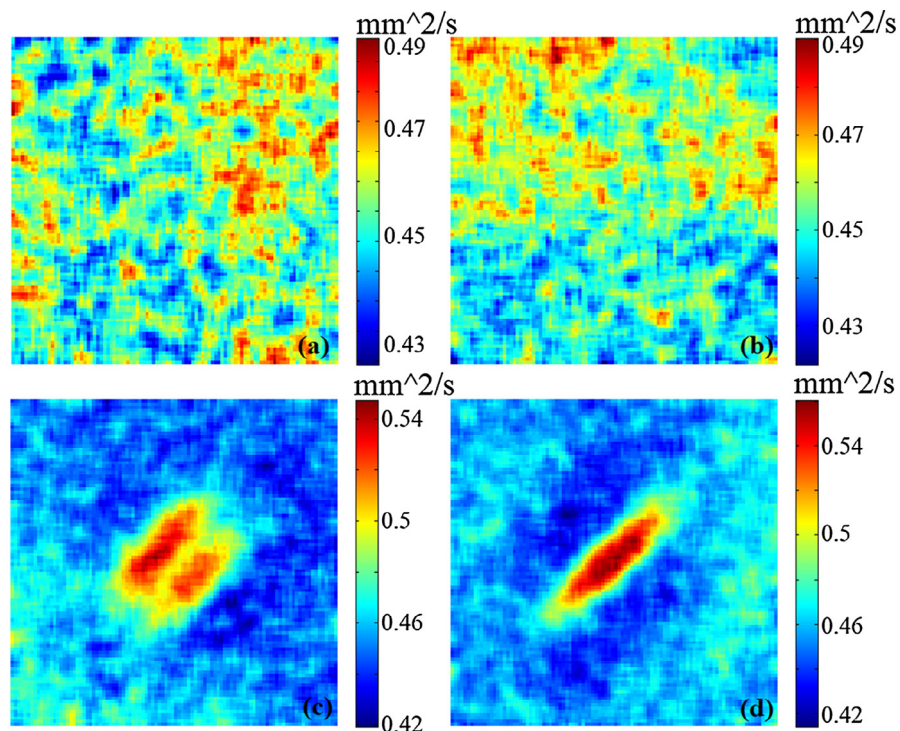
Fig. 6. Surface diffusivity maps reconstructed for an area of  $100 \times 100$  pixels using the LSD method for the laminate exposed to medium heat for (a) S1, (b) M2, (c) M5 and (d) M30.

Fig. 6 shows the results of estimated surface diffusivity maps of the considered samples.

It can be inferred from Fig. 6 that the medium heat exposed laminates clearly picked up damage caused for the initial crack (at 5 min) and extended char (30 min), but did not show major change in terms of detecting the incipient damage characterised by visible discolouration. Hence a statistical approach was adopted where histograms were plotted from multiple trials. Fig. 7 shows the results obtained from statistical analysis, where the histogram of estimated thermal diffusivity values is plotted. The 'as-is' laminate with no damage achieved an approximate Gaussian distribution confirming the thermal diffusivity of the laminate. As expected, this distribution changed owing to the presence of damage, with changes occurring even for the discolouration damage. This is evidenced by higher sigma values ( $>0.0081 \text{ mm}^2/\text{s}$ ) corresponding to the laminate heat exposure conditions. It was also observed that the sigma value increases with increase in exposure time (0.0101, 0.0112 and 0.0117  $\text{mm}^2/\text{s}$ ), indicating a larger damage area evidenced by the deviation in the thermal diffusivity of the laminate.

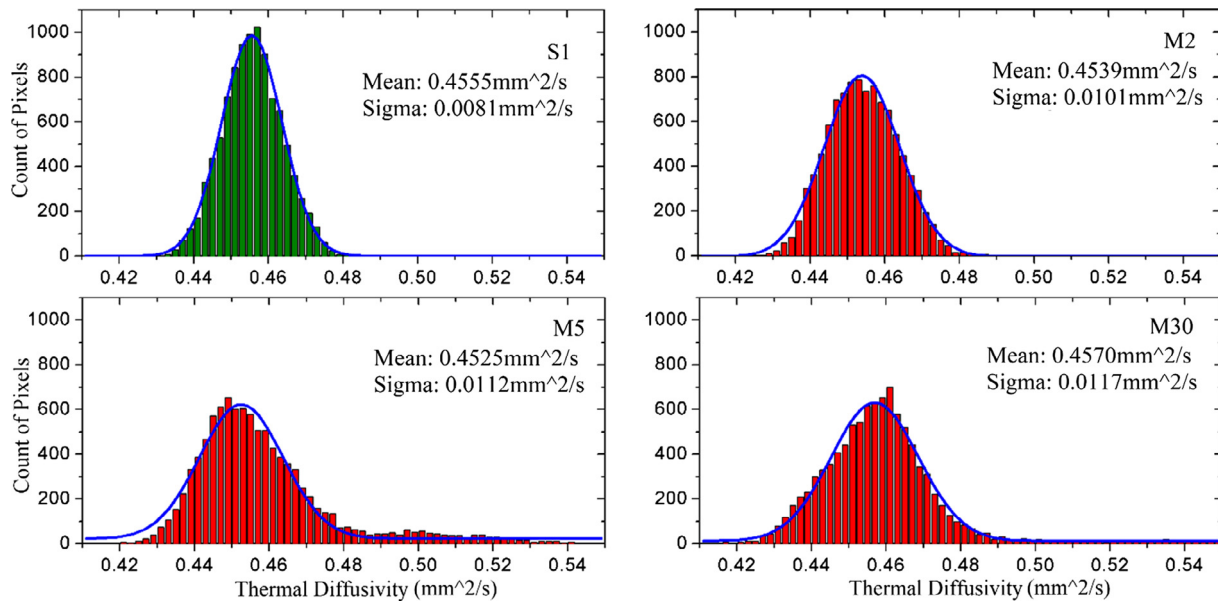
Fig. 7. Histograms plotted for laminate with no exposure and those with medium heat exposure.

Though neither the thermograms nor the diffusivity maps presented any change associated with discolouration, the histogram plot readily confirmed the presence of surface anomaly. Assuming that non-exposed or virgin laminates exhibited a normal Gaussian distribution when plotted for thermal diffusivity, the distribution completely changed for the 5 min and the 30 min exposure conditions where significant change in both the peak and coverage area

were detected with additional tailing for higher diffusivity values exceeding that of  $0.48 \text{ mm}^2/\text{s}$  as indicated by the virgin plate. It can be established from Fig. 7 that the laminates exposed at a medium heat for a 2 min exposure shifted the peak and the coverage area (also evidenced by the increase in sigma value to  $0.0101 \text{ mm}^2/\text{s}$ ) and thus it does not follow the Gaussian distribution any more. Thus, pulsed thermography clearly picked up discolouration through statistical analysis.

The statistical analysis assumed a Gaussian distribution as a reference to understand the ideal behaviour of the 'as-is' laminate. The change in distributions as seen in Figs. 7 and 9 show that the distribution has changed which can be evidenced not just by the fitting but also the sigma values of the histograms.

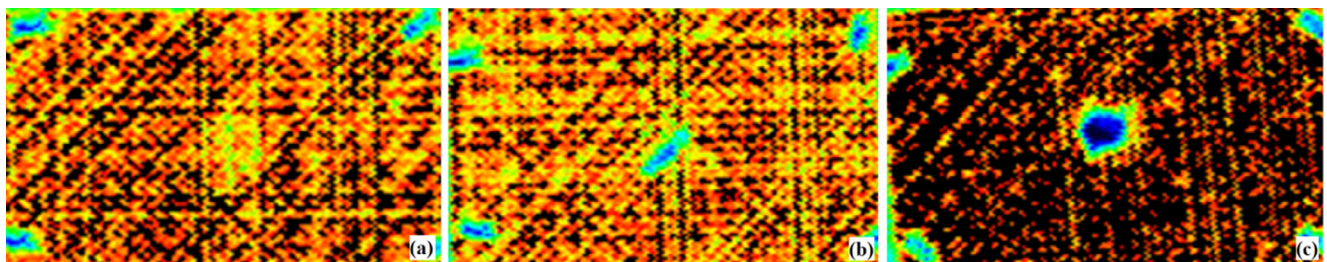
Fig. 8. Immersion UT amplitude image for laminate exposed to medium heat for (a) M2; (b) M5; (c) M30.

Again, the immersion UT results confirmed the presence of both the initial and extended cracks but failed to detect the discolouration damage other than presenting a very minor amplitude change near the exposed area as seen from Fig. 8(a) above.

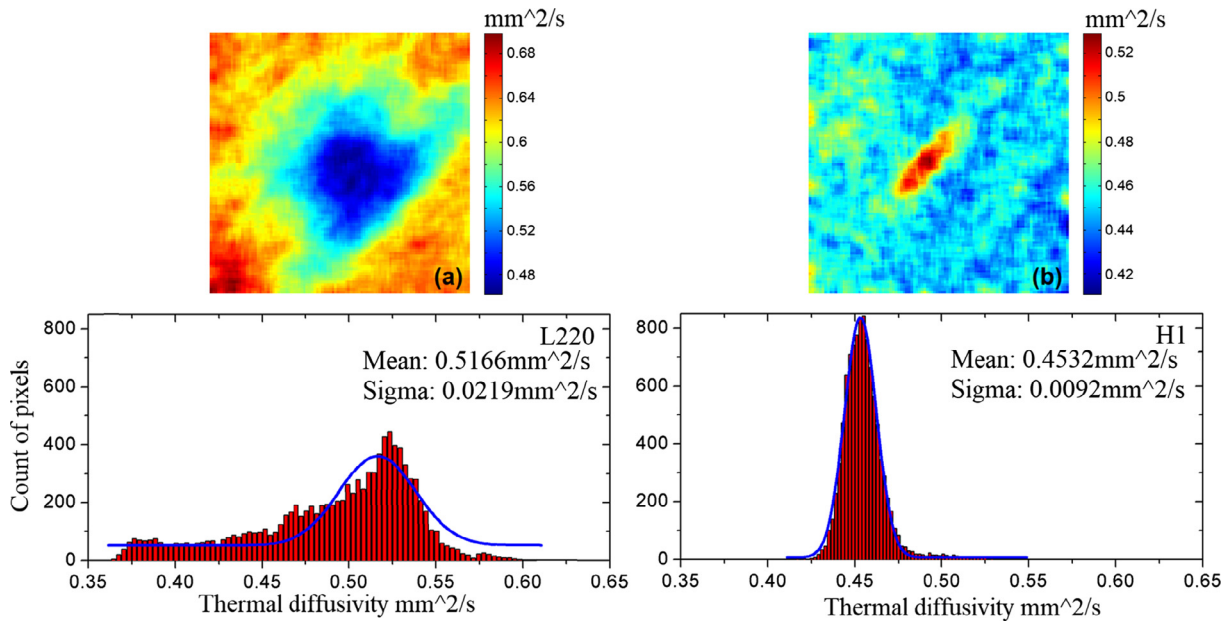
Fig. 9. Thermal diffusivity maps (above) and histograms (below) for (a) L220 (b) H1.

A similar analysis of the laminates exposed to low and high temperature exposure conditions clearly picked up damage on the laminates (Fig. 9). The diffusion map for the high heat sample represented data similar to the medium heat exposure laminates. This is due to the fact that the crack formed instantaneously within the first minute (0.25 min) indicating that the high stress to the resin fibre matrix caused the crack to appear straightaway, leaving limited or no time to undergo the extended degradation process of discolouration and charring. However, the low heat 220 min exposure caused severe localised damage as confirmed by low extended peak from the histograms. This result was found to be in line with the digital image obtained and presented in Fig. 3(a) above. It can be concluded that the sample endured an extended degradation process where there was continuous growth in the area of discolouration which extended to the back surface of the laminate. This feature was only noticed in the low temperature long expo-
