The Fourth International Conference on Through-life Engineering Services

## Degradation Assessment of Industrial Composites using Thermography

Yifan Zhao<sup>a,\*</sup>, Jörn Mehnert<sup>a</sup>, Wei Xu<sup>b</sup>, Mosab Alrashed<sup>b</sup>, Stephen Abineri<sup>b</sup>, Rajkumar Roy<sup>a</sup>
<sup>a</sup>EPSRC Centre for Innovative Manufacturing in Through-life Engineering Services, UK

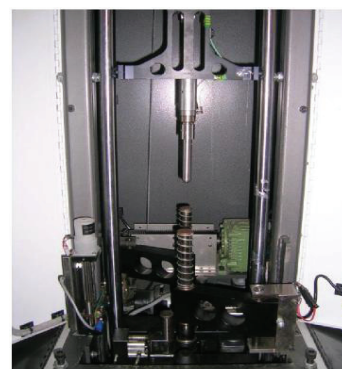
Fig. 3. Drop-weight tower.

Six plates were impacted in the middle with different energy levels using a drop-weight machine. The impactor of this

machine, as shown in Fig. 3, was semi-spherical, 16mm diameter and 2.281kg weight.
