# Normalised Root Mean Square and Amplitude of Sidebands of Vibration Response as Tools for Gearbox Diagnosis

Quick assessment of the condition of gearboxes used in helicopters is a safety requirement. One of the most widely used helicopter on-board mounted condition monitoring system these days is the Health and Usage Monitoring System (HUMS). It has been specifically designed to monitor the condition of all safety-critical components operating in the helicopter through calculation of so called Condition Indicators (CIs) – signal processing routines designed to output a single number that represents the condition of the monitored component. Among number of available parameters there is a couple of CIs that over the years of testing have earned a reputation of being the most reliable measures of the gear tooth condition. At the same time however it has been observed that in some cases those techniques do not properly indicate the deteriorating condition with the propagation of a gear tooth fault with the period

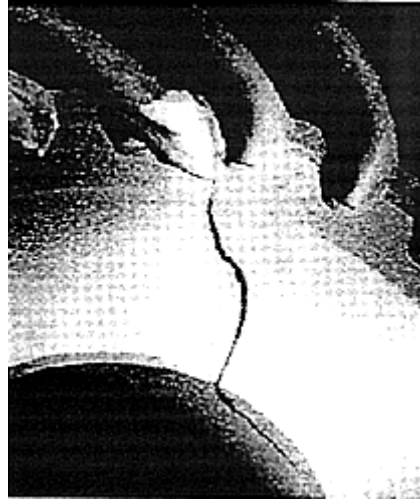
**Figure 2.** A severe gear crack that led to termination of the test [10]

The dataset comprise a total of 85 samples. After recording the last file the test was stopped due to a severe pinion gear crack. Inspection revealed that the fault initiated from the tooth root, extended through the gear web and stopped at a bearing support diameter. A photograph of the gear taken after the test is shown on Figure 2.
