The 5th International Conference on Through-life Engineering Services (TESConf 2016)

# Tensile Response of Adhesively Bonded Composite-to-composite Single-lap Joints in the Presence of Bond Deficiency

Rachana Bhanushali, David Ayre and Hamed Yazdani Nezhad\*

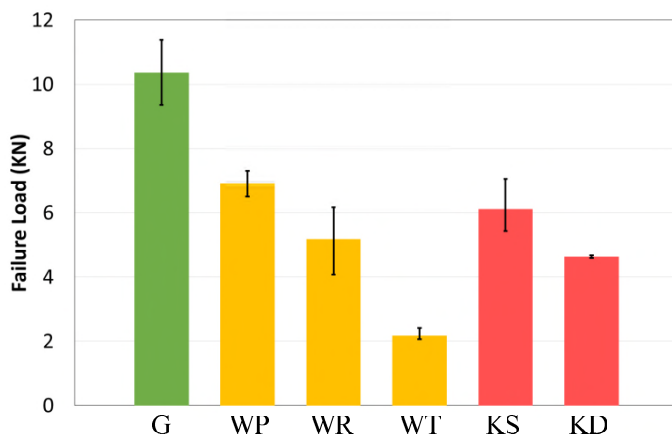
Figure 2. Comparison of failure loads in joints with different bond quality

Consistent data were obtained for each bond category, Figure 2. The KD (double-side PTFE) bond provided the most reproducible data, and WR (rapid cure) bond provided the largest spread in failure loads. The weak joint with the pre-cured bond (WP) represents an incomplete or partial curing scenario in actual bonded repair applications and is of greatest interest. The results in Figure 2 show that despite curing the centre prior to bonding the composite adherends, the joint has been able to sustain 67% of the failure load of the good bond (no defects). Whilst rapid curing using the temperature rate of 4°C/min, twice the specified rate, produced a bond which only reached 50% of the standard joint's failure load. This is approximately the same response as the joint with a double-side PTFE. Among all joint categories, the bonded joint with the reduced cure time exhibited with the greatest reduction (79%) in the failure load.

The images, figure 3, are consistent with the failure load results, figure 2. The pre-cured bond (WP) and the kissing bonds with PTFE films (KS) failed approximately at a same load and their failure mechanism appears to be similar, Figure 3. It should be noted that due to the unsymmetric bond area in the WP and KS categories, unsymmetric secondary bending is introduced, i.e. the composite adherend at the weak bond side undergoes higher bending strain.

Also of interest is the bond cured by rapid heating (WR). As seen, the morphology of the failure surface is different from the others. It has been observed that higher ramp rate could cause increased voids and increased variation in degree of cure due to temperature gradients throughout the bonded joint [14]. This significantly affects the bond and structural integrity. This category with the one with reduced curing time (WT) has both shown the lowest failure loads in Figure 2.

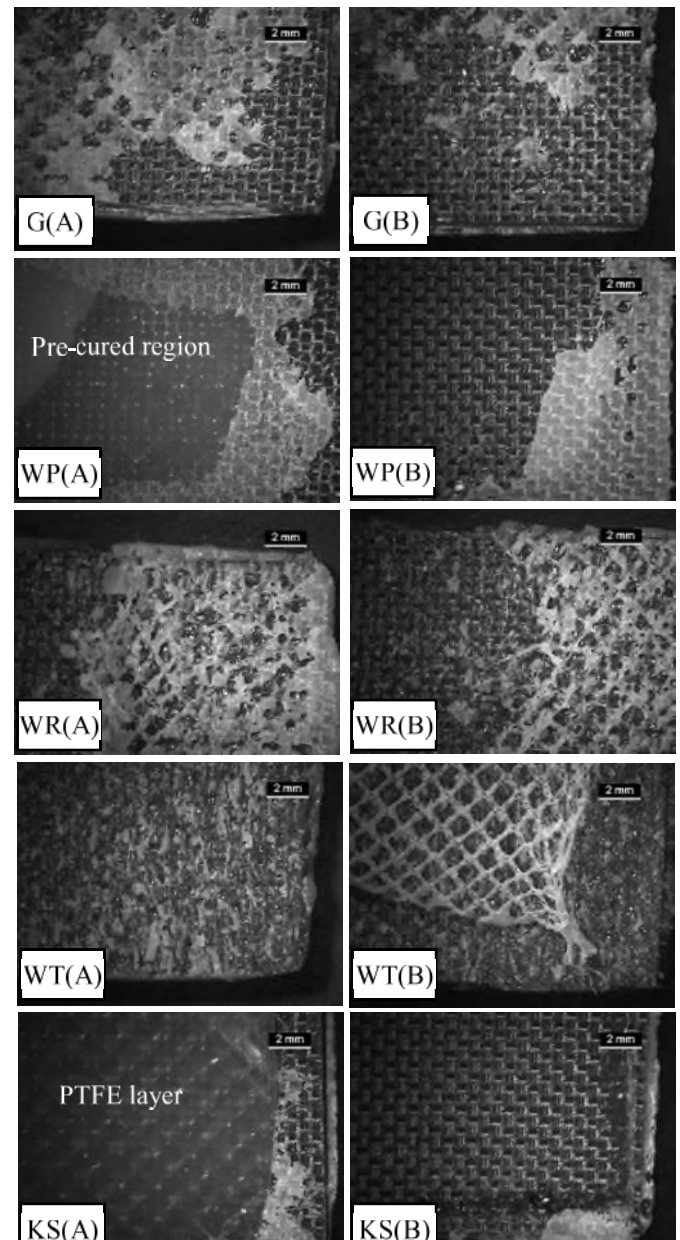
Figure 3. Microscopic images of the bonded joints after failure

All joints were observed to fail at the bond interface. The images from each adherend contact faces (A and B) of the bond of one representative joint from each category (except KD) are shown in Figure 3. Bright and dark regions represent the adhesive and the surface of the composite respectively. The images for the bonds incorporating PTFE film (KS and KD) were very similar and only images for the KS joint are presented. Any cohesive failure behavior of the adhesive was minor, with most joints exhibiting adhesive failure at the adherend/film adhesive interface. This was evident from the microscopic images in Figure 3 where the adhesive has been

observed bonded on one adherend only and peeled from the other. The only exception was the bonded joint cured in a time shorter than the others (WT), where a combination of interface and cohesive failure was observed. This is expected as in a

The adhesive films contain carrier cloth which, based on our observations, did not fail (see e.g. WT(B) in Figure 3), and thus is believed to be directing damage toward the interface. The bond thickness was relatively low (0.25mm) compared to the Standard [10] recommendation (0.76mm). This difference should reduce the joint eccentricity but the reduced thickness is expected to experience higher peel strain from geometry effects.

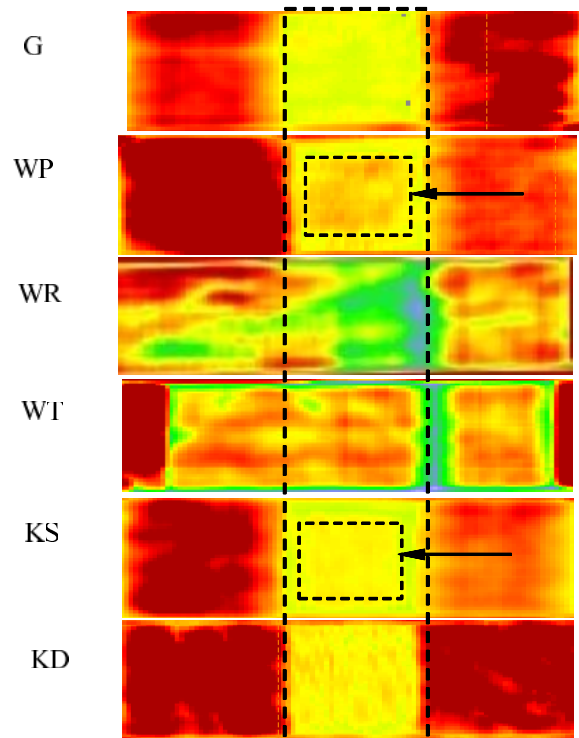
Figure 4. C-scan images of the bonded joints before test (outer dashed line represents the overlap bonded region of the joints (25mm×25mm) while inner dashed lines with arrows represents 20mm×20mm disbond at the centre of the overlap for WP and KS joints)

The C-scanned images of the joints' overlap region is shown in Figure 4, carried out using the parameters given in section 2.3 (the outer dashed line represents the overlap bonded region for all joints). Note that the C-scan images represents attenuation of a probe signal through the two composite adherends and the adhesive (bond). However as the significant difference is expected to arise from the adhesive (bond), and not in the adherends, the difference seen in the colour contours is referred to as defects. Taking the good bond with green/yellow contours as the reference for a bond with no defect, apparent differences observed for the rest of the joints are a sign of bond deficiencies. The WR and WT joints have also shown a clear mismatch and difference in the whole overlap region of the bond, compared to the image of the good bonded joint. This is in agreement with the results in Figure 2 where WR and WT had the most significant drop in failure load compared to the good bond. Clearly for the joint with reduced cure time, the C-scan is able to qualitatively capture the significant mismatch in the adhesion and bulk properties of the pre-maturely cured bond. Moreover, the main outcome from the figure is that the ultrasound technique clearly highlights the bond deterioration at the centre of the overlap region for WP (pre-cured bond) and KS (single-PTFE bond). This central region captured by NDI, shown by the arrows in the figure, represents the 20mm×20mm disband intentionally introduced at the centre of the overlap for WP and KS joints. Surprisingly, the disbond region is not observed for the KD joint which has

two PTFEs at either side of the bond. Understanding this requires further investigation.
