# Effect of Dissolved CO<sub>2</sub> on the Interaction of Stress and Corrosion for Pipeline Carbon Steels in Simulated Marine Environments

Shamsuddeen Ashurah Abubakar, Stefano Mori and Joy Sumner \*

Centre for Energy Engineering, Energy and Sustainability Theme, School of Water, Energy and Environment, Cranfield University, Bedfordshire MK43 0AL, UK; s.abubakar@cranfield.ac.uk (S.A.A.); stefano.mori@cranfield.ac.uk (S.M.)

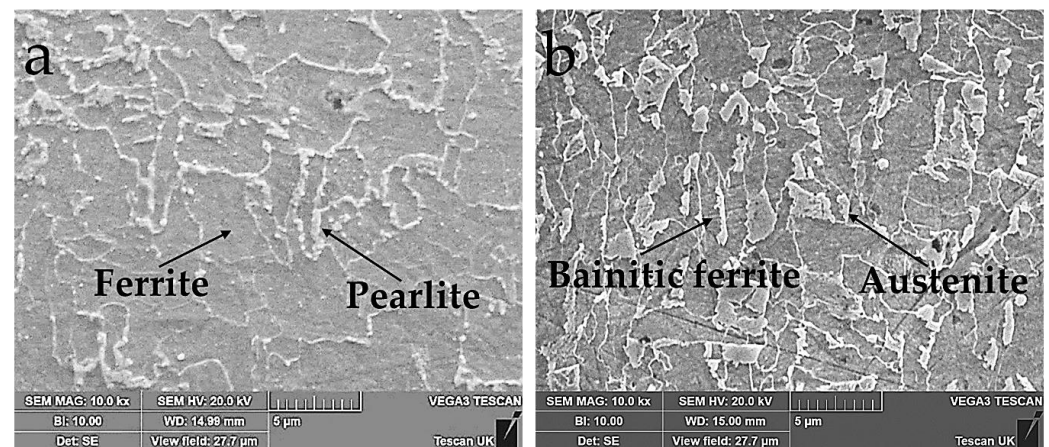
**Figure 1.** Microstructures of the exposed carbon steels as observed via scanning electron microscopy: (a) API 5L X70; (b) API 5L X100.

The materials exposed in this work are API 5L X70 and X100 carbon steels. As observed from Scanning electron microscopy (SEM, Tescan, Brno—Kohoutovice, Czech Republic). (Figure 1a,b, respectively), the X70 steel is composed of globular ferrite grains with grain boundary pearlite grains and coarse dispersion of precipitates, while the X100 steel is made up of bainitic ferrite grains with finely dispersed austenite grains. This is consistent with the literature [27–30]. The micrographs were obtained by polishing the ground surfaces using a 1  $\mu\text{m}$  diamond suspension to obtain a mirror surface finish and then etched with a

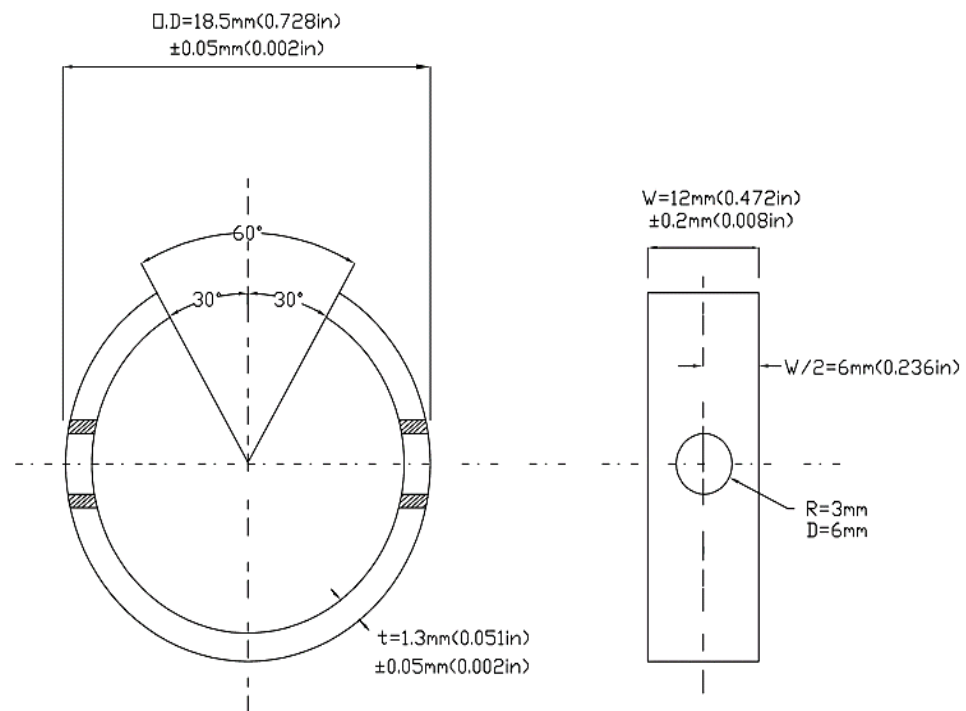
**Figure 2.** C-ring design and dimensions.

C-ring samples were used to assess the impact of CO<sub>2</sub> in 3.5% NaCl solution on the stress corrosion resistance of API 5L X70 and X100 carbon steels. The samples were designed in accordance with the ASTM G38-01 [31] and NACE TM0177-05 standards [32], using ratios of between 10–100 outer diameter to wall thickness (diameter/thickness) and between 2–10 (width/thickness). This provided final sample dimensions of 18.5 mm outer diameter, 1.3 mm wall thickness, and 12 mm width, finished with a 600 grit (P1200). Figure 2 shows the C-ring design.

A constant strain method was used to stress the specimens to the desired stress levels of 80% and 95% of the yield strength for unnotched samples and notched samples stressed at 80% Y.S. Table 2 shows the as-received yield strength of the carbon steels and calculated desired yield strength. Notched samples were machined by engraving 200 μm V-notches across the top center of the C-ring to create a triaxial stress condition adjacent to the root of the notch on the specimens' surfaces. The stress is exerted on the diameter of the C-ring by tightening a bolt at a calculated distance based on the C-ring's outer diameter, its elastic modulus, and wall thickness as outlined in the ASTM G38-01 standard [31] and shown in Equation (7):

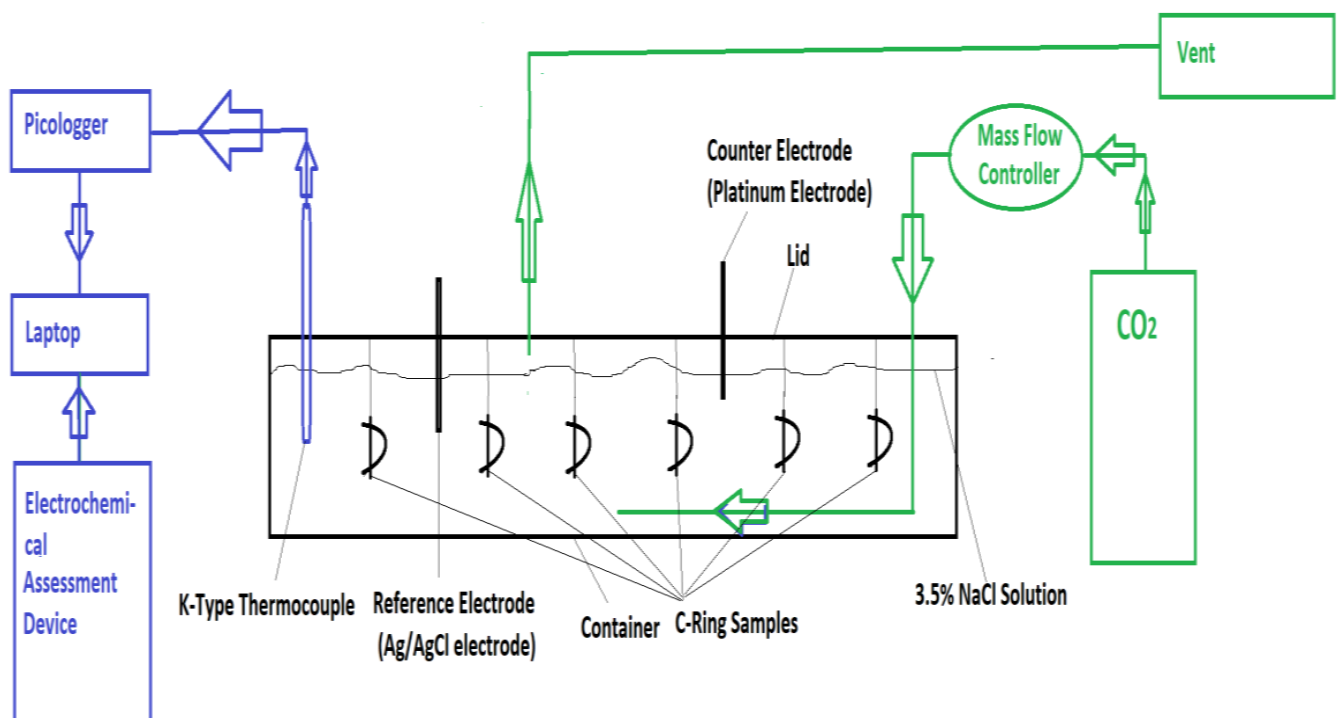
Figure 3. Schematic diagram of the test cell.

Sodium chloride was mixed to give 3.5% salinity (35 g of sodium chloride dissolved in every 1 liter of deionized water). The 3.5% NaCl solution was transferred into a three-electrode electrochemical cell. Figure 3 shows the schematic diagram of the test cell. The test cell solution was then heated or cooled to the desired temperature. The stressed specimens were suspended in the test cell and then the cell was sealed. Depending on the test condition, the desired gas was continuously bubbled in the test cell at 50 mL/min flow rate. N<sub>2</sub> was used to deoxygenate the solution and CO<sub>2</sub> was used to lower the pH from a near-neutral pH of about 7.2 to 5.6 and 6.1 at 5 °C and 25 °C, respectively. The test conditions were maintained for 5 weeks for each experiment. Table 3 presents a summary of the different test conditions and exposed samples.

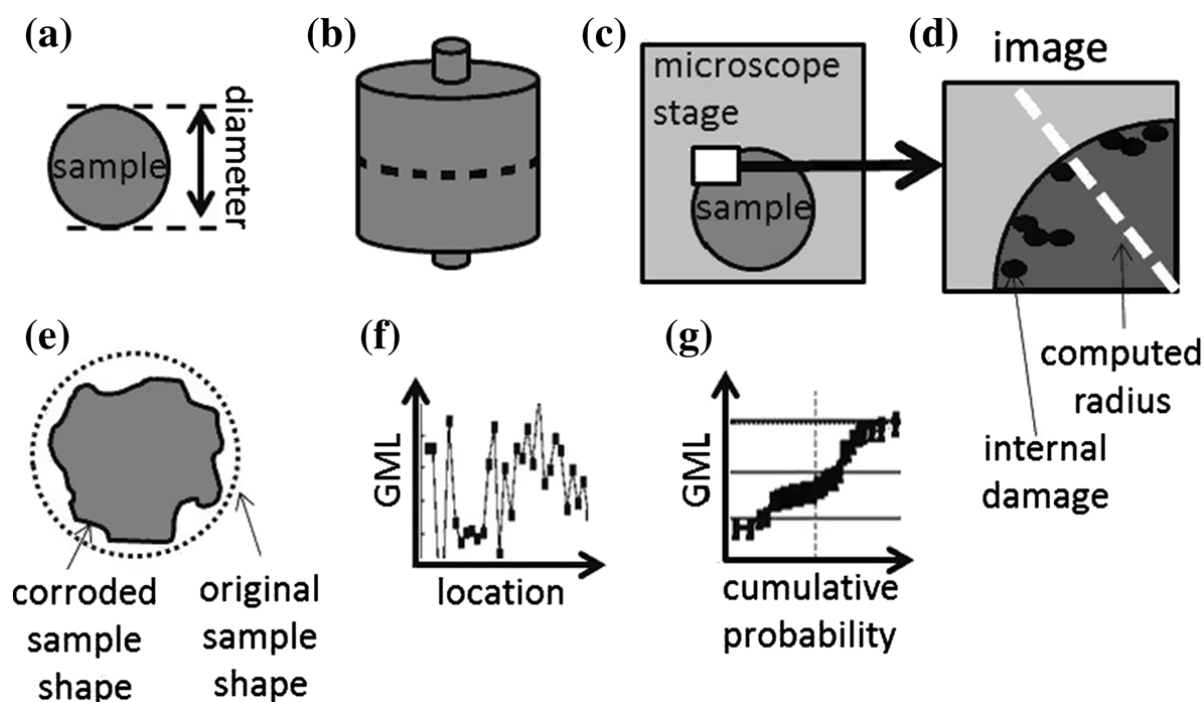
**Figure 4.** Dimensional metrology technique stages to determine metal loss of the exposed samples. Reprinted with permission from Refs. [38,39]. 2015 Taylor & Francis. (a) Pre-exposure dimensions are taken from the samples; (b) the samples are then exposed and cross-sectioned at a high-stress point; (c) the samples are placed on an x-y calibrated Leitz Wetzlar AxioCam ICc 1 microscope (Zeiss group, Oberkochen, Germany) stage with an image analyzer subroutine to measure evenly spaced images of the sample; (d) key points such as internal damage and remaining metal on the image are selected; (e) comparison of pre- and post-exposure sample radii; (f) acquiring a range of different metal losses or internal damage, formed oxides, or scale thicknesses around the sample; and (g) data ordering from most to least damaged to give the cumulative probability of damage [38,39]. The collected data are plotted against cumulative normal distribution (in standard deviations) with a metal loss error of  $\pm 5 \mu\text{m}$ .

Scanning electron microscopy (SEM, Tescan, Brno—Kohoutovice, Czech Republic), energy dispersive spectroscopy (EDS, Oxford Instruments Inc., Oxfordshire, United Kingdom), and X-ray diffraction (XRD, Siemens, Munich, Germany) analysis were carried out on the exposed samples. The scanning electron microscopy images and energy dispersive spectroscopy (EDS) data were obtained via a Tescan Vega 3 Large SEM and Oxford Instruments AztecEnergy V2.2 with AztecHKL V2.2 software (Oxford Instruments Inc., Oxfordshire, United Kingdom). An error of  $\pm 5\%$  was assumed for all EDS measurements [37]. The X-ray diffraction analysis was carried out using a Siemens D5005 X-Ray Diffractometer and a Bruker DIFFRAC plus XRD Commander V2.4.1 with EVA V5.0 software (Siemens, Munich, Germany). Dimensional metrology was also conducted on the stress-oriented sections of the exposed samples in accordance with Sumner et. al. [38,39]. Figure 4 show the stages of the dimensional metrology technique to determine the metal loss.

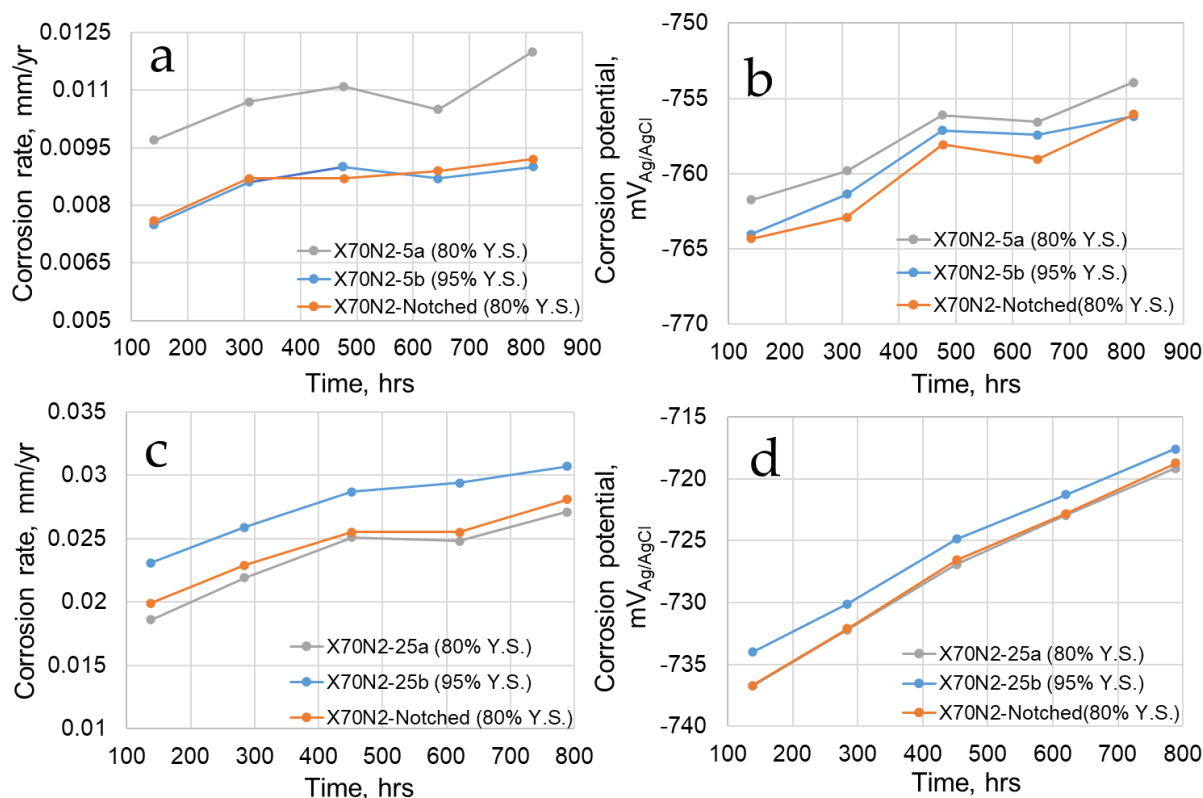
**Figure 5.** Corrosion rates and potentials of the exposed X70 carbon steel C-rings in simulated saltwater solution with  $\text{N}_2$ : (a) corrosion rates at  $5^\circ\text{C}$ ; (b) potentials at  $5^\circ\text{C}$ ; (c) corrosion rates at  $25^\circ\text{C}$ ; and (d) potentials at  $25^\circ\text{C}$ .

Figure 5a–d present the corrosion rates and potentials of the exposed X70 carbon steel samples in solution with  $\text{N}_2$  at 5 °C and 25 °C.

As shown in Figure 5c, continuous increases in corrosion rates with time were observed with a maximum value of 0.0307 mm/year for the sample stressed to 95% Y.S. at 788 h at 25 °C; however, a decrease was observed for the sample stressed to 80% Y.S. and the notched sample at 620 h of exposure. Corrosion rate fluctuations were observed for all samples at 5 °C (Figure 5a). A decrease in corrosion rates was observed for samples stressed at 80% Y.S. and 95% Y.S. at 644 h of exposure; however, a decrease was observed for the notched sample at 477 h of exposure. This trend in corrosion rates could be explained to occur as a result of the continuous formation and rupture of their formed surface films (iron oxide). This causes fluctuations in the cathodic reaction rates taking place on the samples' surfaces, leading to variations in corrosion rates with time. The samples stressed at 80% Y.S. and 95% Y.S. (Figure 5a,c, respectively) were observed to show higher corrosion rates. This occurred as a result of an error in the placement of the samples in the test cell, which led to differential aeration on the exposed samples. Different corrosion potentials were observed on the exposed carbon steels in the simulated 3.5% NaCl solution. This shows the change in the thermodynamic behavior of the different steels with a change in the material's microstructure and solution temperature. A continuous increase in potential was observed throughout the duration of the experiment (Figure 5d) with a maximum value

of  $-718 \text{ mV}_{\text{Ag}/\text{AgCl}}$  obtained from the sample stressed to 95% of Y.S. at  $25^\circ\text{C}$ . At  $5^\circ\text{C}$ , a decrease in potential was observed for all samples at 648 h of exposure, with a maximum value of  $-754 \text{ mV}_{\text{Ag}/\text{AgCl}}$  observed for the sample stressed at 80% Y.S. (Figure 5b).

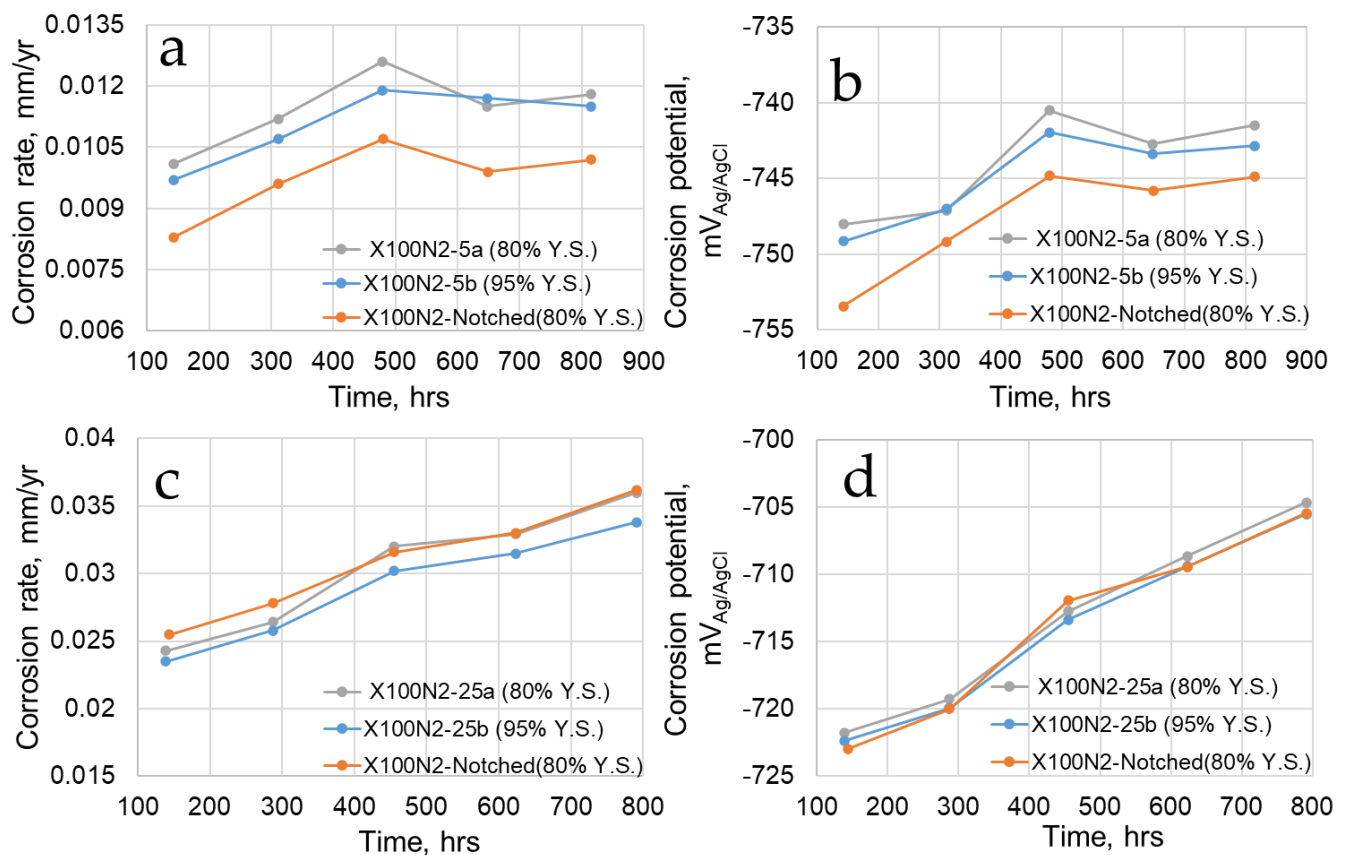
**Figure 6.** Corrosion rates and potentials of the exposed X100 carbon steel C-rings in simulated saltwater solution with N<sub>2</sub>: (a) corrosion rates at 5 °C; (b) potentials at 5 °C; (c) corrosion rates at 25 °C; and (d) potentials at 25 °C.

The X100 samples (Figure 6a,c) were observed to have higher corrosion rates with a maximum of 0.0362 mm/year for the notched sample in comparison with the X70 samples in solution with  $\text{N}_2$  at  $25^\circ\text{C}$ . This shows that the presence of  $\text{N}_2$  gas in the solutions has not much of an effect on the corrosion rate of the different exposed carbon steels. Similarly, fluctuations in corrosion rates and potentials with time were observed on the X100 samples at both  $5^\circ\text{C}$  and  $25^\circ\text{C}$ . A decrease in corrosion rate was observed for the sample stressed at 80% Y.S. and the notched sample at 648 h of exposure at  $5^\circ\text{C}$ . However, a continuous decrease was observed for the sample stressed to 95% Y.S. after 648 h. Similarly, lower corrosion rates were observed on the notched sample relative to the un-notched samples, as in the case of X70 samples stressed at 80% Y.S. and 95% Y.S. (Figures 5a and 5c, respectively). This can also be explained to occur as a result of differential aeration in the test cell. A continuous increase in corrosion rates with time was observed on all samples at  $25^\circ\text{C}$ . Maximum potential values of  $-742 \text{ mV}_{\text{Ag}/\text{AgCl}}$  and  $-705 \text{ mV}_{\text{Ag}/\text{AgCl}}$  (Figure 6b,d), respectively, were observed for the samples stressed at 80% Y.S. at  $5^\circ\text{C}$  and  $25^\circ\text{C}$ . In general, corrosion potential values were observed to change with solution temperature and

material grade. More negative potential values were observed on all samples exposed at 5 °C.

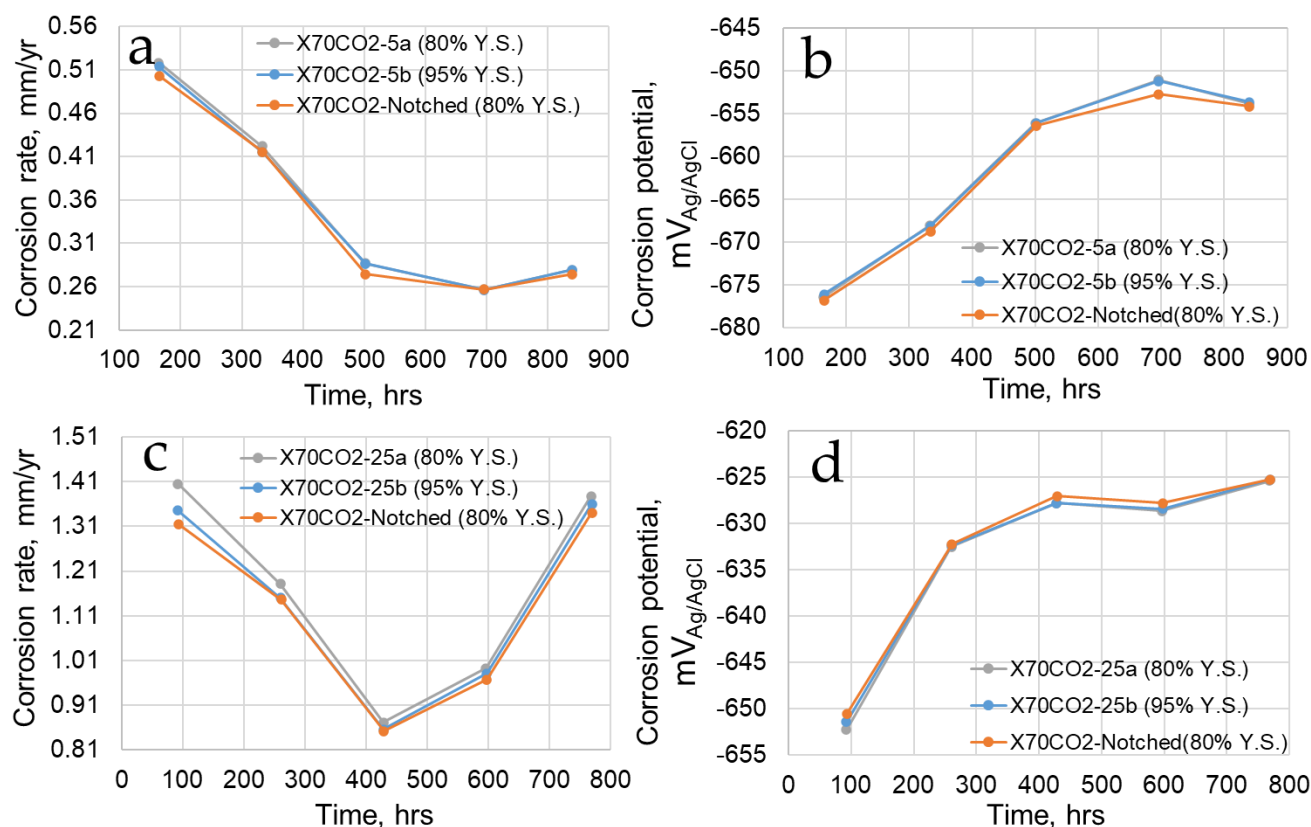
**Figure 7.** Corrosion rates and potentials of the exposed X70 carbon steel C-rings in simulated saltwater solution with CO<sub>2</sub>: (a) corrosion rates at 5 °C; (b) potentials at 5 °C; (c) corrosion rates at 25 °C; and (d) potentials at 25 °C.

The corrosion rates obtained from the X70 samples exposed to solution with CO<sub>2</sub> (Figure 7a,c) were observed to be much higher than those obtained from solution with N<sub>2</sub>. Figure 7a–d present the corrosion rates and potentials of the X70 samples exposed to CO<sub>2</sub> medium at 5 °C and 25 °C. It was observed that the higher the applied stress level, the higher the corrosion rates, while at 25 °C, the higher the applied stress, the lower the corrosion rates. A maximum corrosion rate value of 1.405 mm/year and a minimum of 0.8521 mm/year was obtained for the sample stressed to 80% Y.S. at 25 °C. The calculated corrosion rate values are more or less similar to the values reported by Zhang et al. [44]. A value of 0.9911 mm/year was observed on X70 carbon steel exposed to a soil-extracted solution saturated with 100% CO<sub>2</sub> at ambient temperature. Similarly, Silva et al. [4] reported a corrosion rate value of 1 mm/year to 1.3 mm/year observed on X65 carbon steel exposed to 3.5% NaCl solution saturated with CO<sub>2</sub>. Several literature-based predictive models have been developed to forecast corrosion rates of pipelines in CO<sub>2</sub>-containing solutions, namely, empirical/semi-empirical, elementary mechanistic, and comprehensive mechanistic models [45]; other predictive models include principal component analysis (PCA), multi-layer perceptron neural network (MLPNN), multiple linear regression (MLR), and radial basis function neural network (RBFNN) models [46]. Alsalem et al. [47] developed a model to estimate the corrosion rate of carbon steel in CO<sub>2</sub>-saturated NaCl solution at 25 °C. The predictive model forecast corrosion rate value (about 1.21 mm/year) was similar to our observed corrosion rate, with a maximum value of 1.405 mm/year and a minimum of 0.8521 mm/year. However, the model did not take into consideration the impact of stress on the corrosion of the tested specimens.

Variations in corrosion rate trends were observed on the X70 (Figure 7c) and X100 (Figure 8c) samples exposed to solution with CO<sub>2</sub> at 25 °C. The observed change in the corrosion rates occurred with time, with a continuous increase observed in Figure 7c and a continuous decrease in Figure 8c. X-ray diffraction (XRD) analysis was conducted on the exposed samples and revealed the presence of an iron carbonate layer (FeCO<sub>3</sub>). Figure 9 shows the XRD analysis of an X70 sample exposed at 25 °C. This implies that the steels were able to form a surface layer of iron carbonate in the saturated CO<sub>2</sub> solution, which could serve as a protective film on the surfaces, thereby decreasing the corrosion rate [4,47,50]. Its effect decreases the cathodic reaction rate by surface blocking with the formation of FeCO<sub>3</sub> crystals. This hinders the ability of electro-chemically active species to take part in the charge-transfer process [4,51]. The formation of the iron carbonate layer was observed to strongly depend on the microstructure of the steel and the solution's temperature [52]. The obtained corrosion rate values of the exposed samples indicated lower values in comparison with the reviewed literature corrosion rates of carbon steels in CO<sub>2</sub> environments [4]. This can be explained as a result of the low flow rate pressure (atmospheric pressure) that was applied to the CO<sub>2</sub> in the solution [53].

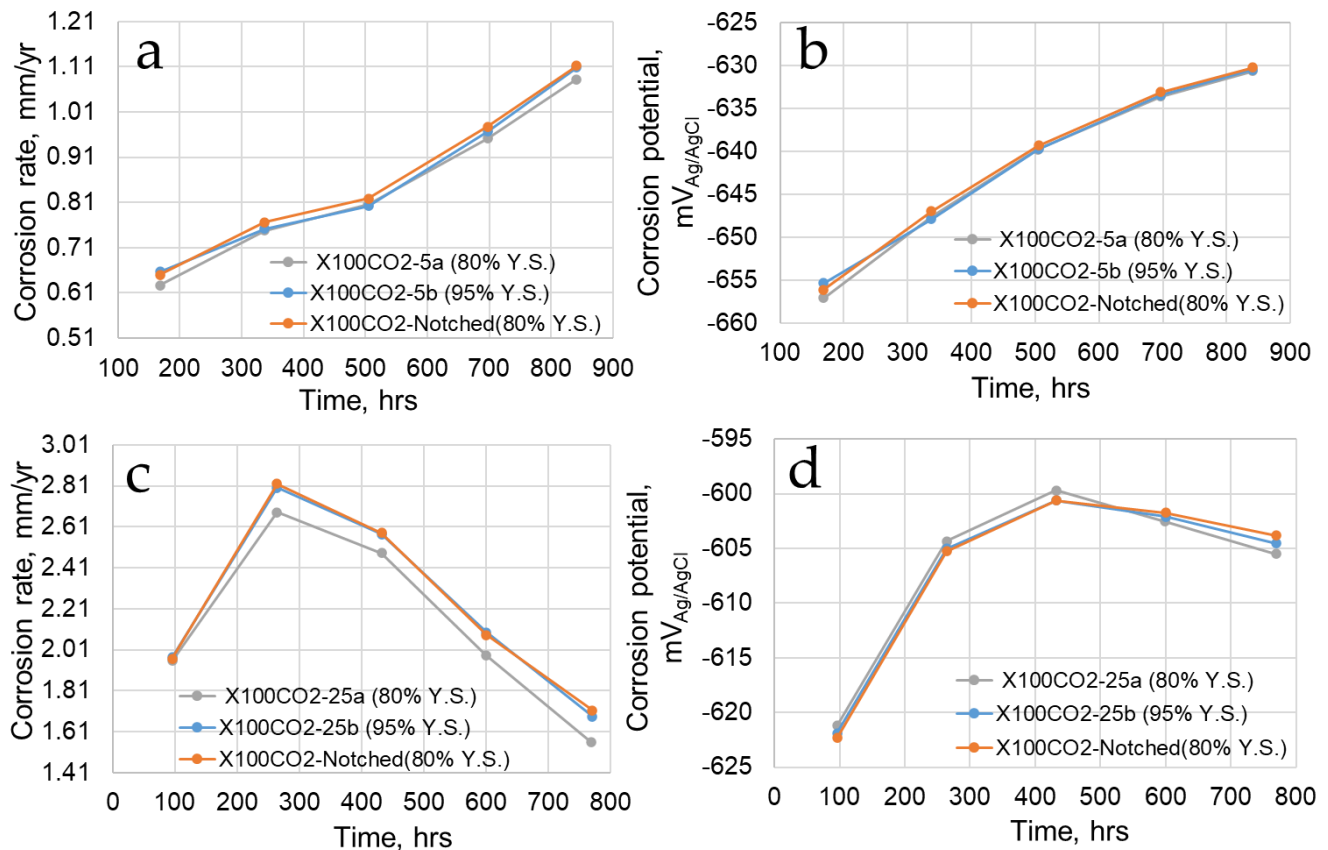
**Figure 8.** Corrosion rates and potentials of the exposed X100 carbon steel C-rings in simulated saltwater solution with CO<sub>2</sub>: (a) corrosion rates at 5 °C; (b) potentials at 5 °C; (c) corrosion rates at 25 °C; and (d) potentials at 25 °C.

The corrosion rates of the X100 samples (Figure 8a,c) were observed to decrease with increasing applied stress levels at 5 °C, while at 25 °C the corrosion rate increased with increasing applied stress. This trend in corrosion rate variations could be said to occur as a result of stressed-induced diffusion of the formed oxides into the steel's microstructure [48,49]. This phenomenon depends on changes in the solution temperature and the carbon steel's microstructure. Figure 8a,d show the corrosion rates and potentials of the exposed X100 carbon steels. Maximum and minimum corrosion rate values of 2.8211 mm/year and 1.7141 mm/year at 264 h and 770 h of exposure were observed on the notched sample at 25 °C. Gadala and Alfantazi [50] reported a corrosion rate value of 2.3360 mm/year observed on X100 carbon steel exposed to NS4 soil solution saturated with CO<sub>2</sub> at 25 °C. In general, the corrosion rates of X70 at 5 °C were observed to continuously decrease with time, with a continuous increase for the X100 samples. At 25 °C, a continuous increase was observed after 429 h of exposure time for the X70 samples, with a decrease after 264 h of exposure for the X100 samples. In general, the X100 samples at all exposure conditions were observed to show higher corrosion rates relative to the X70 samples. This indicates that the X100 samples have higher corrosion current density, which leads to higher corrosion rates. Variations in corrosion potentials were observed on all exposed material grades with changes in solution temperature. At 5 °C, a decrease in potential was only observed for the X70 samples at 840 h, with a continuous increase for the X100. A decrease in potential was observed at 597 h and 432 h of exposure, respectively, for the X70 and X100 samples at 25 °C. A maximum potential of  $-625 \text{ mV}_{\text{Ag}/\text{AgCl}}$  was obtained for the X70 notched sample stressed to 80% Y.S., and  $-604 \text{ mV}_{\text{Ag}/\text{AgCl}}$  for the X100 notched sample at 25 °C. This clearly indicates variation in the thermodynamic behavior of the different material grades with changes in microstructures and solution temperatures. As observed in Figure 7b,d and Figure 8d, variations in the corrosion rates and the trend in the potentials can occur on samples, as the potential only serves as an indication of the thermodynamic

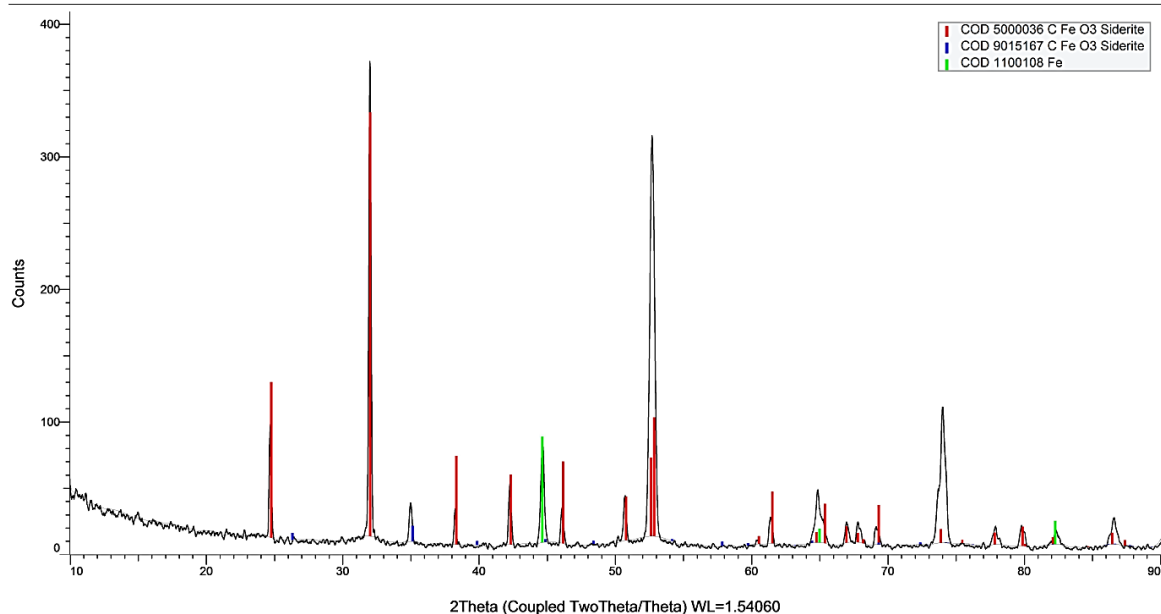
## X70CO2-25 (Coupled TwoTheta/Theta)

**Figure 9.** XRD analysis of exposed X70 specimen in simulated saltwater solution with CO<sub>2</sub> at 25 °C after 840 h.

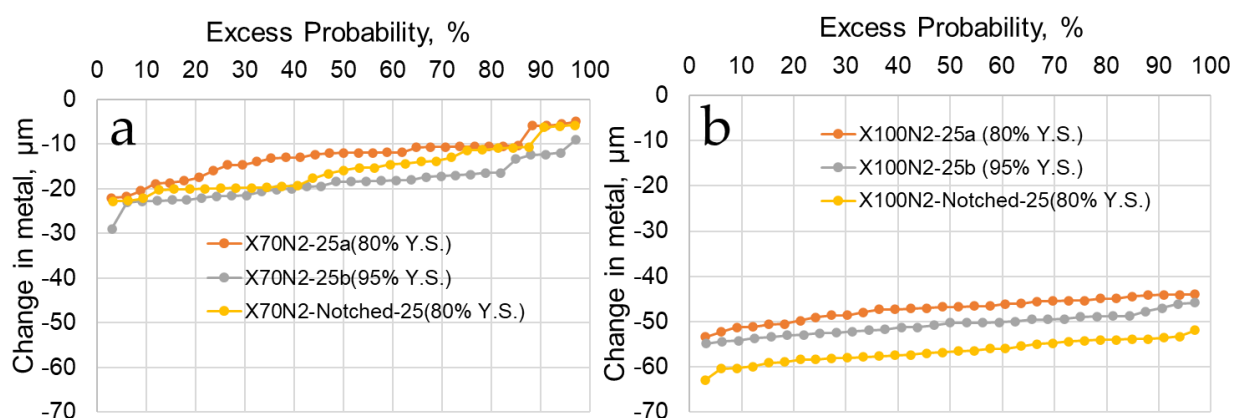
**Figure 10.** Cumulative probability of metal loss exceedance graphs of C-ring samples exposed to simulated saltwater solution with N<sub>2</sub> at 25 °C: (a) X70 samples; (b) X100 samples.

Dimensional metrology of the samples after an exposed period of 840 h was conducted via optical microscopy. The measured samples' coordinates were used to calculate the cumulative probability of metal loss exceedance. Figure 10a,b, respectively, show the cumulative probability of metal loss exceedance obtained from the datasets of the exposed X70 and X100 samples in solution with N<sub>2</sub> at 25 °C. The dataset for the X70 sample stressed at 80% Y.S. shows a relatively low metal change over half of the sample surface. An even distribution of metal loss was observed over most of the sample that was stressed at 95% Y.S., with the significant formation of pits below the 6% or less probability level. The notched sample presented a more significant metal change over the sample's surface. The dataset for the X100 samples at all levels of applied stress presents a relatively low metal change throughout the majority of the samples with an even damage distribution.

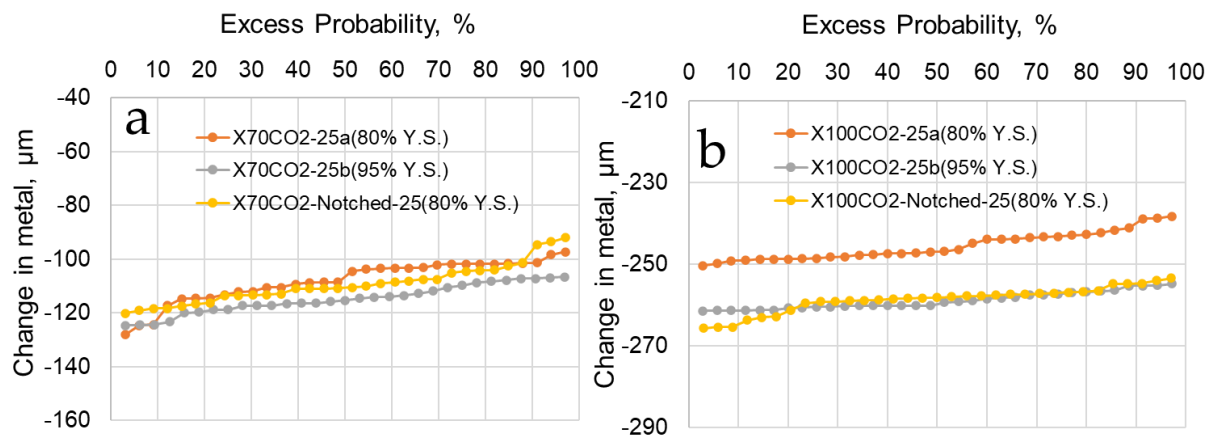
**Figure 11.** Cumulative probability of metal loss exceedance graphs of C-ring samples exposed to simulated saltwater solution with  $\text{CO}_2$  at 25 °C: (a) X70 samples; (b) X100 samples.

Datasets for the X70 and X100 samples exposed to solution with CO<sub>2</sub> at 25 °C as shown in Figure 11a,b, respectively, show a relatively significant metal loss at all stress levels and probability but with low pit features. Relatively even and lower distributions

of metal change were observed on the X70 sample stressed at 95% Y.S., with higher pit formation below the 12% probability level for the sample stressed to 80% Y.S. The X100 notched sample presented a higher probability of about 24% or less to form pitting on the sample's surface. The calculated corrosion rates of the exposed samples tally with the obtained metal loss values when converted to 5 weeks of exposure time. For example, a maximum value of 2.8211 mm/year was calculated for the X100 notched sample; however, converting to a metal loss value of 5 weeks resulted in a value of 271  $\mu\text{m}$  ( $\pm 5 \mu\text{m}$ ).

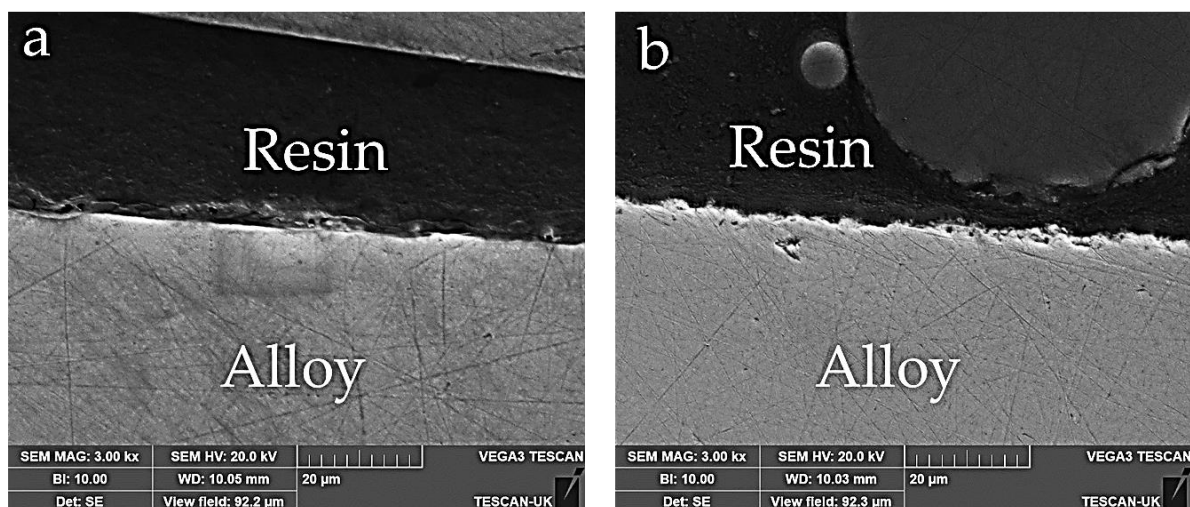
**Figure 12.** SEM secondary electron images of the exposed X70 C-ring samples in simulated saltwater solution with  $\text{N}_2$  stressed at 80% Y.S.: (a) at 5 °C; (b) at 25 °C.

Conducting scanning electron microscopy analysis of the exposed samples after testing provided a better understanding of the materials' SCC behavior in the tested environmental conditions. Cross-sectional areas of the stress-oriented sections of the exposed samples were examined in order to understand the type of corrosion morphology on the samples' surfaces. Figure 12a,b, respectively, show the SEM images of the X70 samples stressed at 80% Y.S. exposed to solution with  $\text{N}_2$  at 5 °C and 25 °C. The samples were observed to show little surface roughness at 25 °C, with a different morphology from that formed at 5 °C. A considerable degree of anodic dissolution was observed on the samples at 5 °C, which was greater at 25 °C.

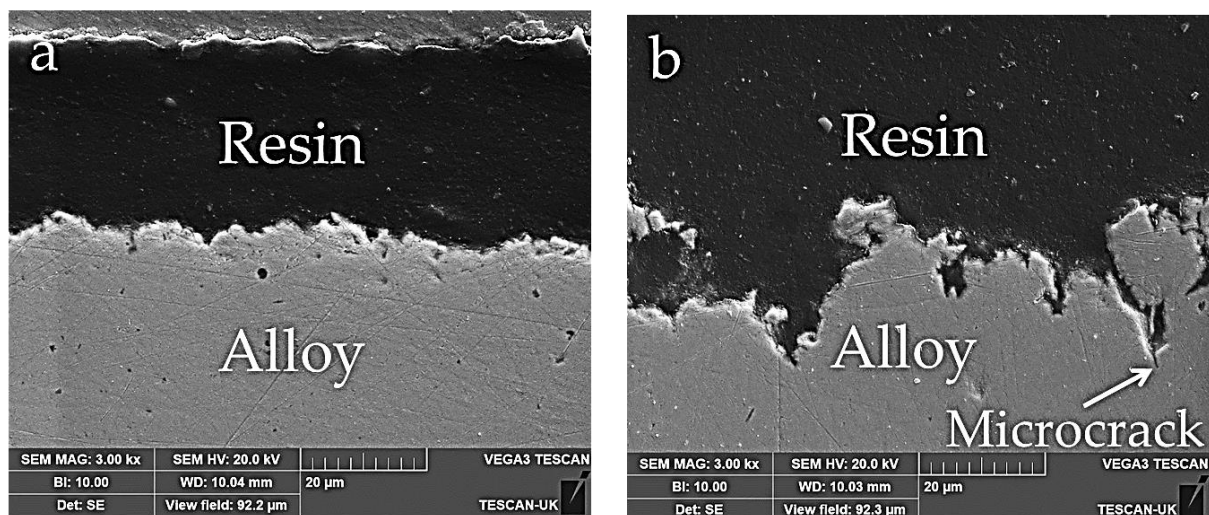
**Figure 13.** SEM secondary electron images of the exposed X70 C-ring samples in simulated saltwater solution with CO<sub>2</sub> stressed at 80% Y.S.: (a) at 5 °C; (b) at 25 °C.

A clear increase in metal dissolution was observed on the X70 samples exposed to solution with CO<sub>2</sub> at 5 °C and 25 °C stressed at 80% Y.S. as shown in Figure 13a,b, respectively. The corrosion morphologies on the samples exposed at 5 °C were observed to have elliptical but wide and shallow pits, while at 25 °C, the morphologies show a type of deep undercutting metal dissolution. Discontinuous micro-cracks were observed on the samples exposed at 25 °C. This confirms the possibility of SCC occurrence on the carbon steel.

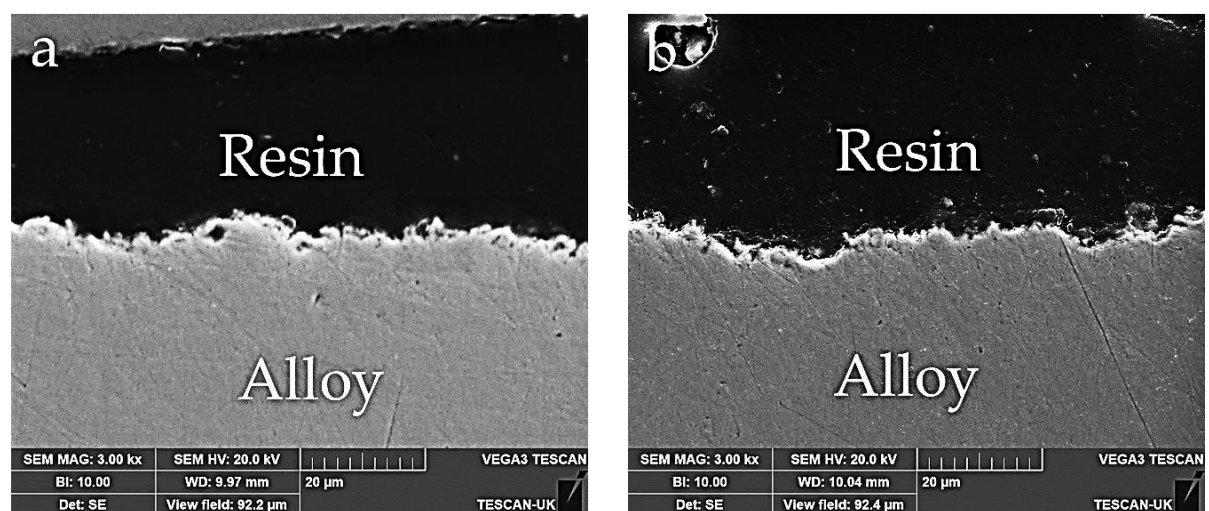
**Figure 14.** SEM secondary electron images of the exposed X100 C-ring samples in simulated saltwater solution with CO<sub>2</sub> stressed at 80% Y.S.: (a) at 5 °C; (b) at 25 °C.

The corrosion morphologies of the exposed X100 carbon steels in solution with CO<sub>2</sub> at 5 °C and 25 °C stressed at 80% Y.S., as shown in Figure 14a,b, respectively, presented much wider and deeper elliptical surface corrosion morphologies, which increased with increasing temperature from 5 °C to 25 °C. The variation in corrosion rates and morphologies observed on the exposed carbon steels is said to occur as a result of changes in the microstructure of the carbon steels and the presence of precipitates in their microstructures. The presence of precipitate in a microstructure provides nucleation sites for crack initiation and hydrogen traps, which can lead to hydrogen embrittlement and subsequent stress corrosion cracking [54].

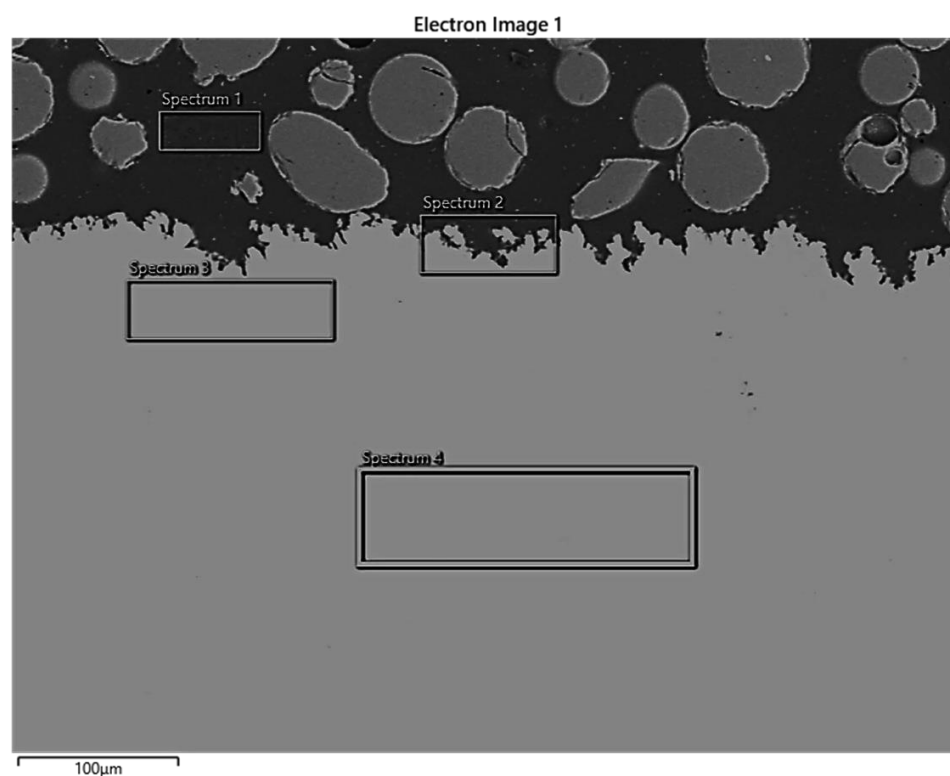
**Figure 15.** SEM backscattered electron image of exposed X70 carbon steel C-ring in simulated saltwater solution with CO<sub>2</sub> at 25 °C stressed at 80% Y.S. Data from the EDS spectra are reported in Figure 16.

The compositions of the EDS spectra (Figure 15) of the exposed X70 sample in solution with CO<sub>2</sub> at 25 °C stressed at 80% Y.S. are presented in Figure 16 (in weight percentages). Spectrum 1, which is mainly resin, is not reported in the analysis. The carbon content from all spectra is also not reported as EDS does not correctly quantify the percentage of carbon present in the analyzed samples. Approximately equal percentages of Si were observed in spectra 2, 3, and 4 with values of 0.31, 0.29, and 0.33 wt.%, respectively. Increasing percentages of Mn and Fe were observed with the change in spectrum location. Spectrum 4, which is mainly the alloy, presented higher percentages of Mn and Fe (1.89 wt.% and 93.72 wt.%, respectively). In comparison with spectrum 4, a similar value of Fe (93.64 wt.%) was observed in spectrum 3, which is closer to the alloy–resin interface.

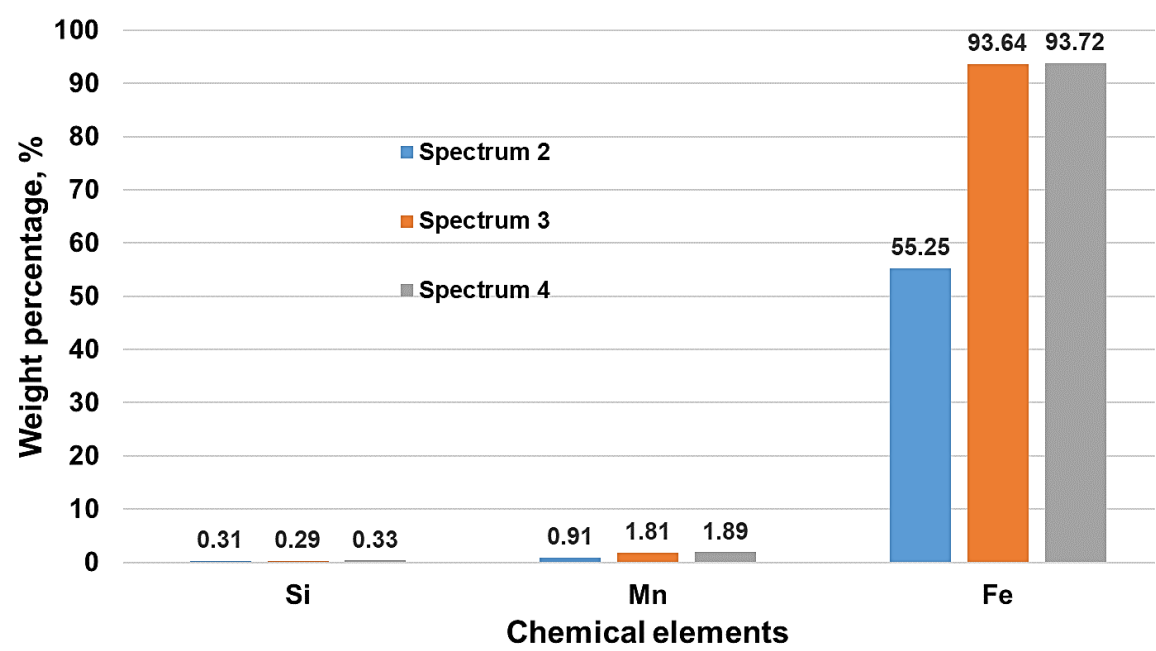
**Figure 16.** EDS compositions of the exposed X70 sample elements in simulated saltwater solution with CO<sub>2</sub> at 25 °C stressed at 80% Y.S.

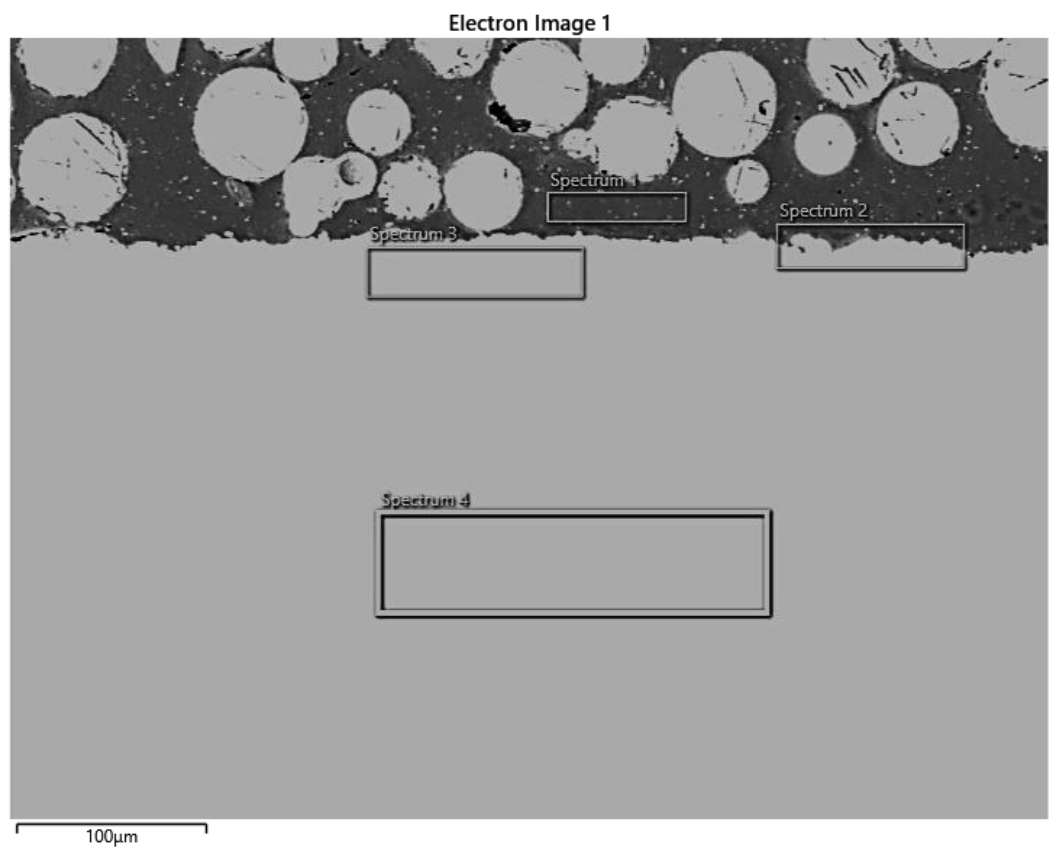
**Figure 17.** SEM backscattered electron image of the exposed X100 carbon steel C-ring in simulated saltwater solution with CO<sub>2</sub> at 25 °C stressed at 80% Y.S. Data from the EDS spectra are reported in Figure 18.

Different compositions of the EDS spectra (Figure 17) of the exposed X100 sample in solution with CO<sub>2</sub> at 25 °C stressed at 80% Y.S. was observed as shown in Figure 18 (in weight percentages). An increased percentage of Si was observed on the analyzed X100 samples, in comparison with the X70 sample. The highest percentage of Si and Mn were observed in spectrum 3 (Figure 18) with a value of 0.98 wt.% and 2.03 wt.%, respectively. Approximately equal percentages of Fe were observed in spectra 3 and 4 (92.2 wt.% and 92.3 wt.%, respectively). Traces of Cl were observed in spectrum 2 with a value of 0.21 wt.%. This can be explained to occur as a result of the simulated 3.5% NaCl solution to which the samples were exposed. In general, no significant differences were observed in the Mn and Fe percentages between the analyzed X70 and X100 samples.

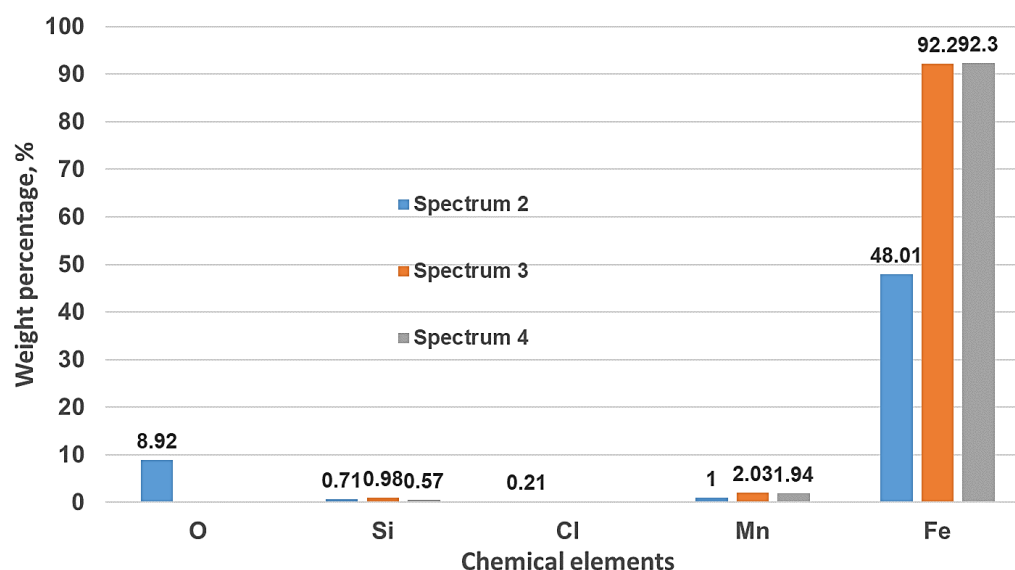
**Figure 18.** EDS compositions of the exposed X100 sample elements in simulated saltwater solution with CO<sub>2</sub> at 25 °C stressed at 80% Y.S.
