# Improving the manufacturability and assessing the performance of rare earth zirconates for thermal barrier coatings<sup>☆</sup>

Luis Isern<sup>a,\*</sup>, Koldo Almandoz Forcen<sup>a</sup>, Christine Chalk<sup>a</sup>, Gyaneshwara Brewster<sup>b</sup>, Alan Johnstone<sup>b</sup>, John Nicholls<sup>a</sup>

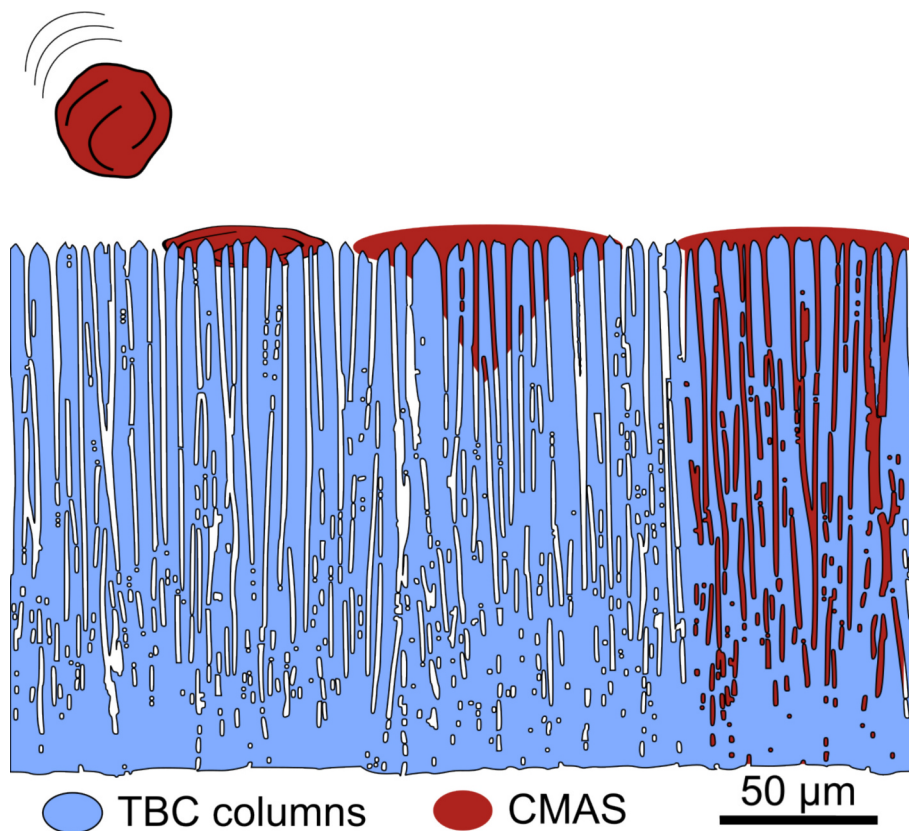
**Fig. 1.** Diagram of CMAS infiltration on a TBC deposited by EB-PVD. From left to right, the CMAS particles approach the coating, impact, melt, and infiltrate down the columnar interspace.

[4,5], providing a simulation of behaviour at relevant temperatures for engine operation. EB-PVD PYSZ is susceptible to infiltration by molten CMAS down the vertical pores of its columnar structure, as illustrated in Fig. 1, losing strain compliance, and degrading due to the CMAS slag. By contrast, REZ TBCs rapidly react with CMAS, precipitating crystalline products that block the vertical porosity and effectively stop infiltration [6]. Other advantages of REZ over PYSZ are their increased phase stability, lower thermal conductivity, and increased sintering resistance [2,3]. Because of these advantages, many subsequent studies worked on the deposition of REZ TBCs by EB-PVD, especially for gadolinium zirconate  $\text{Gd}_2\text{Zr}_2\text{O}_7$  (GZ) [1,7], samarium zirconate  $\text{Sm}_2\text{Zr}_2\text{O}_7$  [8] and lanthanum zirconate  $\text{La}_2\text{Zr}_2\text{O}_7$  (LZ) [9,10]. However, some initial studies e.g. [11] noticed difficulties in the deposition of those systems in the form of compositional fluctuations, which notably affected the LZ system which also tends to lack a defined columnar structure [9,10,12]. In addition, the pyrochlore structure of the REZ lacks the ferroelastic toughening mechanism exhibited by PYSZ, and thus is more susceptible to damage by erosion of solid particles by up to an order of magnitude [13], which happens when particles impact the top of the TBC.

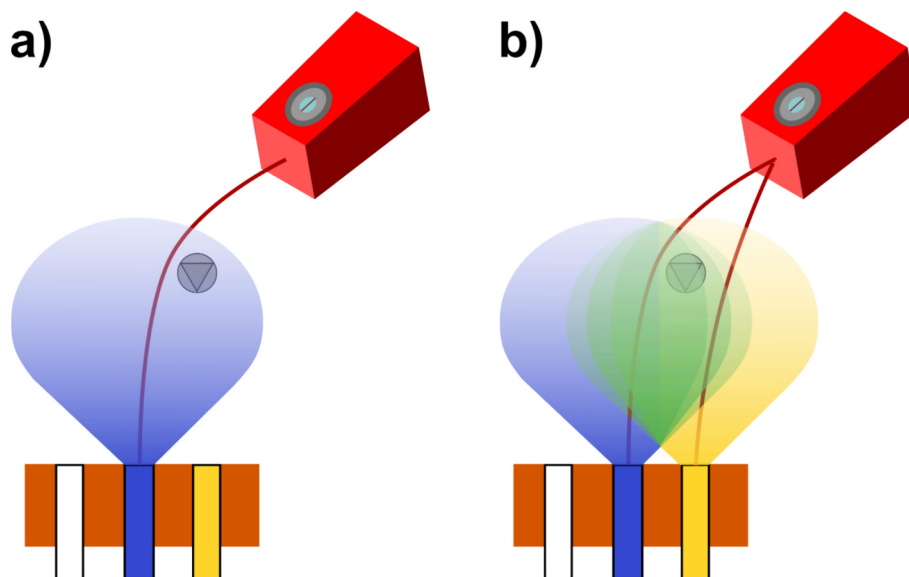
Fig. 2. Comparison of the distributions of the evaporation plumes of a) single-ingot evaporation and b) co-evaporation of two ingots, illustrated by different ingot colours.

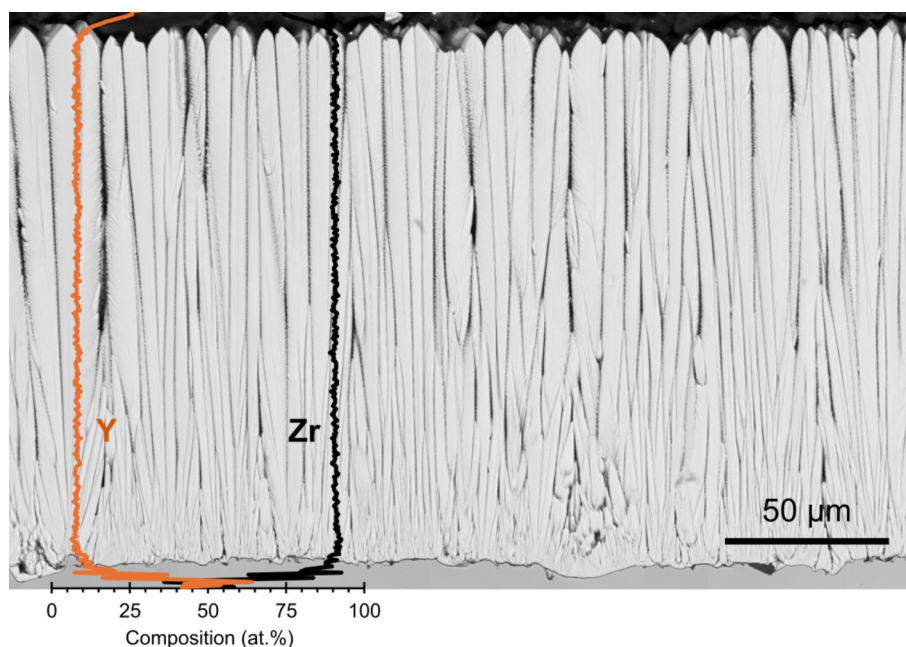
Fig. 3. Cross-section of PYSZ TBC on aluminised Nimonic 75 alloy in as-deposited condition taken with backscattered detector, overlaid with EDX linescan normalised to only include the metallic elements of the oxides (Y in orange and Zr in black).

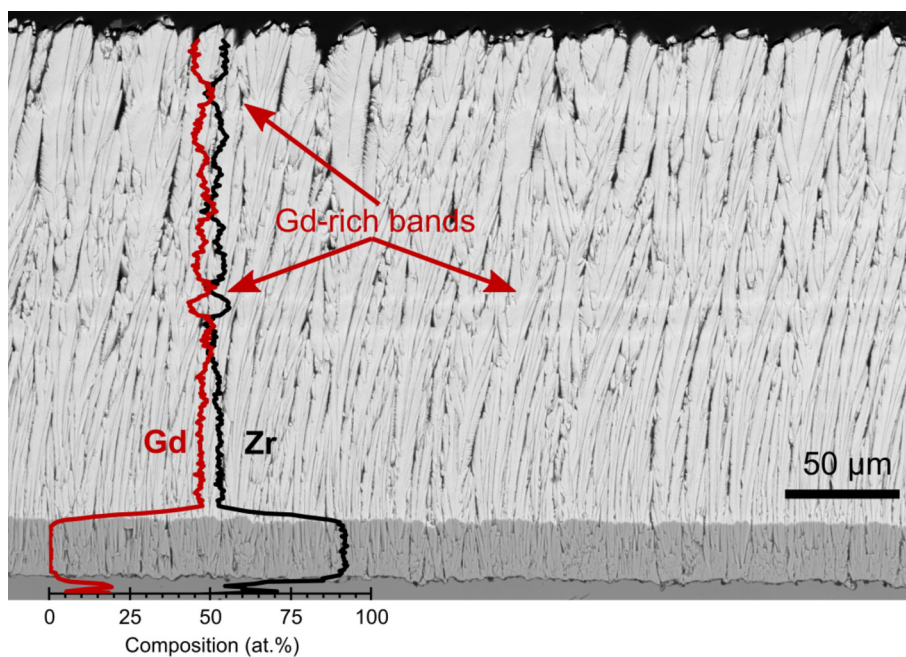
**Fig. 4.** Cross-section of gadolinium zirconate TBC on aluminised Nimonic 75 alloy in as-deposited condition taken with backscattered detector, overlaid with EDX linescan normalised to only include the metallic elements of the oxides (Gd in red, Zr in black, Y not plotted). Some Gd-rich banding is noticeable.

The NZ TBCs for both trials display a marked columnar structure with some degree of branching (Fig. 5a and b), similar to the GZ system (Fig. 4). Also like GZ, the columns seem to lean  $\sim 15^\circ$  off the vertical for the TBCs from the first trial (Fig. 5a), especially evident for the NZ1 layer that is thicker ( $46.3 \pm 0.8 \mu\text{m}$ ) than the NZ2 layer ( $39.0 \pm 1.1 \mu\text{m}$ ), but some bending can be observed in the NZ2 layer too (Fig. 5b). The same inclination can be found in the second trial, while the normal component of this inclination is negligible as assessed in cross-sections perpendicular to the initial orientation (Fig. 5b). This alternative view highlights the branching especially on the outer third of the coating.

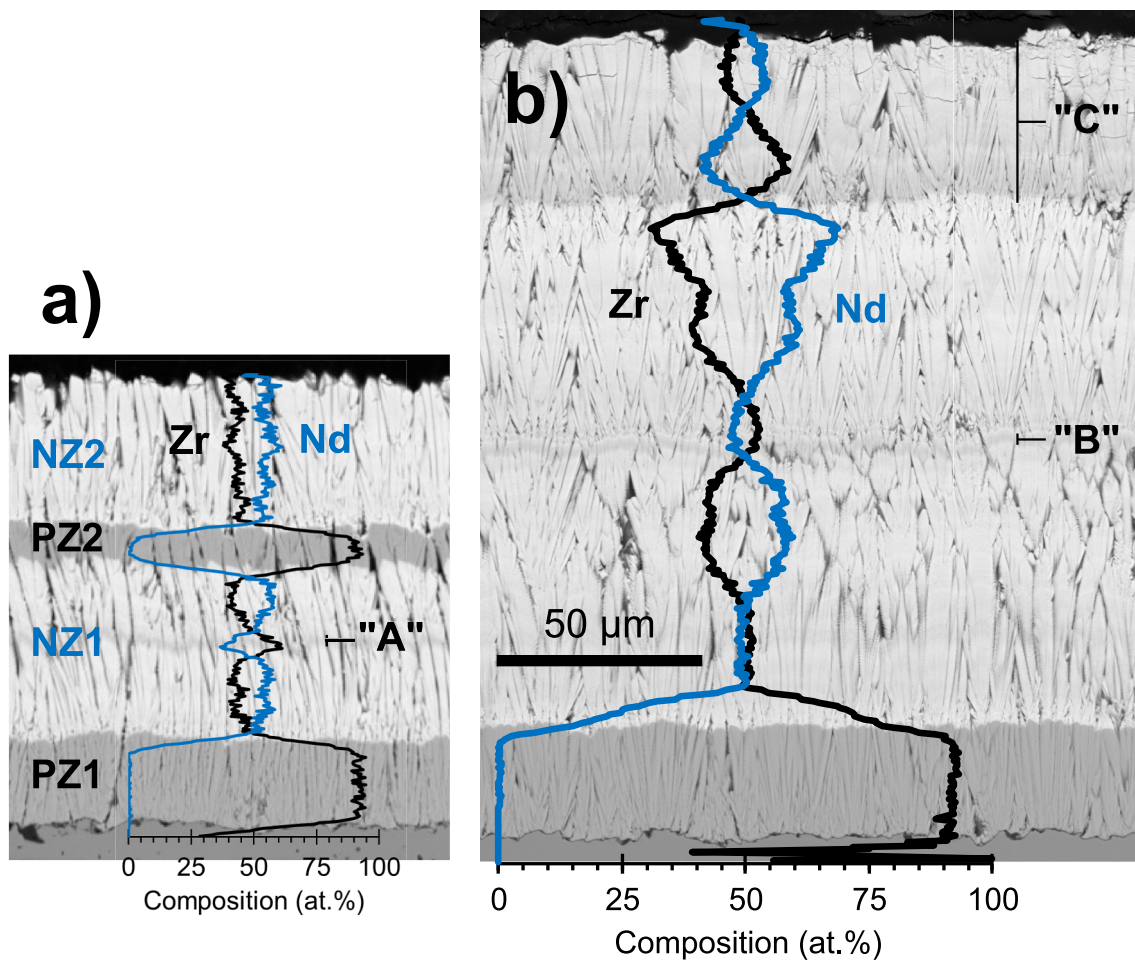
**Fig. 5.** Cross-section of neodymium zirconate TBC on aluminised Nimonic 75 alloy in as-deposited condition taken with backscattered detector, a) from 4-layer system and b) from 2-layer coating overlaid with EDX linescan normalised to only include the metallic elements of the oxides (Nd in blue, Zr in black, Y not plotted). Key regions have been highlighted and named by capital letters.

The backscattered images suggest a fairly uniform stoichiometry of the NZ layers with a few notable exceptions that are more Zr-rich: around the middle of NZ1 layer in the first trial (“A”), a region slightly past the first third of the second trial (“B”) and for the whole last quarter of the second trial (“C”). The EDX linescan provides a more nuanced account of the Zr/Nd ratio, which is on average slightly richer in Nd than stoichiometric during the second trial (average Zr/Nd ratio of 0.88). Interestingly, the lower part of the NZ layer is stoichiometric  $\text{Nd}_2\text{Zr}_2\text{O}_7$  (Zr/Nd ratio of 1.01), which is then slightly enriched in Nd (Zr/Nd = 0.79) until instance “B” is reached (Zr/Nd = 1.06) to continue with the enrichment in Nd until Zr/Nd = 0.68 (i.e. Zr/Nd  $\sim 2/3$ ). After that, instance “C” is reached where there is a reversal and Zr/Nd

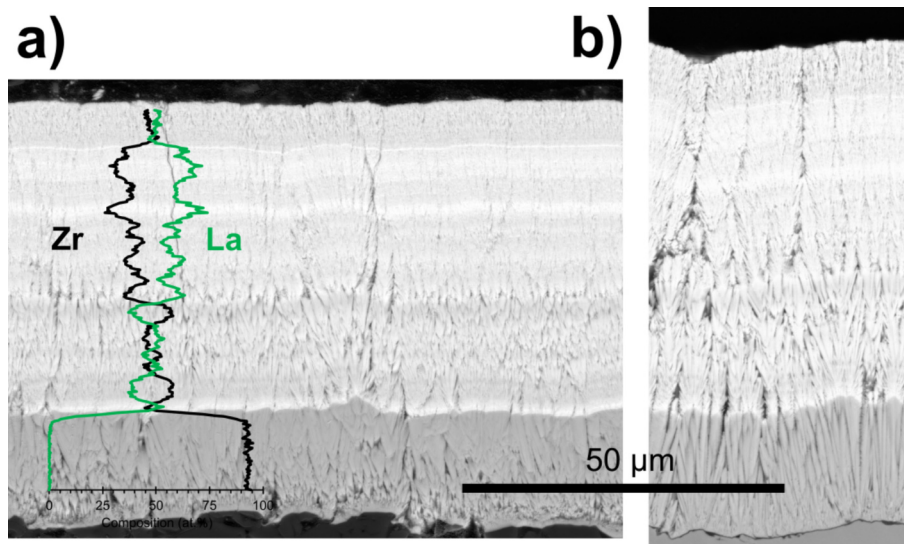
**Fig. 6.** Cross-section of lanthanum zirconate TBC in as-deposited condition taken with backscattered detector, a) on alumina substrate plus overlay of EDX linescan normalised to only include the metallic elements of the oxides (La in green, Zr in black, Y not plotted), and b) on aluminised Nimonic 75 alloy.

The LZ system displays the most widespread cracking systems due to the lack of a defined columnar structure (Fig. 14). The sample presented in Section 3.1.3 was relatively thin (LZ topcoat 47.3 ± 1.0 μm as per Fig. 6) and had the highest SSER of all (51.8 g/kg), although only a few datapoints were available for the calculation. In this sample, the cracking neatly follows the compositional banding, with the crack avoiding the tougher Zr-rich bands (Fig. 14a, point “A”). A second deposition was performed to obtain a thicker coating, which had an LZ topcoat thickness of ~100 μm (Fig. 14b). This sample withstood the test for twice as long (1.61 g vs 0.69 g of erodent at point of failure) so a more accurate SSER calculation could be performed (45.1 g/kg). The second sample behaves in the same way as the first, with the fibrous structure unable to stop crack propagation (“B”).

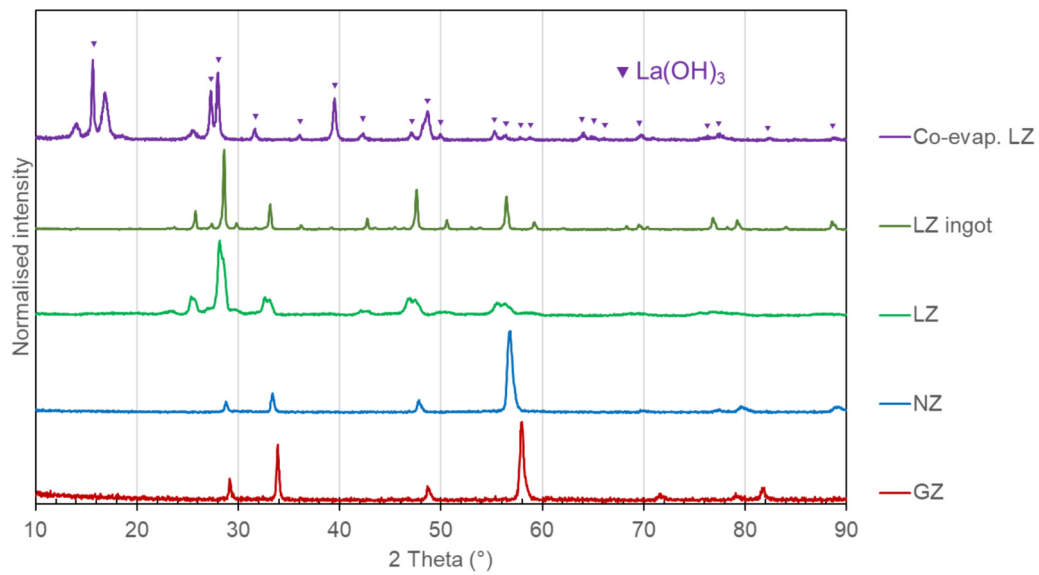
Fig. 8. XRD spectra obtained from the surface of co-evaporated LZ TBC, the LZ TBC produced from a single ingot, the LZ ingot, the NZ TBC and the GZ TBC.

The crystalline structure of the LZ coating deposited from a single source shows peaks at  $\sim 26^\circ$  and  $\sim 42^\circ$  indicative of pyrochlore superlattice in LZ (which is more clear in the LZ ingot), as well as main double-peaks. On the other hand, the GZ spectrum matches the JCPDS card number 01-078-4083 corresponding to Fm-3 m space group (defective fluorite), while lacking pyrochlore superlattice peaks such as those observed in JCPDS card number 01-075-8269 corresponding to Fd-3 m space group. The NZ pattern also lacks the pyrochlore peaks and is similar to JCPDS card number 01-078-1289 (Fm-3 m).

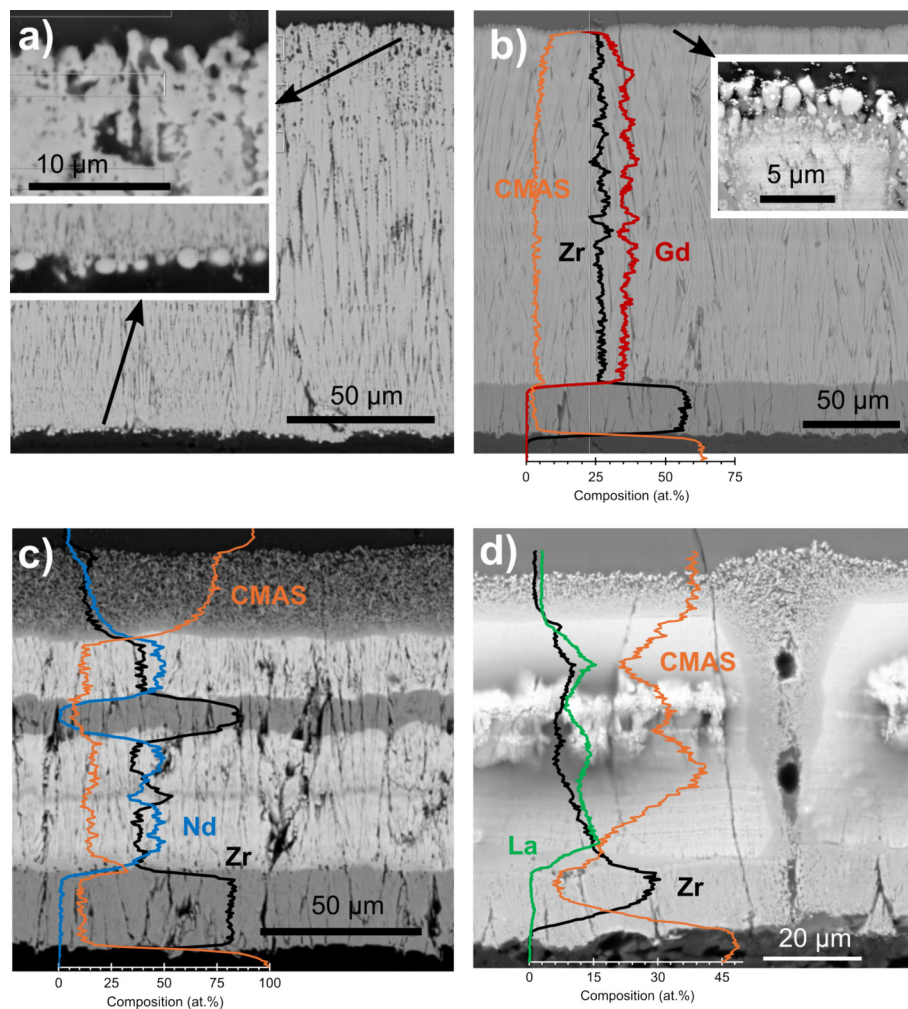
Fig. 9. Cross-section images of different TBCs after CMAS exposure for 30 min at 1300 °C taken with backscattered detector, overlaid with EDX linescan normalised to only include the metallic elements of the oxides. a) PYSZ, b) gadolinium zirconate, c) neodymium zirconate, d) lanthanum zirconate.

PYSZ provides a benchmark performance. After exposure, PYSZ is fully infiltrated as attested by EDX and the formation of spherical globules at the base of the columns (Fig. 9a). Moreover, the morphology of the columns and internal porosity is severely affected due to interaction with CMAS.

GZ displays the best resistance to CMAS infiltration. A thin ( $3\text{--}5 \mu\text{m}$ ) reaction layer forms that effectively blocks CMAS infiltration down the columns (Fig. 9b), after coating consumption of only  $10\text{--}15 \mu\text{m}$ . A small amount of CMAS is detected below the reaction layer, probably due to infiltration while the reaction layer was forming. The morphology of the GZ columns has been preserved, except for consumption of the tips to the reaction layer. Note that the CMAS linescan has been constructed by adding the contributions of Ca, Mg, Al and Si and, therefore, the alumina substrate makes the CMAS proportion artificially surge at the bottom of the coating.

NZ also displays outstanding resistance to CMAS infiltration. A much thicker ( $\sim 25 \mu\text{m}$ ) reaction layer is formed than in the case of GZ, but the coating consumption is also small at  $15\text{--}20 \mu\text{m}$  (Fig. 9c). The morphology of the NZ columns is perfectly preserved too.

Finally, the LZ system forms a reaction layer  $\sim 20 \mu\text{m}$ , similar to NZ in thickness but not in effectiveness, as CMAS seems to have penetrated through the whole LZ coating thickness (d). Inspection of wider sections of the coating revealed the periodic appearance of wide vertical cracks like that to the right of Fig. 9d, which act as conduits for CMAS infiltration. These are probably formed during the expansion of the coating when heating up, as the cracks are filled with molten CMAS but were not noticeable in the as-deposited condition. The faint columnar features of LZ have been completely lost and the morphology has significantly changed after CMAS infiltration.

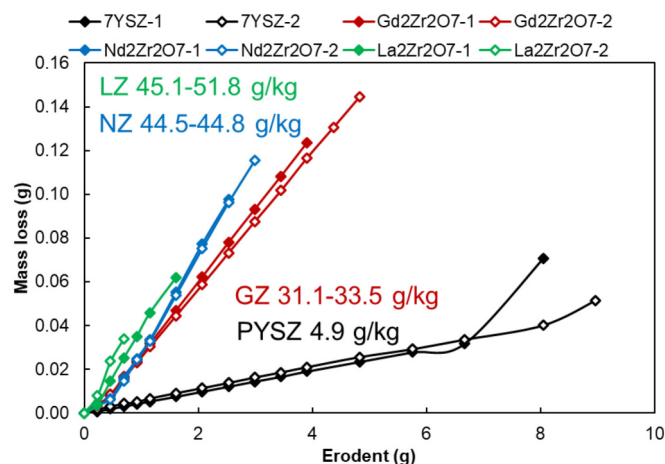
Fig. 10. Curves of mass loss vs erodent used during erosion testing of PYSZ, GZ, NZ and LZ coatings including their steady state erosion rate.

Rates (SSER, see Fig. 10) between the two samples of each system was very low for all columnar systems ( $\sim 8\%$  for GZ and much lower for the

rest), and higher at 15 % for the LZ system. PYSZ had the highest erosion resistance of all with an SSER of 4.9 g/kg or 0.8 mm<sup>3</sup>/g (assuming bulk

PYSZ density) for both samples, much lower than the REZ systems. GZ was the next best system for erosion resistance at 31.1 and 33.5 g/kg, or 4.9 and 5.3 mm<sup>3</sup>/g, followed by NZ at 44.5 and 44.8 g/kg, or 7.4 and 7.5 mm<sup>3</sup>/g. NB For NZ, the 2-layer design has been tested. It is worth noting that the NZ curve seems to have a lower slope below 1.15 g of erodent on the X-axis, but the SSER has been calculated using datapoints from both. Finally, the LZ system is the least erosion resistant at 45.1 and 51.8 g/kg, or 7.6 and 8.8 mm<sup>3</sup>/g.

The main drawback of the REZs as PYSZ replacements is their lower fracture toughness, which leads to increased coating loss by solid particle erosion. As expected, the results in Fig. 10 highlight a significant difference between the coating families: the rate of material loss of PYSZ was between 6.4 and 10.6 times lower than that of REZs. Differences in

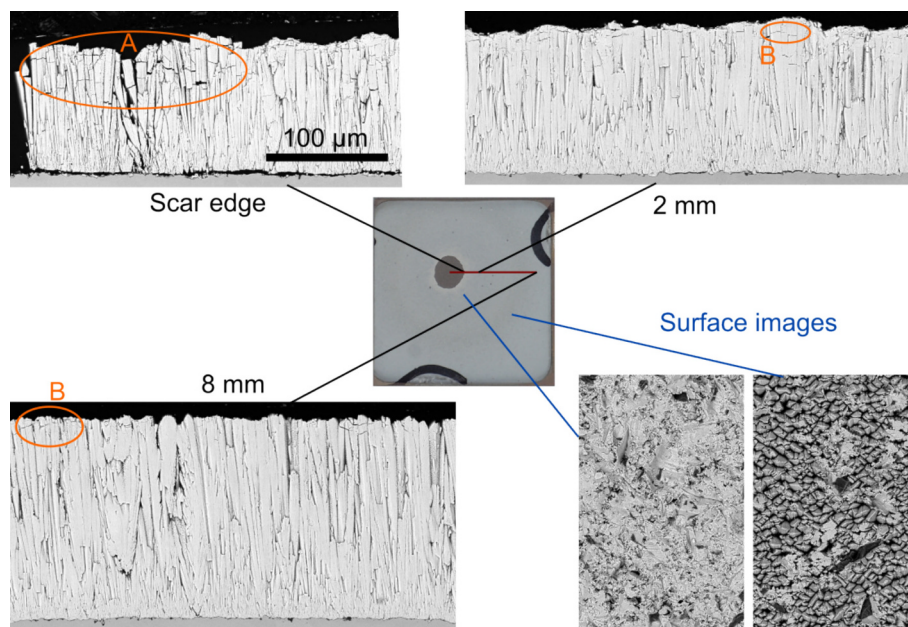
Fig. 11. Composite image of an eroded PYSZ TBC sample. The macroscopic optical image indicates the locations where cross-sections and surface images were taken with backscattered SEM detector (all at the same magnification). The reference positions of the cross-sections are related to the distance to the edge of the delaminated area (scar).

The erosion mechanism of the TBCs was identified via cross-section images taken across the erosion scar. For the columnar systems, horizontal cracks formed parallel to the coating surface, which eventually coalesce and lead to material removal. The PYSZ system has many unconnected cracks around the scar edge (Fig. 11, point “A”), which suggests cracks are formed by different impacts and, in general, do not propagate well across columns, although some degree of contiguous cracking just under the surface is observed in a few locations (“B”).

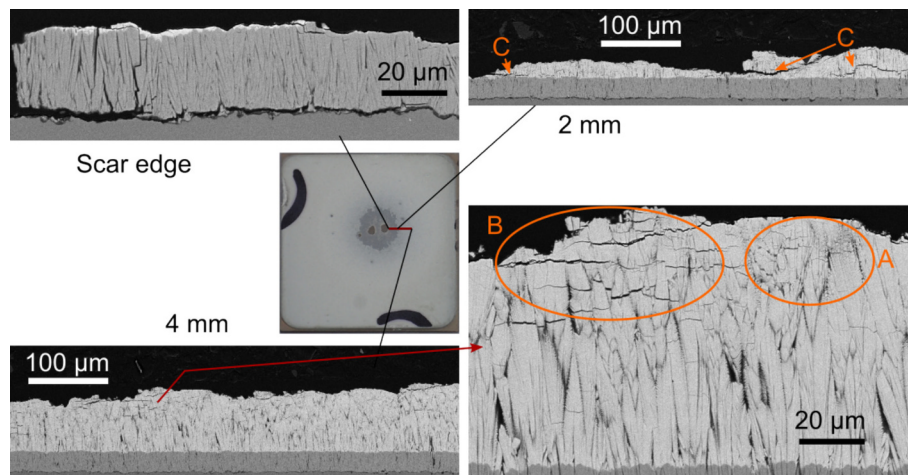
**Fig. 12.** Composite image of an eroded GZ TBC sample. The macroscopic optical image indicates the locations where cross-sections were taken with backscattered SEM detector. The reference positions of the cross-sections are related to the distance to the edge of the delaminated area (scar).

The GZ coating, next best in erosion resistance, shows some degree of unconnected cracking away from the scar (Fig. 12, point “A”), but those

cracks are of larger length than in PYSZ and often affect a few neighbouring columns (“B”). A significant number of contiguous cracks are found closer to the scar (“C”), which probably contributes to the increased rate of material removal.

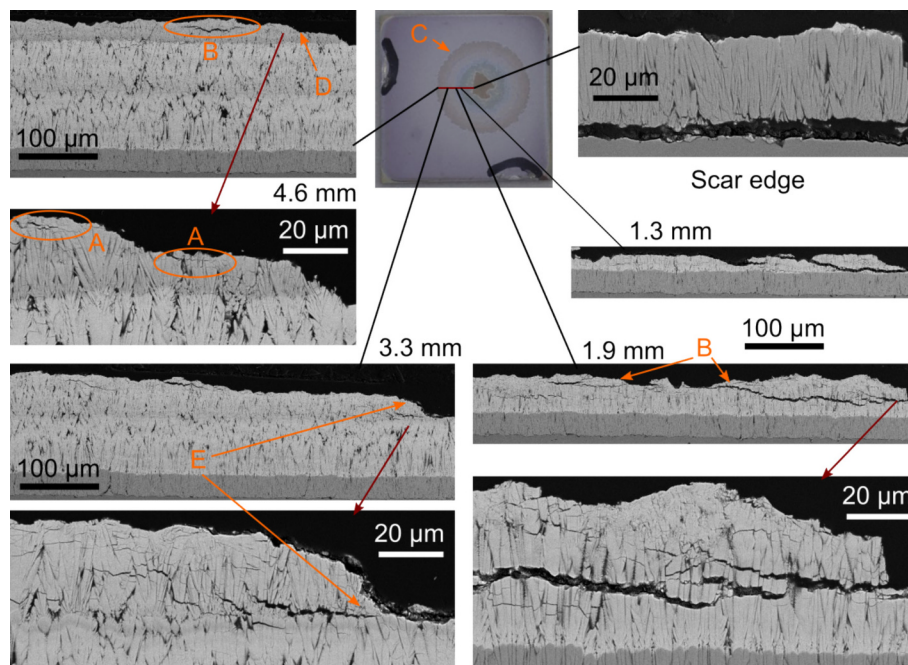
**Fig. 13.** Composite image of an eroded NZ TBC sample. The macroscopic optical image indicates the locations where cross-sections were taken with backscattered SEM detector. The reference positions of the cross-sections are related to the distance to the edge of the delaminated area (scar).

The NZ system displays a similar cracking behaviour to GZ, with again some cracks affecting only a few columns (Fig. 13, point “A”) but also with several contiguous, long cracks (“B”). The inhomogeneities in composition seen in the as-deposited condition (Fig. 5) seem to be affecting the erosion behaviour of the sample and leading to the formation of “rings” visible on the sample surface (Fig. 13, point “C”). These rings correspond to “steps” in the cross-sections that follow both the top, darker region of the coating (“D”) and the band around halfway through the coating thickness (“E”).
