# Aircraft Skin Inspections: Towards a New Model for Dent Evaluation

Pasquale Lafiosca\*, Ip-Shing Fan<sup>†</sup> and Nicolas P. Avdelidis<sup>‡</sup>

*Cranfield University*

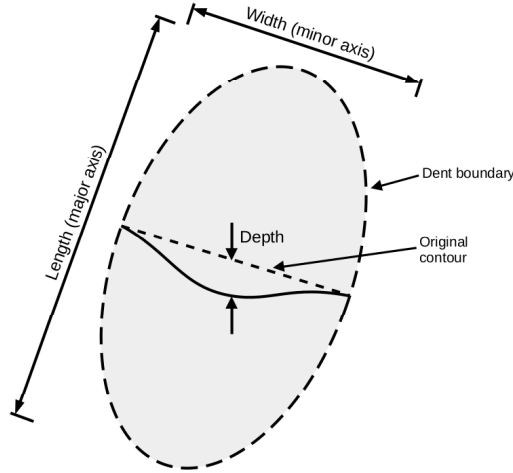
Figure 1: Traditional dimensional evaluation of dents.

The Boeing 737-400 SRM [4], here taken as reference, provides the only accepted definitions for such type of aircraft. A dent on metal is “*a damaged area that is pushed in from its normal contour with no change in the cross-sectional area of the material. The edges of the damaged area are smooth. This damage is usually caused by a hit from a smoothly contoured object. The length of the dent is the longest distance from one end to the other end. The width of the dent is the second longest distance across the dent, measured at 90 degrees to the direction of the length*” [4] (see Fig. 1). The depth

is measured where the width is taken and there must be no other kind of damages like gouges or cracks at the same location [4]. Similarly, a dent on composites is a *concave depression which does not break the fibers* [4].

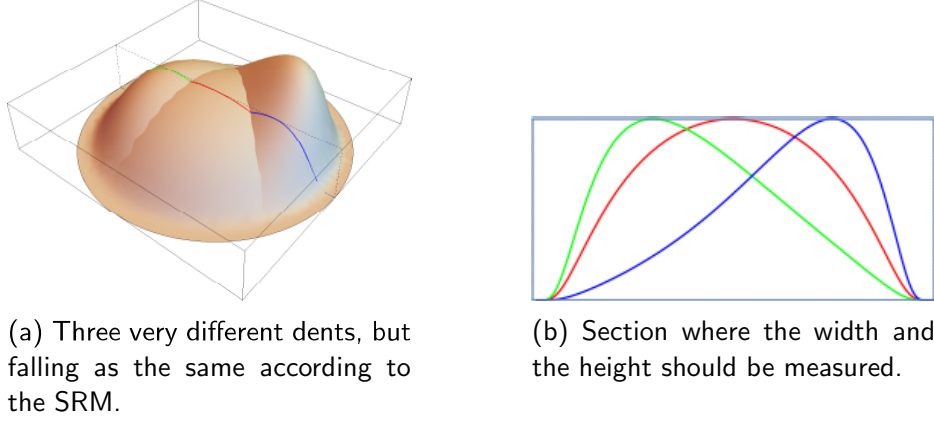
Figure 2: SRM definition implicitly model a dent like a “box”.

During maintenance, repair and overhaul (MRO) operations dents must be *found*, *measured* and *evaluated* in order to identify the necessary repair actions, if any [8]. The above definition implicitly defines the currently used model for dents as a “box”, whose dimensions are equal to the length, width and depth of the dent. Moreover, it must be remarked that, as the depth is measured where the width is taken, the box might not even be the one completely containing the dent. Fig. 2 shows a set of dents falling within the same box.

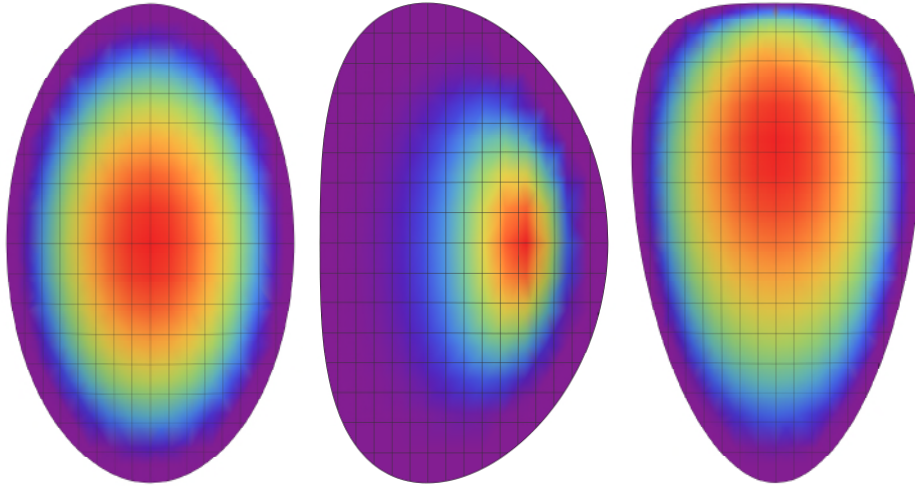
Figure 3: These three illustrative dents have all the same length and width and depth (as heatmap) and are thus classified in the same way by the SRM. However, they have evidently different shapes.

Consider, for example, the three illustrative dents represented in Fig. 3. By following the SRM to the letter, these dents should be classified in the

exact same way, yet they have completely different shapes. In all likelihood, also their structural characteristics are different.

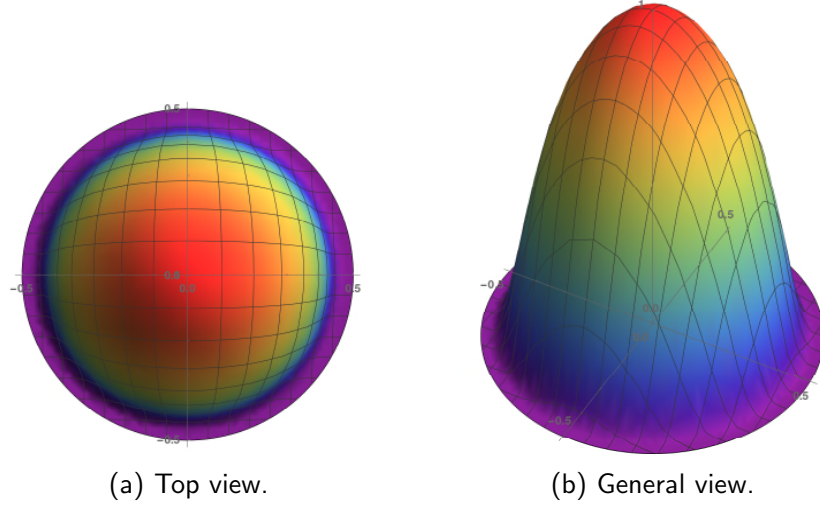
Figure 4: Reference dent function  $\text{refDent}(x, y)$  with unitary  $xyz$  dimensions,  $p = 1$ ,  $s_x = s_y = 0$  and  $b = e$ .

The reference function  $\text{refDent}(x, y)$  showed in Fig. 4 has unitary dimensions along the three axis and can be easily rescaled to produce a general dent:

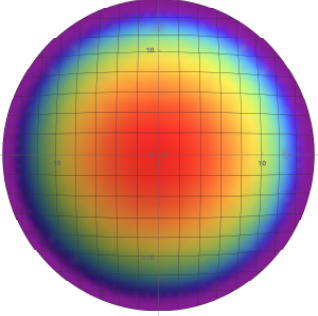
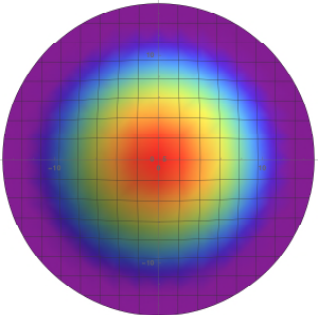
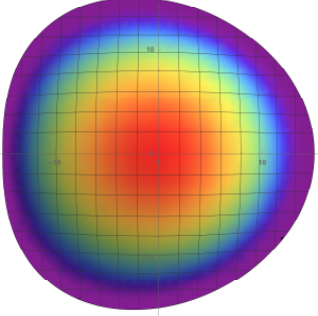
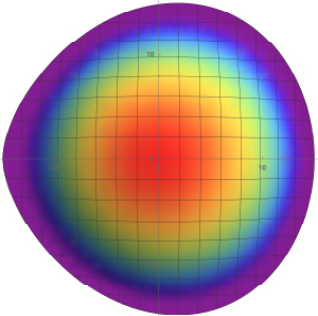
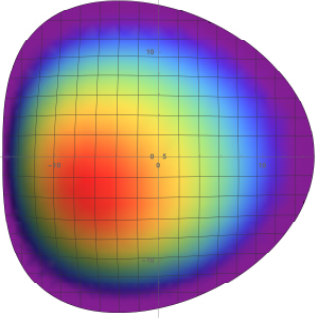
| Top view | Overall view | Parameters |
|---|---|---|
| | | $l = 30$<br>$w = 30$<br>$d = 5$<br>$b = 2$<br>$p = 1$<br>$s_x = 0$<br>$s_y = 0$ |
| | | $l = 30$<br>$w = 30$<br>$d = 5$<br>$b = 10$<br>$p = 1$<br>$s_x = 0$<br>$s_y = 0$ |

| Top view | Overall view | Parameters |
|---|---|---|
| | | $l = 30$<br>$w = 30$<br>$d = 5$<br>$b = e$<br>$p = 0.8$<br>$s_x = 0$<br>$s_y = 0$ |
| | | $l = 30$<br>$w = 30$<br>$d = 5$<br>$b = e$<br>$p = 1.2$<br>$s_x = 0$<br>$s_y = 0$ |

| Top view | Overall view | Parameters |
|---|---|---|
| | | $l = 30$<br>$w = 30$<br>$d = 5$<br>$b = e$<br>$p = 0.7$<br>$s_x = -0.2$<br>$s_y = -0.1$ |

Table 1: Examples of the proposed dent model for different parameter values, where  $e$  stands for the Euler’s number.

Before discussing the possible applications in the following section, some shapes obtained with the proposed model are shown in Table 1, accompanied by their corresponding parameters. Depth values have been intentionally exaggerated for visualisation purposes.

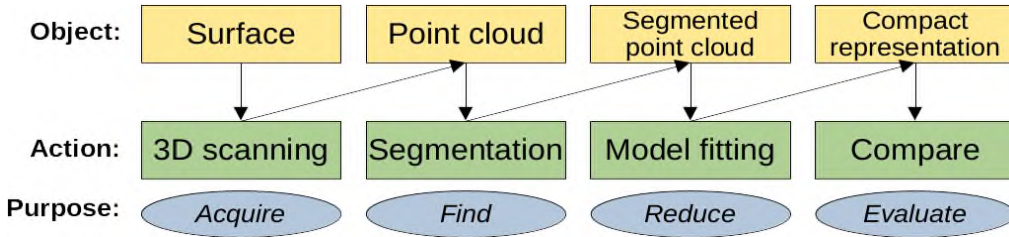
Figure 5: Expected workflow of an automated dent inspection system.

The model introduced in the previous section proposes the use of 7 parameters that all have a physical meaning. However, they cannot be easily measured manually (e.g. with rules, gauges, etc.) and, thus, the model benefits from the combination with 3D scanning technologies. The intended workflow is displayed in Fig. 5.

Starting from the physical surface to be assessed, its point cloud representation is acquired. Then a *segmentation* of some sort must be applied in order to actually isolate each dent by separating dented and non-dented areas [20]. In MRO, both the manual approach and the recent 3D scanners aim at extracting length, width and depth as prescribed by the SRM [22]. Reducing the amount of information to a handful of parameters is necessary to make the measure intelligible and comparable. However, as shown above, the sole measures of depth, width or length do not adequately represent the actual shape and create high degree of ambiguity in the following evaluation.

The approach proposed in Fig. 5 can lead to more targeted interventions, ultimately saving costs. In order to accomplish this, the current practices are supposed to be revised and updated to embrace the increased capabilities brought by 3D scanning. This process of change has already started with the introduction of new devices, however, as part of a highly regulated and safety-critical industry, it is likely to take several years.

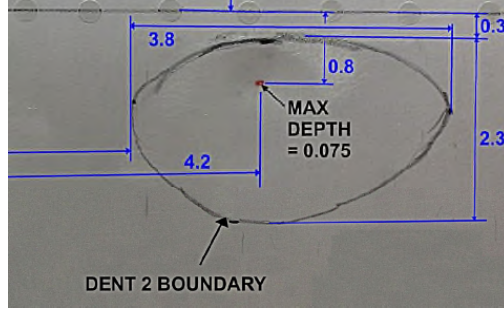
Figure 6: The complex shape of a dent cannot be expressed by only a combination of length, width and depth. In this picture the engineer relied on drawings to express the actual shape and the position of maximum depth, so that a better structural evaluation could be carried on. Even using 3D scanning, such great amount of data is ineffective if comparison is then done by means of depth and width/depth ratio only.

Fig. 6 is extracted from a “C” check report. It shows a dent manually marked and measured by the engineers. While this method may appear approximated and cumbersome, it responds to the need for communicating more about the actual dent shape, and thus obtain specific repair instructions from the aircraft manufacturer. On the other hand, one may represent the damage by its full 3D point cloud. While this is rich of data, it is not easily comparable nor manageable in terms of extracting general repair recommendations.

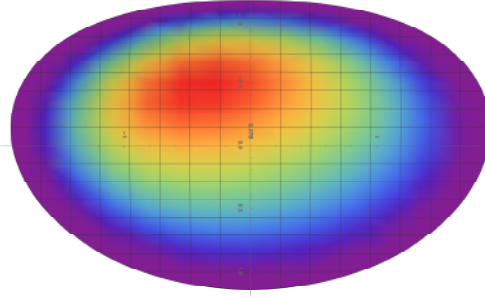
Figure 7: Shape obtained with  $b = 2.7$ ,  $l = 2.3$ ,  $w = 3.8$ ,  $d = 0.075$ ,  $p = 0.85$ ,  $s_x = -0.2$  and  $s_y = -0.12$  which could potentially represent the dent of Fig. 6.

Assuming the use of a 3D scanning, instead, the shape showed in Fig. 7, calculated by means of Eq. (4), may easily approximate the actual one and with an intelligible set of only 7 parameters. While length, width and depth are the same as in the classical evaluation, the 4 extra degrees of freedom address the necessity of an accurate and compact description that was previously attempted by manual drawings only.

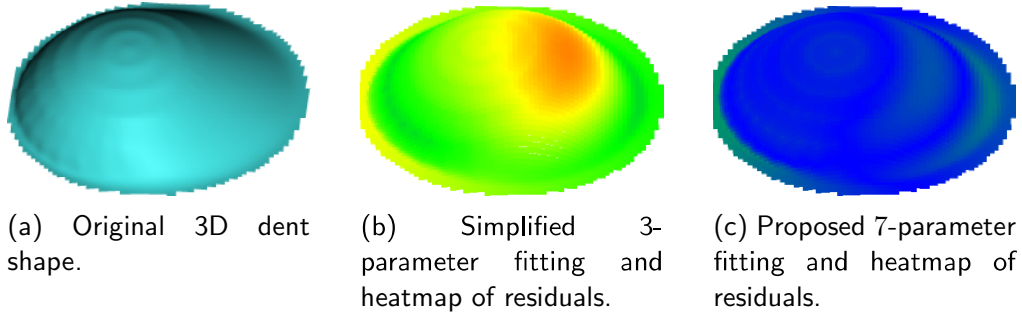
Figure 8: Dent obtained from a 45° collision and residual heatmaps (blue = 0 mm, red = 1 mm mm). The proposed model is capable to follow the natural dent shape and the MAE is reduced by an order of magnitude.

In the  $45^\circ$  collision example, the fitting by the simplified model gave

$l = 5.55$  mm,  $w = 5.09$  mm and  $d = 1.46$  mm with a MAE of 0.51 mm. The proposed model found  $l = 6.10$  mm,  $w = 5.48$  mm,  $d = 1.24$  mm,  $p = 1.01$ ,  $s_x = -0.11$ ,  $s_y = 0.00$  and  $b = 3.11$ , with a MAE of only 0.053 mm. The original 3D dent and the two residuals are shown in Fig. 8, where red indicates high residual areas.

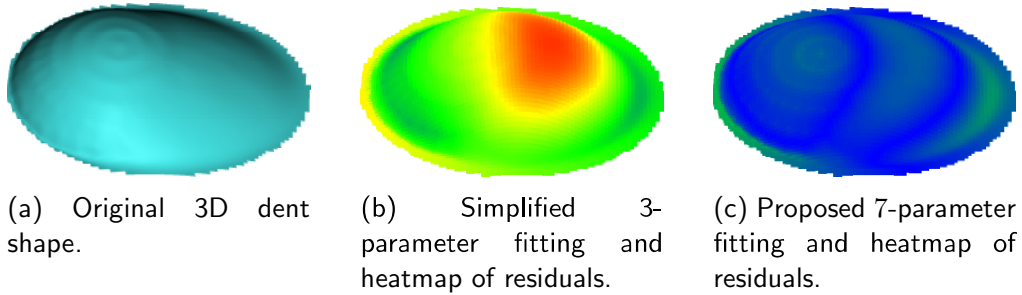
Figure 9: Dent obtained from a 60° collision and residual heatmaps (blue = 0 mm, red = 1 mm mm). Also in this case the MAE is greatly reduced.

In the 60° collision example, the fitting by the simplified model gave  $l = 6.36$  mm,  $w = 5.14$  mm and  $d = 1.48$  mm with a MAE of 0.52 mm. The proposed model found  $l = 6.66$  mm,  $w = 5.21$  mm,  $d = 1.12$  mm,  $p = 0.96$ ,  $s_x = -0.12$ ,  $s_y = 0.00$  and  $b = 2.37$ , with a MAE of only 0.08 mm. Fig. 9 represents the original shape and the fitting residuals.

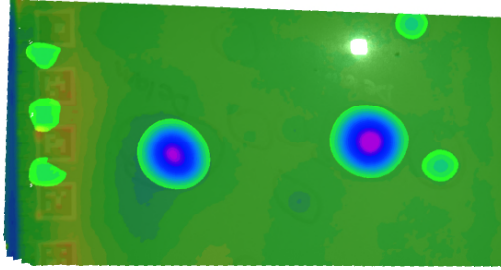
Figure 10: One of the point clouds from which dents were extracted.

In order to validate the approach, the 7 parameters evaluation was applied to point clouds obtained by 8tree's *dentCHECK* tool. Fig. 10 shows one of the point clouds from which the dents where isolated.

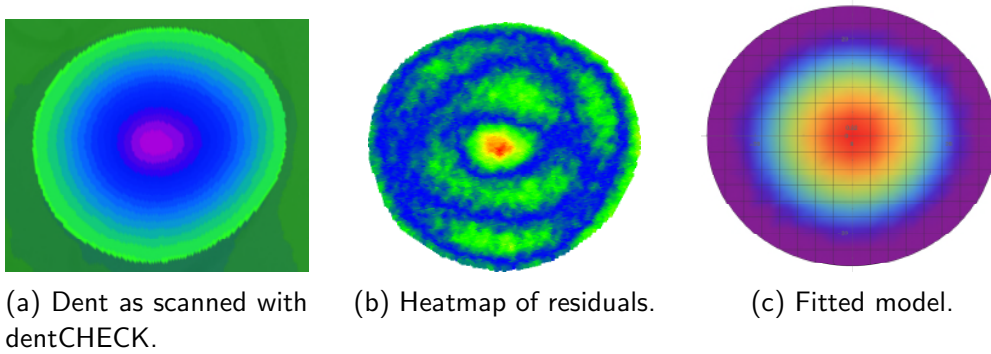
Figure 11: Evaluation on the first dent. The MAE was 0.02 mm.

After fitting the model, the first dent had  $l = 59.76$  mm,  $w = 53.42$  mm,  $d = 0.82$  mm,  $p = 0.99$ ,  $s_x = 0.01$ ,  $s_y = 0.00$  and  $b = 10.00$ , with a MAE of 0.02 mm. The isolated dent and its corresponding model are shown in Fig. 11.

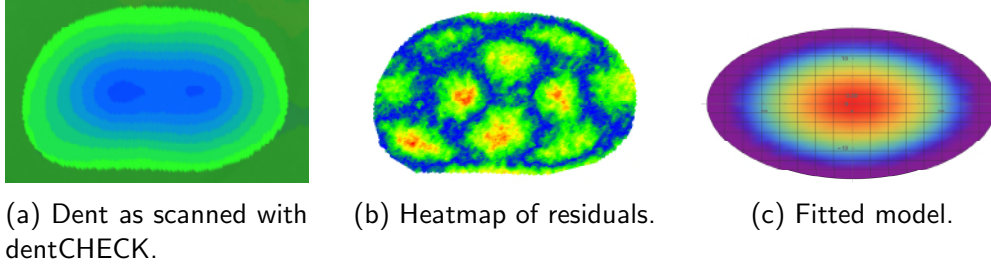
Figure 12: Evaluation on the second dent. The MAE was 0.02 mm.

The same was repeated on a second, more irregular dent, producing  $l = 64.88$  mm,  $w = 33.66$  mm,  $d = 0.39$  mm,  $p = 1.01$ ,  $s_x = 0.01$ ,  $s_y = 0.00$  and  $b = 4.64$ , with a MAE of 0.02 mm but with less accuracy in representing the edge. Details are shown in Fig. 12.
