# Surface Roughness Evolution to Identify Incubation Time for Hot Corrosion of Nickel-Base Superalloys: CMSX-4, CM247LC DS and IN6203DS at 550 °C

In the absence of protective scales, nickel-base superalloys have an extremely limited hot corrosion incubation period before increased rates of attack are experienced. This paper reports on the nickel-base superalloys: CMSX-4, CM247LC DS and IN6203DS subjected to 550 °C hot corrosion exposures of durations ranging from 0 to 800 h, during which none of the superalloys developed a fully protective scale. The aim of the research was to identify the incubation period of each superalloy and this was achieved by means of surface roughness evaluations. A metrology exercise was performed on the cross section of test specimens which produced Cartesian data points which were subsequently converted to Ra and Rz data. Statistical analysis of the results suggested the incubation period lasted approximately 400, 500 and 200 h, respectively, for each superalloy. It was concluded that refractory metal phases within the microstructure were associated with the relatively short IN6203DS incubation period. This paper demonstrates that monitoring the change

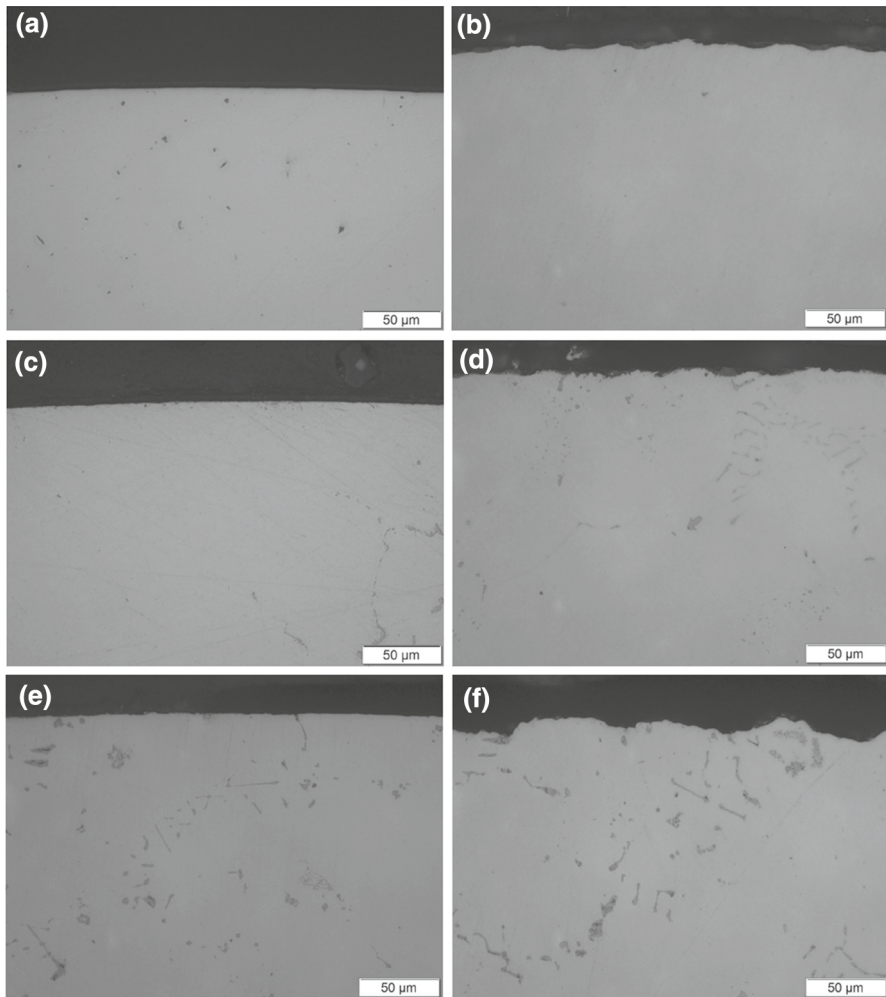
**Fig. 1** Cross sections of superalloys showing surface roughness comparisons before and after exposure to the tested 550 °C hot corrosion conditions. Images include CMSX-4 before (a) and after 800 h exposure (b), CM247LC DS before (c) and after 800 h exposure (d), and IN6203DS before (e) and after 800 h exposure (f)

Each superalloy under investigation, CMSX-4, CM247LC DS and IN6203DS, experienced non-uniform metal loss giving rise to an increase in surface roughness (Fig. 1) during the 800 h of exposure to the 550 °C hot corrosion conditions. Figure 2 illustrates the evolution of the Ra and Rz surface roughness during this period in the form of boxplots. Visual assessments of the boxplots revealed a similar pattern for both the Ra and Rz data from each superalloy. That is, the Ra and Rz surface roughness initially appeared to show an extremely subtle positive trend with exposure time, albeit with significant overlap of the data with that of the as-machined specimen (0 h exposure). After the initial period, both the Ra and Rz data experienced an increase in the rate of the surface roughening over time, with the respective boxplots suggesting this may have occurred after approximately: 400 h for CMSX-4, 500 h for CM247LC DS and 200 h for IN6203DS.

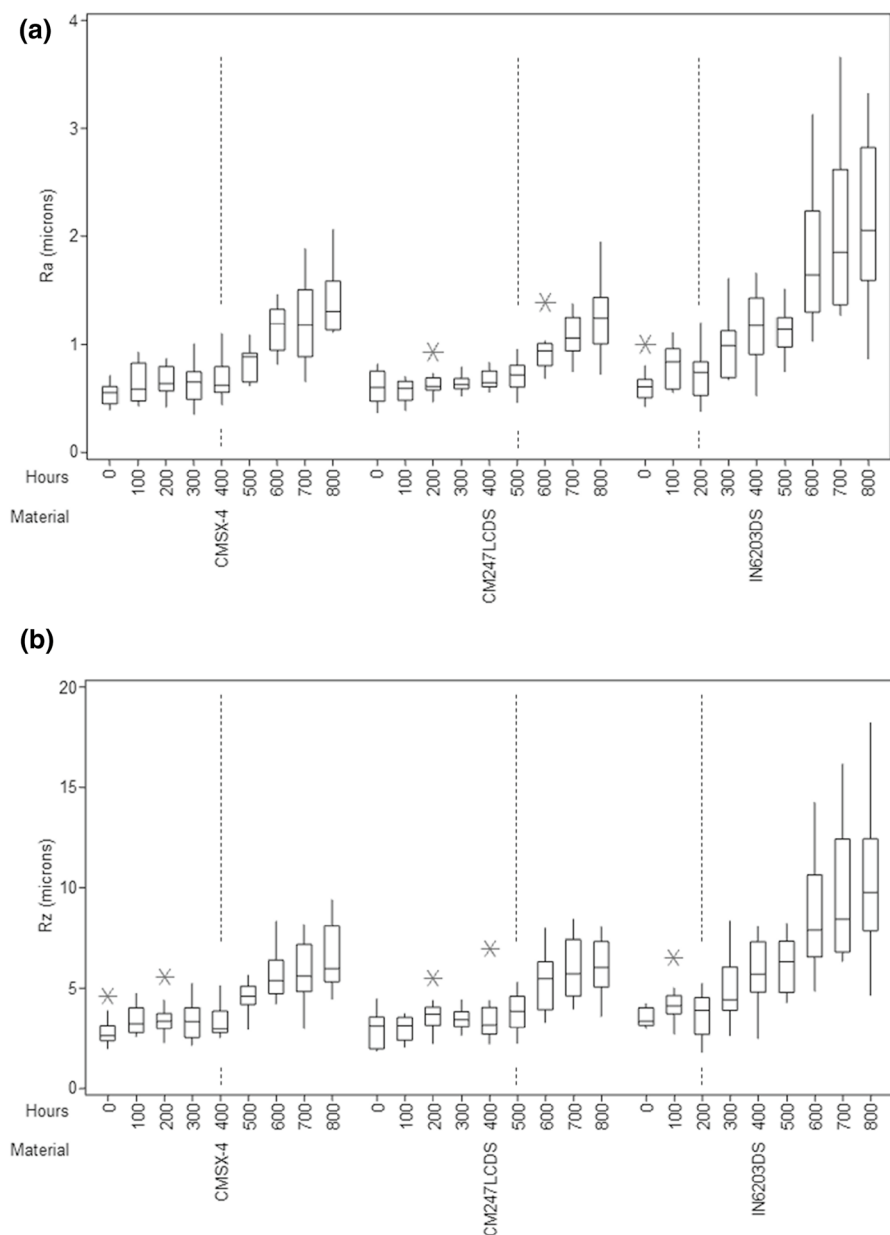
**Fig. 2** Illustration of the evolution of the (a) Ra and (b) Rz surface roughness with respect to exposure to the tested 550 °C hot corrosion conditions. The vertical dashed lines represent the approximate duration when the transition of hot corrosion from incubation to propagation occurs. The asterisks denote the outliers within the respective datasets

The respective boxplots for each superalloy also showed that during the initial, extremely subtle, increase in the surface roughening, the Ra and Rz datasets were plausibly normally distributed with constant variance. Once the superalloys experienced the increase in rate of the surface roughening, the datasets still appeared

The equations describing the trend lines within Fig. 3 also provided an estimation of the maximum penetration rate of the 550 °C hot corrosion attack during the incubation and propagation stages. For both stages, the rate was greatest for IN6203DS which provided further confirmation that this superalloy had the least resistance to the 550 °C hot corrosion conditions. This resulted in IN6203DS suffering greater levels and variance of surface roughening (Fig. 2) than the CMSX-4 and CM247LC DS superalloys at the end of the testing.

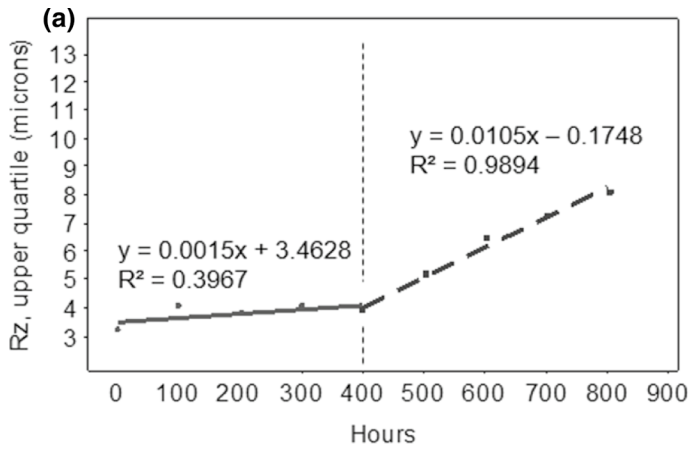
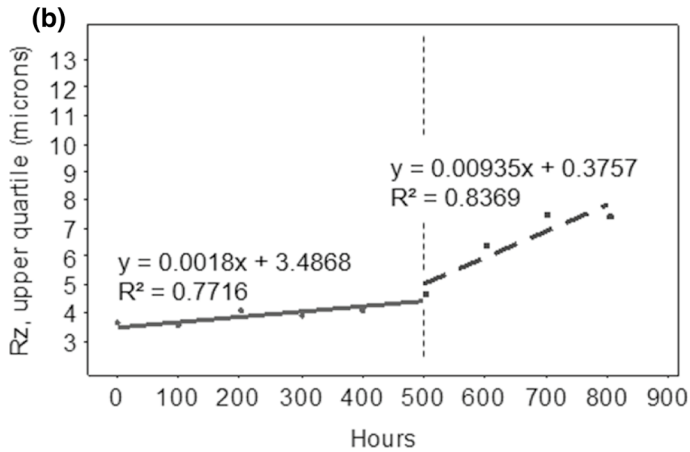
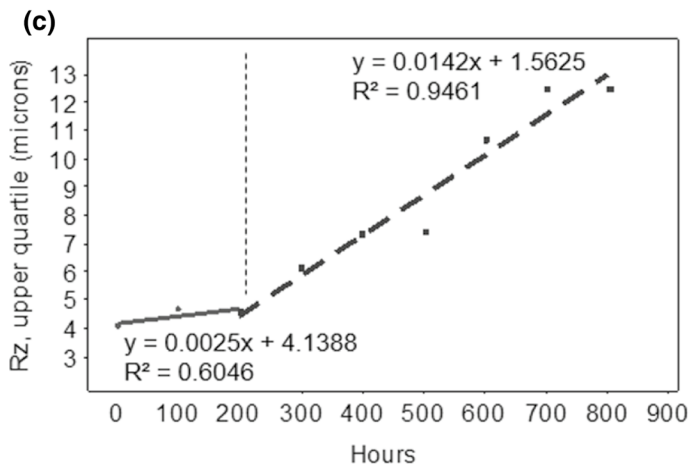
◀ **Fig. 3** Illustration of the Rz upper quartile data points, split into two series approximating the maximum 550 °C hot corrosion penetration rates during the incubation and propagation stages in (a) CMSX-4, (b) CM247LC DS and (c) IN6203DS superalloys. The vertical dashed lines represent the approximate duration when the transition of hot corrosion from incubation to propagation occurs

The boxplots and one-way ANOVA tests have indicated that all three superalloys experienced an increase in the rate of surface roughening during exposure to the 550 °C hot corrosion conditions. These increases appeared to be consistent with a transition from the incubation stage to the propagation stage of the 550 °C hot corrosion. To determine more precisely the time to transition, the Rz upper quartile data points were split into two data series for each superalloy and plotted against exposure time (Fig. 3). The split in the data was based on the last exposure duration where the surface roughness was plausibly the same as that of the as-machined specimen (and this dataset was included in both data series). Trend line equations were then used to estimate the point of transition for each superalloy by determining simultaneous solutions. These calculations estimated the ‘actual’ duration of the incubation stage before the transition to propagation as: 404 h for CMSX-4, 415 h for CM247LC DS and 220 h for IN6203DS. The results of these calculations are consistent with the results of the boxplots and one-way ANOVA tests for the CMSX-4 and IN6203DS superalloys but not for CM247LC DS. The lack of consistency for CM247LC DS appears to be the result of the 800 h Rz dataset for this superalloy, underestimating the true surface roughness (Figs. 2, 3). This may have occurred due to the data being obtained from 12 locations, each with arc lengths of 300 µm, which represented approximately 19% of the total perimeter of the cross section of the test specimen, missing the worst of the surface roughness. This would have meant that the 800 h Rz upper quartile data point acted in an overly influential manner resulting in the underestimation of the point of transition from the incubation to propagation stage for CM247LC DS.

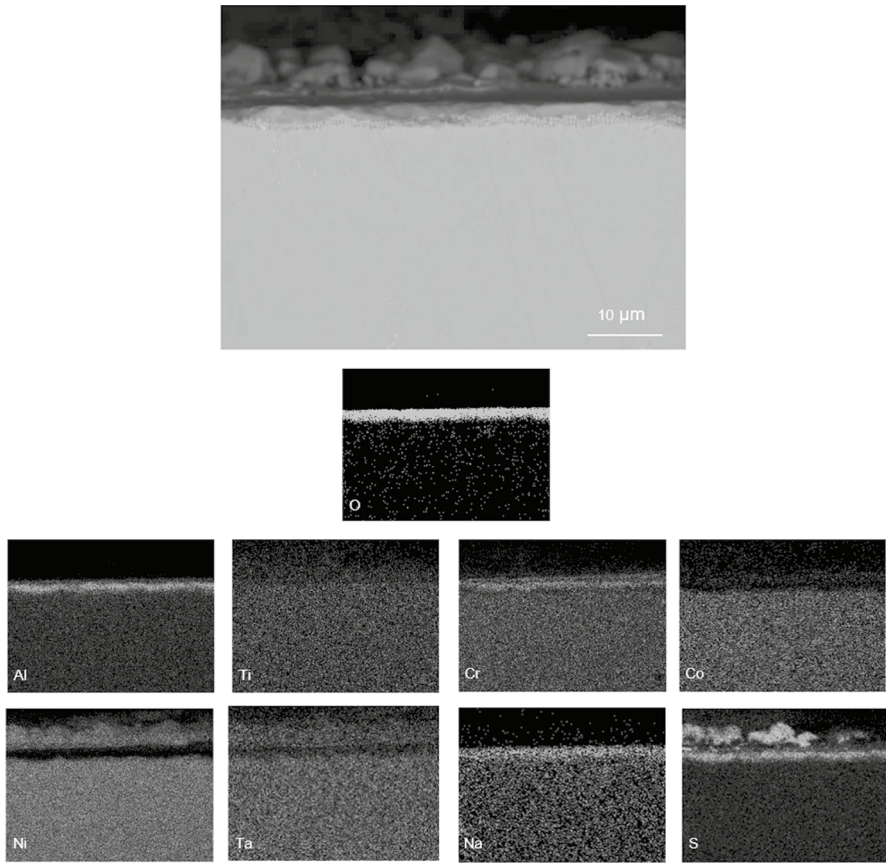
**Fig. 5** Back-scattered electron images and EDX elemental maps of the scale on CM247LC DS superalloy after 800 h exposure to the tested 550 °C hot corrosion conditions

A similar EDX map of the CM247LC DS superalloy (Fig. 5) led to similar conclusions as for the CMSX-4 superalloy with the exception that the external surface appeared to be mainly nickel and sulphur. Although oxygen did not appear to be associated with these elements, it was thought that these were still sulphates based on the test temperature.

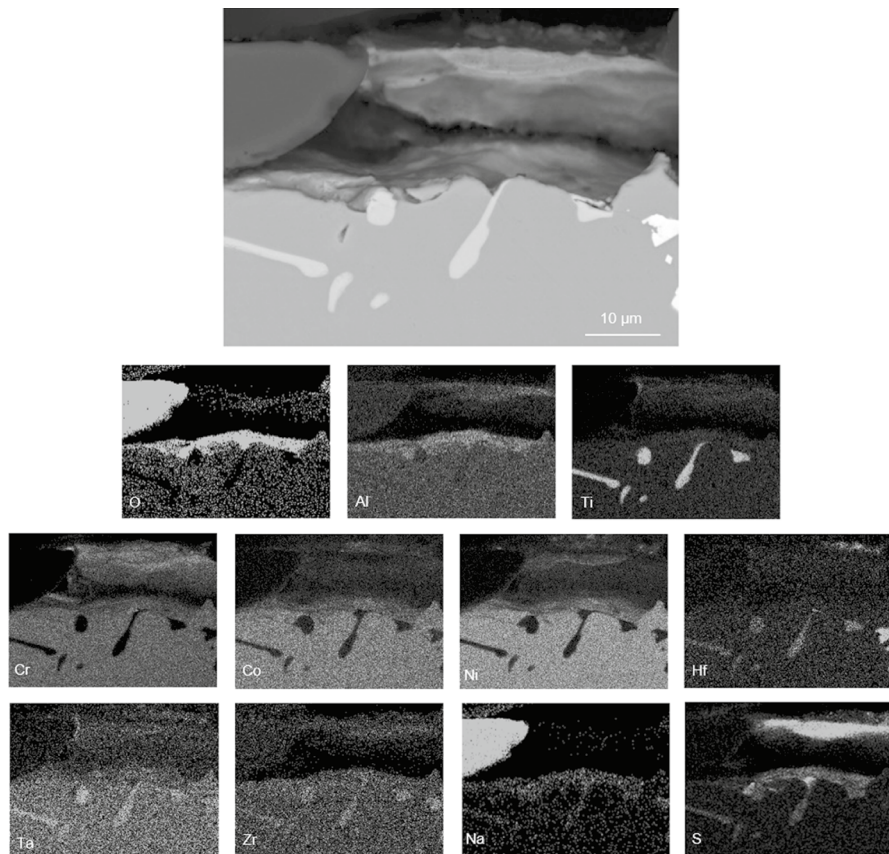
**Fig. 6** Back-scattered electron images and EDX elemental maps of the scale on IN6203DS superalloy after 800 h exposure to the tested 550 °C hot corrosion conditions

The EDX mapping of IN6203DS (Fig. 6) indicated that a protective chromia scale had not formed on this superalloy. Instead, a complex scale involving the elements: oxygen, aluminium, chromium, cobalt, nickel, titanium, hafnium, tantalum and zirconium appeared to be present. This complex scale also provided little protection against the 550 °C hot corrosion as evidenced by the sodium and sulphur within the scale leaving IN6203DS prone to surface roughening. In addition, the EDX mapping revealed phases within the IN6203DS microstructure which contained the refractory elements: titanium, hafnium, tantalum and zirconium. These phases were most likely carbides and the surface roughening appeared to be at its greatest in the material adjacent to these carbides (Fig. 6). SEM investigations of similar refractory metal carbides that were remote from the surface (Fig. 7) suggested a mismatch in the lattice structure with the matrix. This was possibly caused by the thermal cycling during the 550 °C hot corrosion exposure creating micro-cracking around the carbides owing to a difference in the thermal expansion coefficients as compared to the matrix, or may have been due to sample preparation. It is therefore proposed that for refractory metal carbides connected to the surface, the respective interfaces with the matrix acted as short-circuit diffusion paths. This was most likely due to the dislocation arrays which exist at these locations, or possibly the potential thermal cycle micro-cracking, which enabled sulphur to diffuse into and combine with the sulphur attack from

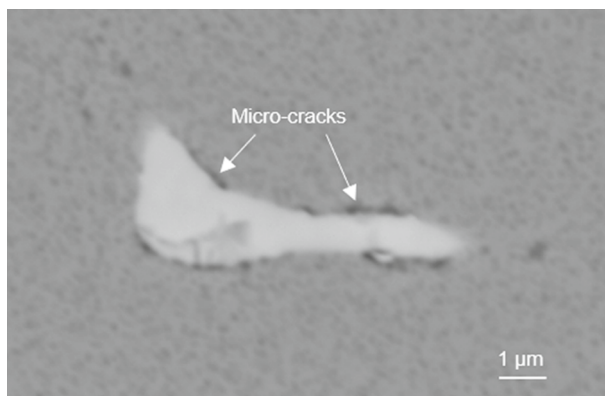
**Fig. 7** Refractory metal carbide phase within IN6203DS superalloy showing micro-cracking at interface with the matrix

the surface causing surface roughening adjacent to the carbides. Based on this, it is highly plausible that the refractory metal carbides were responsible for IN6203DS showing the lowest resistance to the exposure conditions and experiencing greater levels and variance of surface roughening.
