## Correction: Effect of Deposit Chemistry on the Stress Corrosion Cracking Susceptibility of CMSX-10 at 550 °C and 700 °C

**Correction to: High Temperature Corrosion of Materials (2026) 103:7**  
<https://doi.org/10.1007/s11085-025-10366-y>

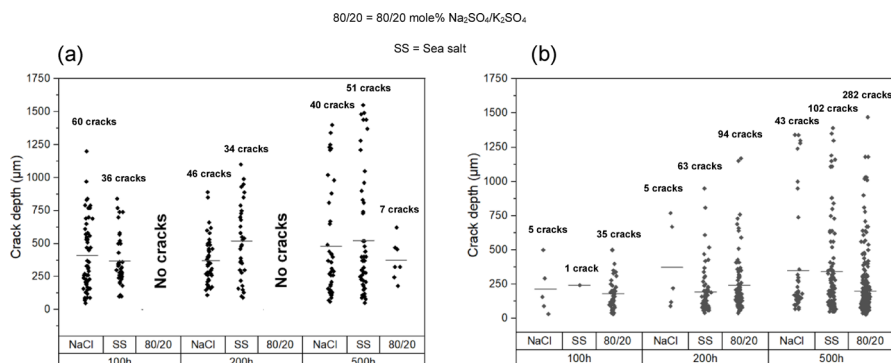
The plot below is the wrong plot that is shown in the original article.

**Fig. 4** Crack depth measured on C-rings with different salts and exposed at **a** 550 °C and **b** 700 °C

In this article the wrong figure appeared as Fig. 4 (b) specifically in the number of cracks in the sea salt salted sample at 500 h. The number of cracks that shows up on the plot at 500 h is 48, but it should be 102; the figure should have appeared as shown below. For completeness and transparency, the old incorrect and correct versions are displayed below.

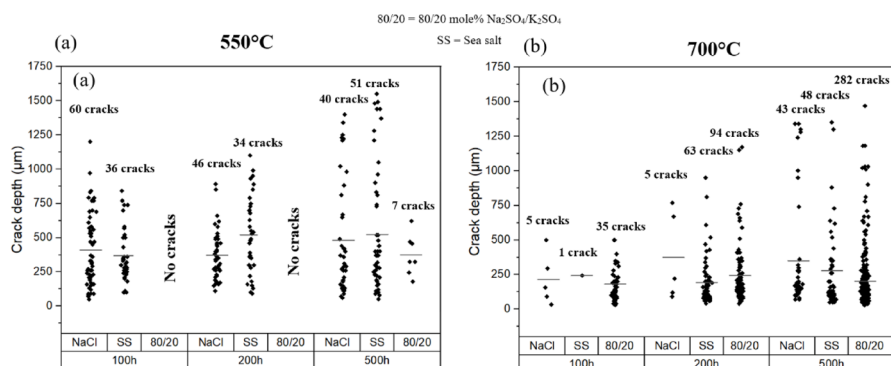
The plot below is the corrected plot.

**Fig. 4** Crack depth measured on C-rings with different salts and exposed at **a** 550 °C and **b** 700 °C

In addition to the above, in page 16, the sentence in the last paragraph stating “Sea salt showed a very similar behaviour to NaCl in terms of the number of stress corrosion cracks initiated” should have been “Sea salt showed a significantly higher number of cracks than NaCl only after 200 h and 500 h of exposure.”
