# Laser array spots thermography for detection of cracks in curved structures

**Abstract.** The laser array spot thermography (LAST) is a fully non-contact and non-destructive method for the inspection of surface cracks with high efficiency. In this study, the detection capability of this method for the inspection of surface cracks in structures with curved surfaces is experimentally studied. The influence of the inspection angle on the crack imaging results is also investigated. The experiment results show that cracks in surface of the pipes with different dimeters can be detected and imaged by LAST.

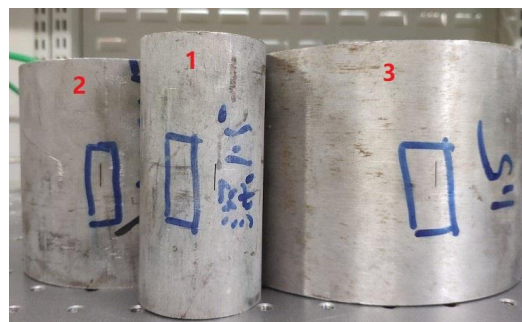
Fig. 2. Picture of SUS pipes specimens with diameters of 50mm, 100mm, 150mm.

To examine the performance of the LAST technique, experimental evaluation is performed. As shown in Fig. 2, the specimen used in experiments are three pipes made of SUS 304. Small notches were respectively

introduced in the outer surface of three pipes using a wire-cut electric discharge machining (EDM) to simulate the surface cracks. The specifications of specimens and cracks are shown in Table 1.
