# On the chemical composition, microstructure and mechanical properties of a Nitrogen-contaminated Ti-6Al-4V component built by Wire-Arc Additive Manufacturing

**Abstract.** Additive manufacturing (AM) using recycled Ti-6Al-4V (Ti64) feedstock material from wrought waste streams is a novel process that can reduce the overall energy cost and carbon (CO<sub>2</sub>) footprint when compared to primary-production routes. The potential contamination of recycled feedstock material (e.g. C, O, N and Fe) can affect the microstructure and mechanical properties of the component. In this work, a Ti64 test wall built using wire arc AM (WAAM) was studied, where the top half only was contaminated by N through the shielding gas during deposition. This allowed a direct comparison of Ti64 WAAM material with high and low N content, deposited under otherwise identical conditions, to replicate the worst-case scenario of N contamination from using recycled swarf. The hardness of the N-contaminated section was found to be 25% higher than the uncontaminated section of the wall, demonstrating the N solid solution strengthening in Ti64. The room temperature transformed microstructure was found to have a 2

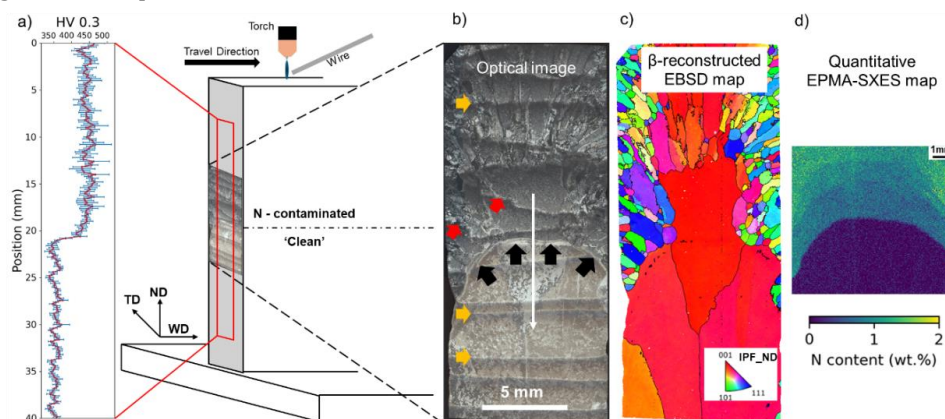
The hardness profile shown in figure 1(a) was obtained from micro-hardness mapping by averaging 25 indents in TD, which indicates a significant increase in hardness in the contaminated part (top, ~445HV) than the clean part (bottom, ~ 354 HV). A large area optical image of the etched cross section is presented in figure 1(b), and reveals that the dissimilar-colour interface between the uncontaminated Ti64 material (referred to as 'clean part') and the first contaminated layer (black arrows) is not flat, but instead curved, matching the bead profile of similar Ti64 WAAM deposits in this plane [7]. HAZ bands are also clear in figure 1(b). However, the HAZ bands adjacent to the interface are curved and irregular (red arrows), unlike the parallel HAZ bands in the clean bottom part and those in the top contaminated part but located farther from the interface (orange arrows). The  $\beta$ -reconstructed EBSD map in figure 1(c) shows clear grain refinement in the outer layer of the contaminated part, which differs from the highly textured ( $\langle 001 \rangle // ND$ ) coarse columnar  $\beta$  within the central region and the bottom clean part of the wall. figure 1(d) is a quantified EPMA map showing the N level across the interface. The concentration of N across the interface changes with a stepped profile with a sharp transition between 0.03 wt.% and 0.67 wt.% followed by a gradual gradient, with a final discontinuous transition to ~ 1.1 wt.%, matching the bead profile of several deposited layers. This 'transition gradient' is similar to those seen in WAAM dissimilar-alloy builds where the alloy feedstock is switched mid-deposition [8]. Averaged N concentrations measured by EPMA in the clean/contaminated sections are given in table 1. Similar analysis has also been applied to C and O but show a uniform distribution throughout the deposition.

**Figure 1.** (a) N-contamination WAAM wall schematic diagram and reference frame, alongside a hardness profile on the ND across the interface. (b) An optical image taken from the interface. Fusion boundary between clean and contaminated part is indicated by black arrows. Some HAZ bands are highlighted by red and orange arrows. (c) A  $\beta$ -reconstructed EBSD map of the same area. (d) Quantified EPMA-SXES map showing N level at the interface. The white line on the optical image indicates where the SEM-BSE scanning was performed (figure 2).

The hardness measurement showed that there is a ~25% increase in the contaminated part compared to the clean part, which is indicative of an increase in the yield strength as has been demonstrated previously (e.g. [10]). This increase in hardness is likely attributed to N solid solute strengthening effect, as previously reported in pure Ti [11, 12] but conversely reduces the ductility.

Furthermore, the outer layer of the N-contaminated section was found to have a refined parent  $\beta$  grain structure as illustrated in figure 1(c). This observation is consistent with previous findings in dual phase Ti alloys with wider mushy zones [8]. It is suggested that the outer layer refinement is caused by the maximum thermal gradient tilting away from the ND during solidification, following the normal of the curved bead profile. This allows the dendrites growing away from the ND to gain a growth advantage over the  $\langle 001 \rangle //$  ND columnar  $\beta$  grains and block their growth. This effect is explained in more detail in reference [16]. The thermal gradient is more likely to affect the N contaminated section, since N is known to increase the width of the mushy zone. In addition, due to the relatively high level of N in the sample, nitrides may form in the melt pool, which could act as heterogeneous nucleation sites and contribute to the  $\beta$  grain refinement during solidification, which has been demonstrated with artificial nucleants introduced to the melt pool [17].

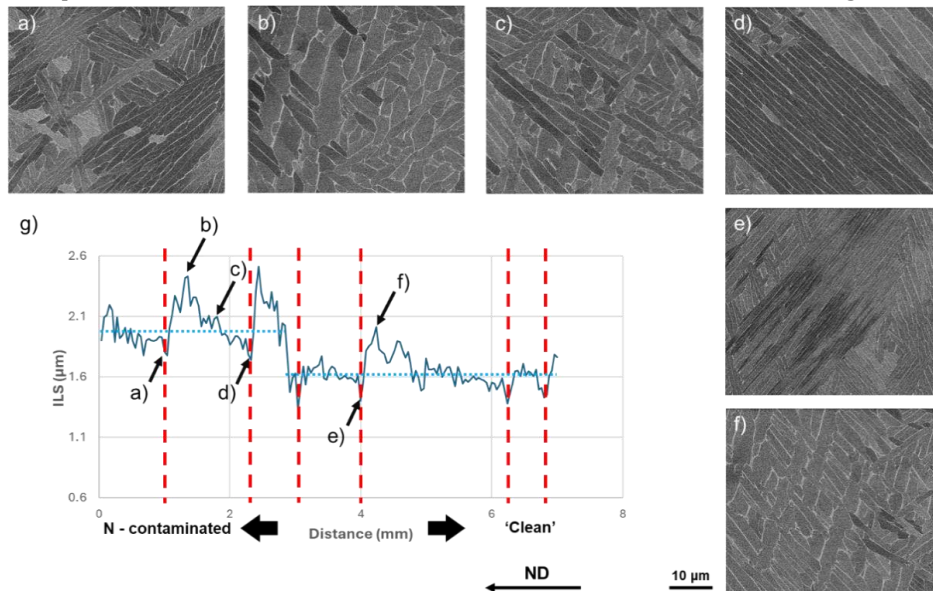
the HAZ bands a characteristic ‘saw tooth’, repeating pattern is observed, where the ILS increases as it approaches the bottom of the HAZ band and subsequently drops rapidly at the top of the HAZ band [7]. The abrupt change in ILS is linked to the effect of the  $\alpha \rightarrow \beta$  phase transformation on transformation microstructure as shown in figure 2, which is consistent with previous work [7].

More importantly, the ILS measurements show that the average ILS is ~25% larger in the contaminated part compared to the clean part. This discrepancy suggests that a higher level of N has a more pronounced effect than the heat accumulation on the  $\alpha$ -lath coarsening.

**Figure 2.** (a-d) Sequential SEM-BSE images showing the microstructure from one HAZ band to another. (e) and (f) are two SEM-BSE images showing the microstructure across one HAZ band from the clean section. (g) Linear intercept  $\alpha$ -lamellar spacing (ILS) measurement across 6 HAZ bands across the interface taken from the position highlighted in figure 1(b) by the white arrow.

The transformation microstructure analysis reveals a ~25% coarsening of the lath thickness in the contaminated part. Coarsening of the transformation microstructure of Ti64 leads to a higher ductility [13], which could cause the WAAM-built Ti64 component to exhibit an increased

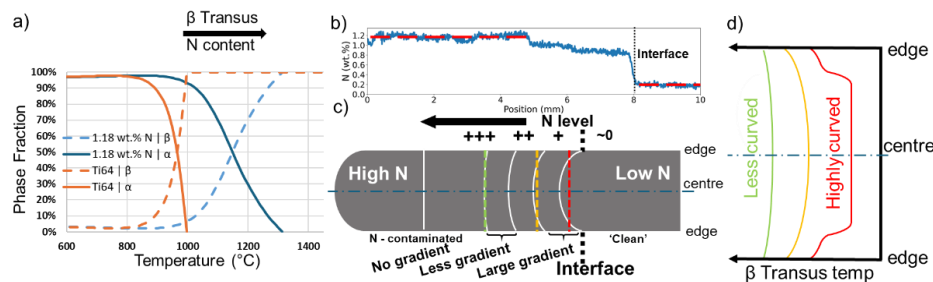
**Figure 3.** (a) A diagram showing the  $\beta$ -transus temperature of Ti64 (no contaminants) and Ti64 with higher N content (1.18 wt.% as given by EPMA). (b) A line profile of a longer higher spatial resolution EPMA map to show the N content on each part and the gradient along ND. (c) A schematic illustration of the distribution of the N gradients along the ND and (d) a schematic diagram showing  $T_{\beta}$  profiles relating to HAZ band behaviour.

Nitrogen is an  $\alpha$  stabiliser in Ti [2] and is known to have a similar effect as O in increasing the  $\beta$ -transus temperature ( $T_\beta$ ) [15]. This is an important consideration in AM Ti64 microstructures with variable N concentration because of the thermal cycling that occurs below the  $T_\beta$  causing partial  $\alpha \rightarrow \beta$  phase transformation, leading to the formation of HAZ bands. In order to predict the effect of N on the  $T_\beta$  in Ti64, phase transformation temperature calculations of Ti64 were performed using the 'Thermo-calc' software with the ICP measured composition of the contaminated wall, except for the N where the averaged EPMA value (1.18 wt.%) was used that was considered more reliable (see figure 3a). The significant increase in the  $T_\beta$  may explain the coarsening of the transformation microstructure on the N-contaminated side. During the thermal cycling below  $T_\beta$ , the  $\alpha$  regions are subjected to partial  $\alpha \rightarrow \beta$  phase transformation leading to transformation microstructure coarsening [7]. A higher N content in the contaminated section is proposed to accelerate this coarsening kinetic as the partial phase transformation occurs at a higher temperature and leads to a coarser transformation microstructure than in the clean section.

However, the spatial distribution of N, as revealed by the EPMA map in figure 3(d), is heterogeneous along the TD. The EPMA map shows a sharp N gradient directed towards the 'C' shaped interface, which is consistent with the bead profile. As illustrated by the N profile along the ND in figure 3(b), there is a sharp transition at the interface followed by a gradual gradient which results from the remelting and liquid mixing of the previous layer during deposition. After depositing another 2 layers above the interface (approximately 4 mm), the N content reaches a steady level. Figure 3(c) is a schematical illustration of the N spatial distribution of a ND-TD cross section. Red, yellow and green dashed lines along the TD were plotted on figure 3(c) to represent locations that experienced the same thermal history and align with the HAZ bands at the build centreline. Corresponding  $T_\beta$  schematic profiles (based on the N EPMA map and phase diagram trends) that match the same centreline positions have been added in figure 3(d) and are proposed to correspond to the curvature of the irregular HAZ bands shown in figure 1(b). Initially, there is a high N gradient when crossing the fusion boundary (that is aligned with the bead profile) in TD between layers, which results in high HAZ band curvature. However, as the N gradient diminishes moving further from the interface, the curvature of the  $T_\beta$  profile and HAZ bands decrease.
