## Effect of grain boundary precipitation on the mechanical integrity of EBW joints of Inconel 625

The precipitation effects on the mechanical behavior of electron beam welded joints of Inconel 625 in the as-welded [AW] and post-weld heat treatment [PWHT] conditions have been investigated in this research study. A PWHT comprising of direct aging [DA] treatment at 700 °C for 100 h in vacuum at a pressure of 10<sup>-5</sup> mbar was performed on the weld joints. The microstructure of the base alloy opined the precipitation of MC system carbides and  $\gamma''$  strengthening phase after subjecting to DA. Also, Nb-Mo rich precipitates and the Laves phase was noticed in the inter-dendritic arms of the fusion zone (FZ) of welded joints in the AW conditions. DA treatment has a notable effect on the weld mechanical characteristics of Inconel 625 joints. The precipitation of  $\gamma''$  strengthening phase is reasoned for the significant rise in the yield strength [YS] and tensile strength [TS] of the base alloy and EBW joints.

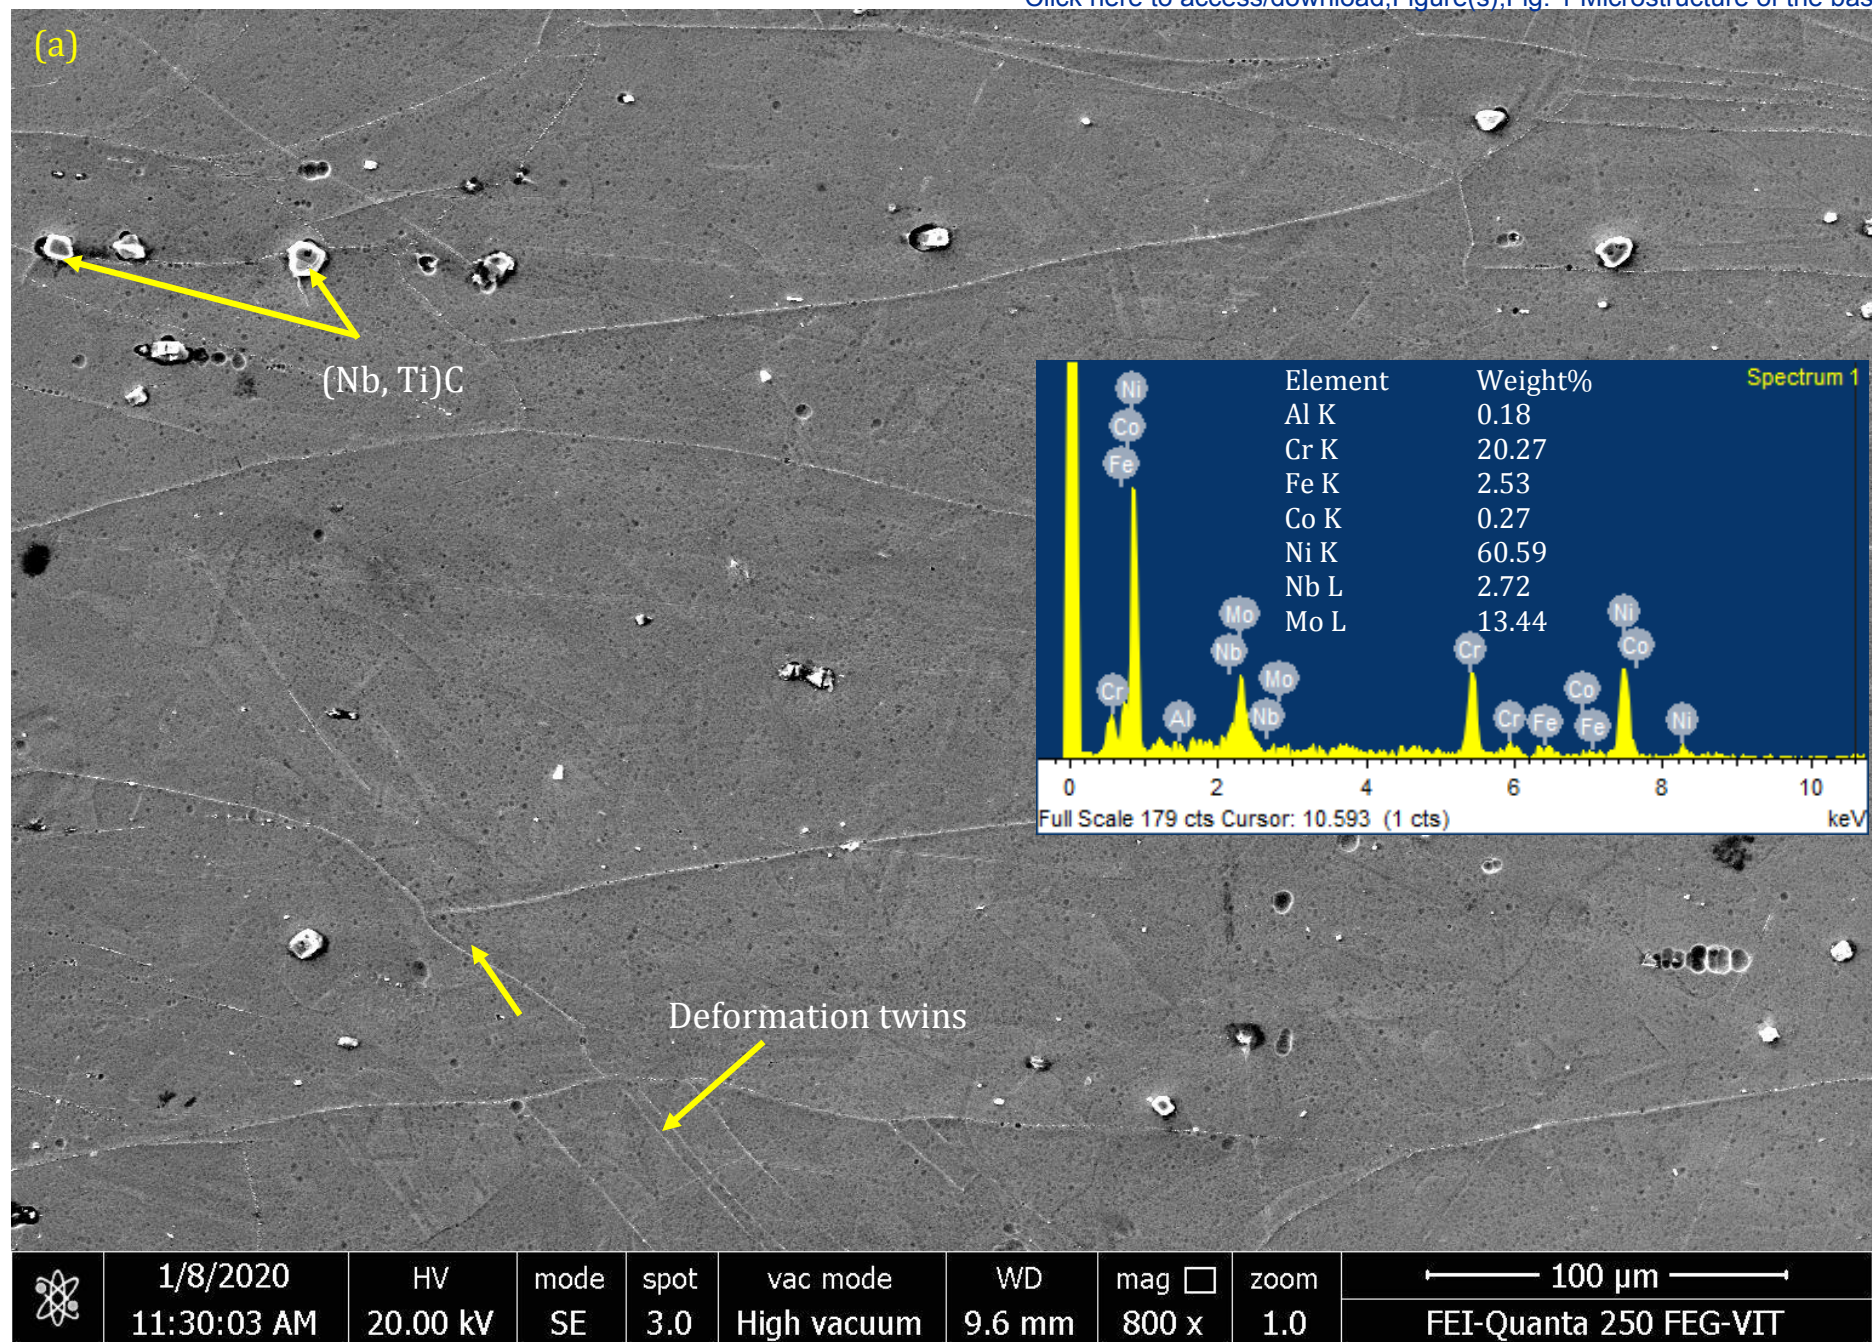
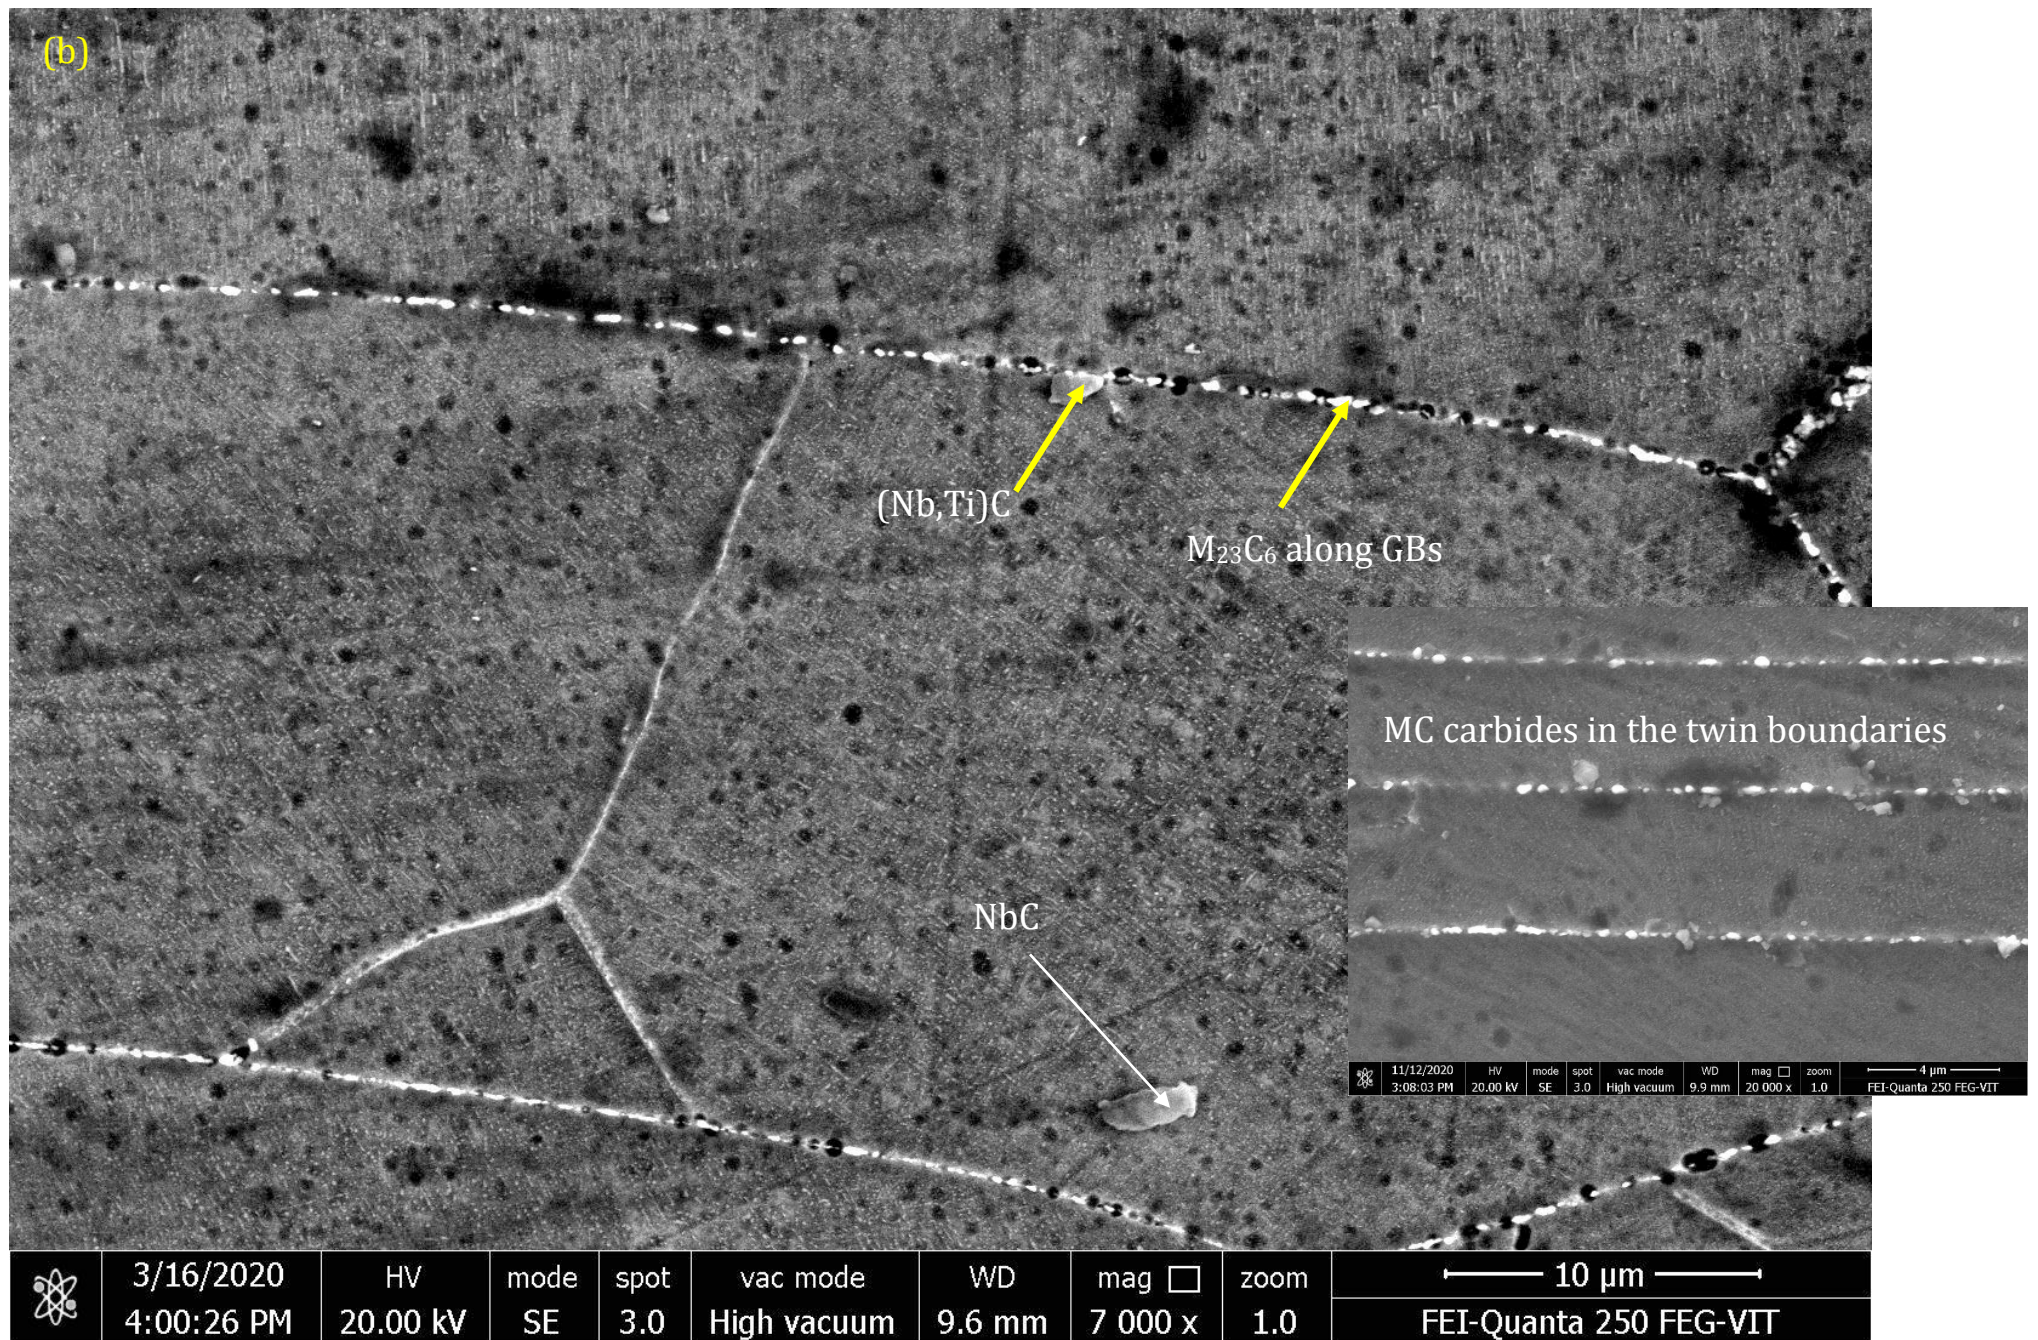
Fig. 1 Microstructure of the base alloy Inconel 625 in the (a) as-received and (b) after subjecting to direct ageing treatment respectively

The microstructure of the base alloy shown in [Fig. 1\(a\)](#) comprises elongated Ni-rich austenitic matrix with the twin boundaries and polygonal-shaped carbides or carbonitrides of Nb and Ti. Under high magnification, continuous, fine precipitates at the grain boundaries are also recognized [\[Fig. 1\(b\)\]](#) on the parent metal side of Alloy 625 after subjecting to 100 h heat treatment. The precipitates have grown along the  $\gamma$  matrix grain boundaries of the base alloy region and have typical elliptical morphology. Based on this morphology, these precipitates are identified to be  $\gamma''$  strengthening phase. Precipitates of similar morphology were reported by [Malej et al. \[15\]](#) during thermal aging of Inconel 625 for 25, 240, and 504h. Similarly, in the base alloy region, a large number of twins appeared and also have fine precipitates at twin boundaries. The authors believe that these fine precipitates along the twin boundaries are probably  $M_{23}C_6$  secondary carbides and  $\gamma''$  phase.

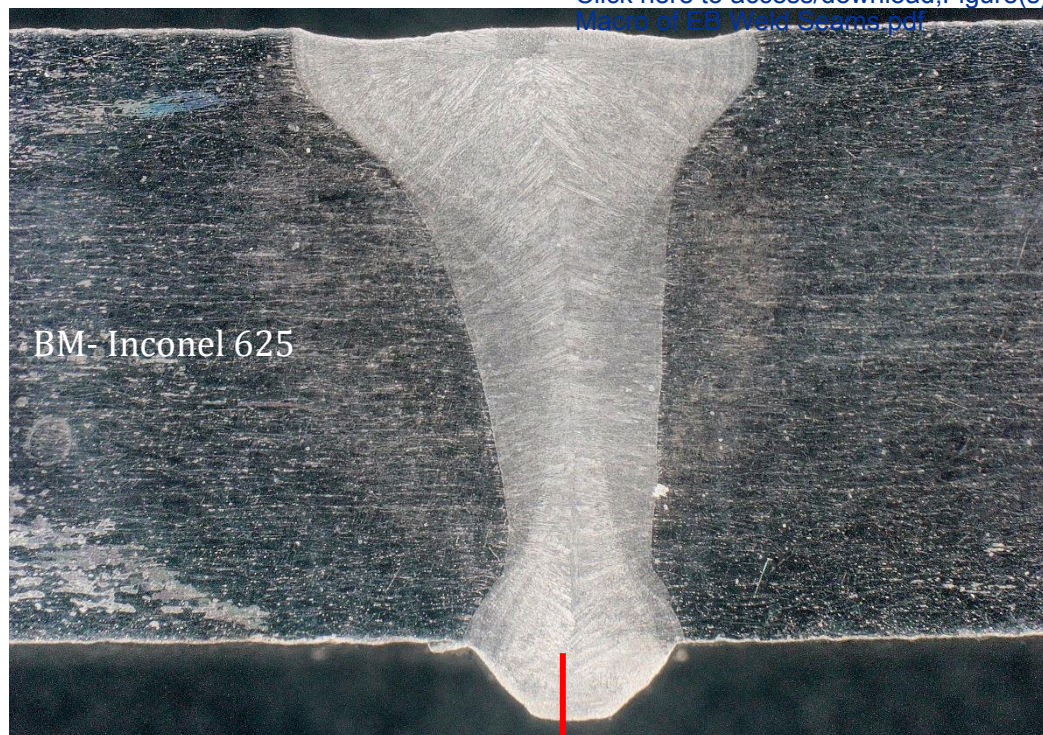
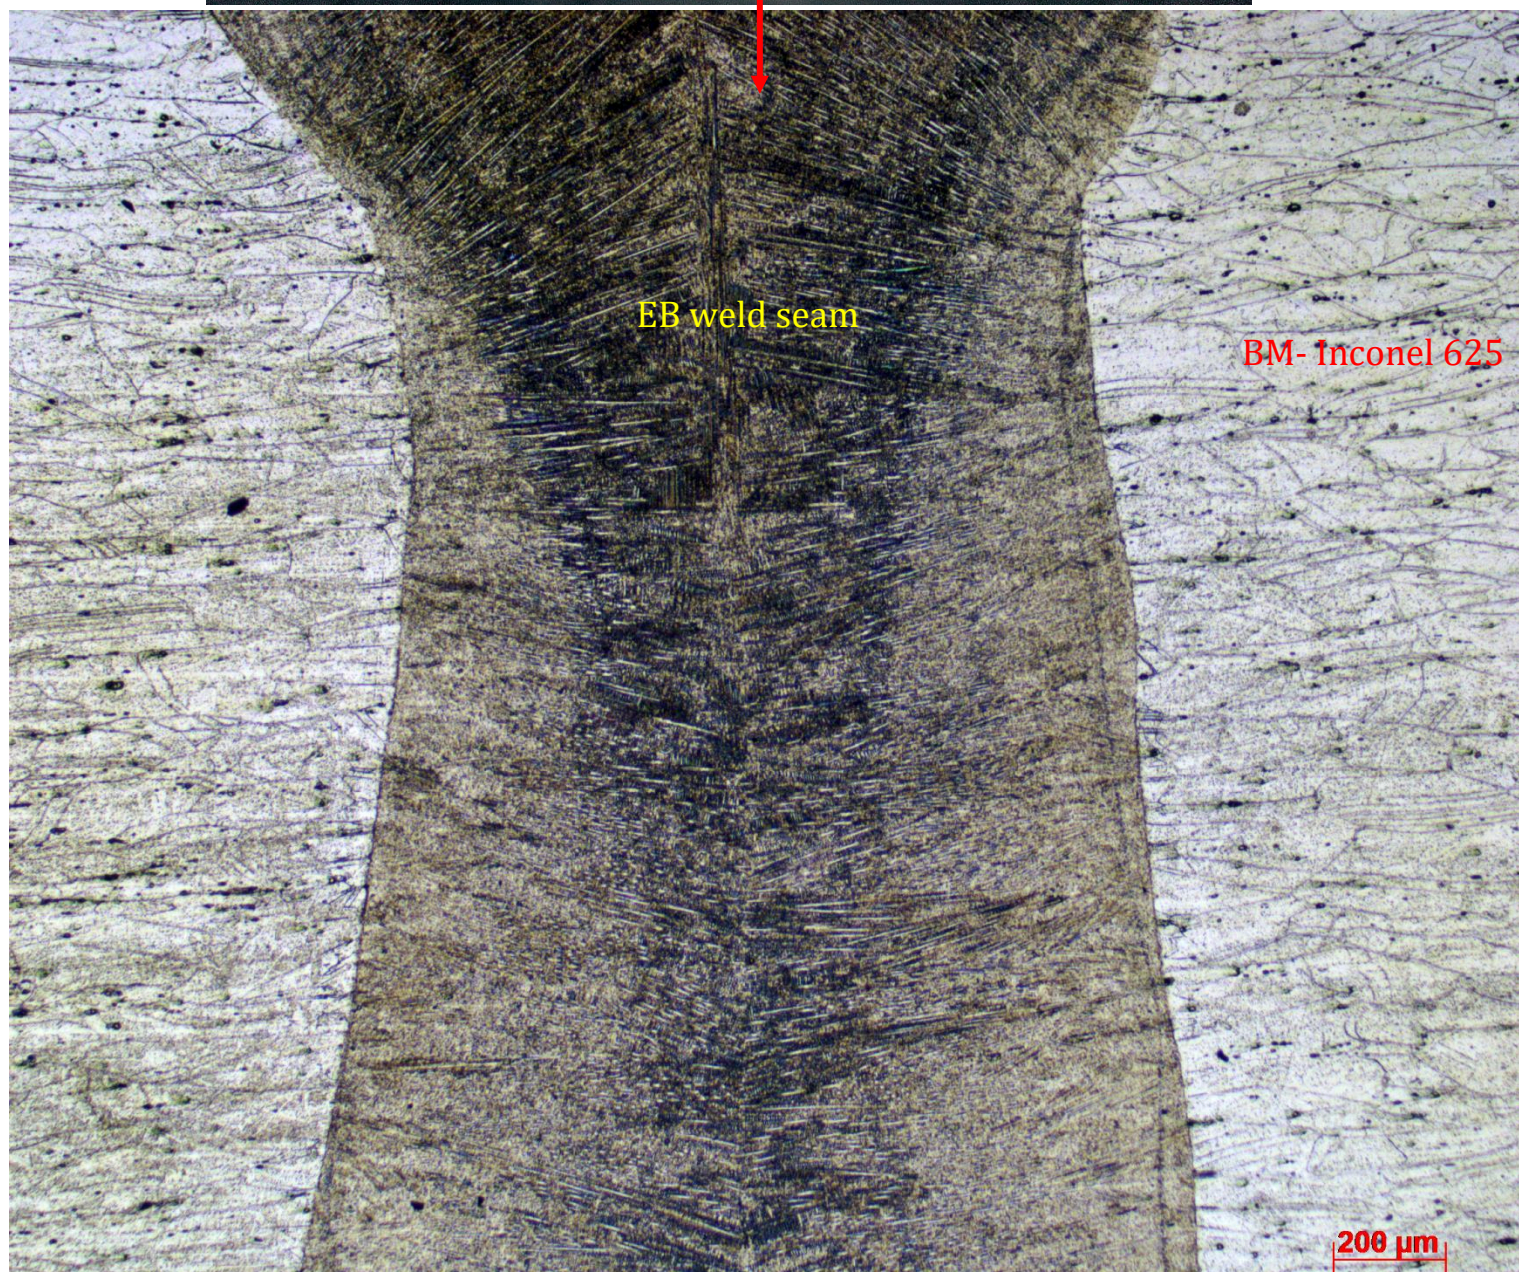
Fig. 2 Cross-sectional macrographs showing the EB weld seams of Inconel 625

Inconel 625 was analyzed using the cross-sectional macrostructural image provided in Fig. 2(a) and 2(b). Full penetration without defects indicates that the process specifications adopted in the research are appropriate. Interface microstructures of the EBW seams in the AW and PWHT conditions are shown in Fig. 3(a) and 3(b). It is opined from Fig. 3 that no major microstructural changes are noticed except the precipitation of grain boundary carbides across the interface after aging for 100 h.

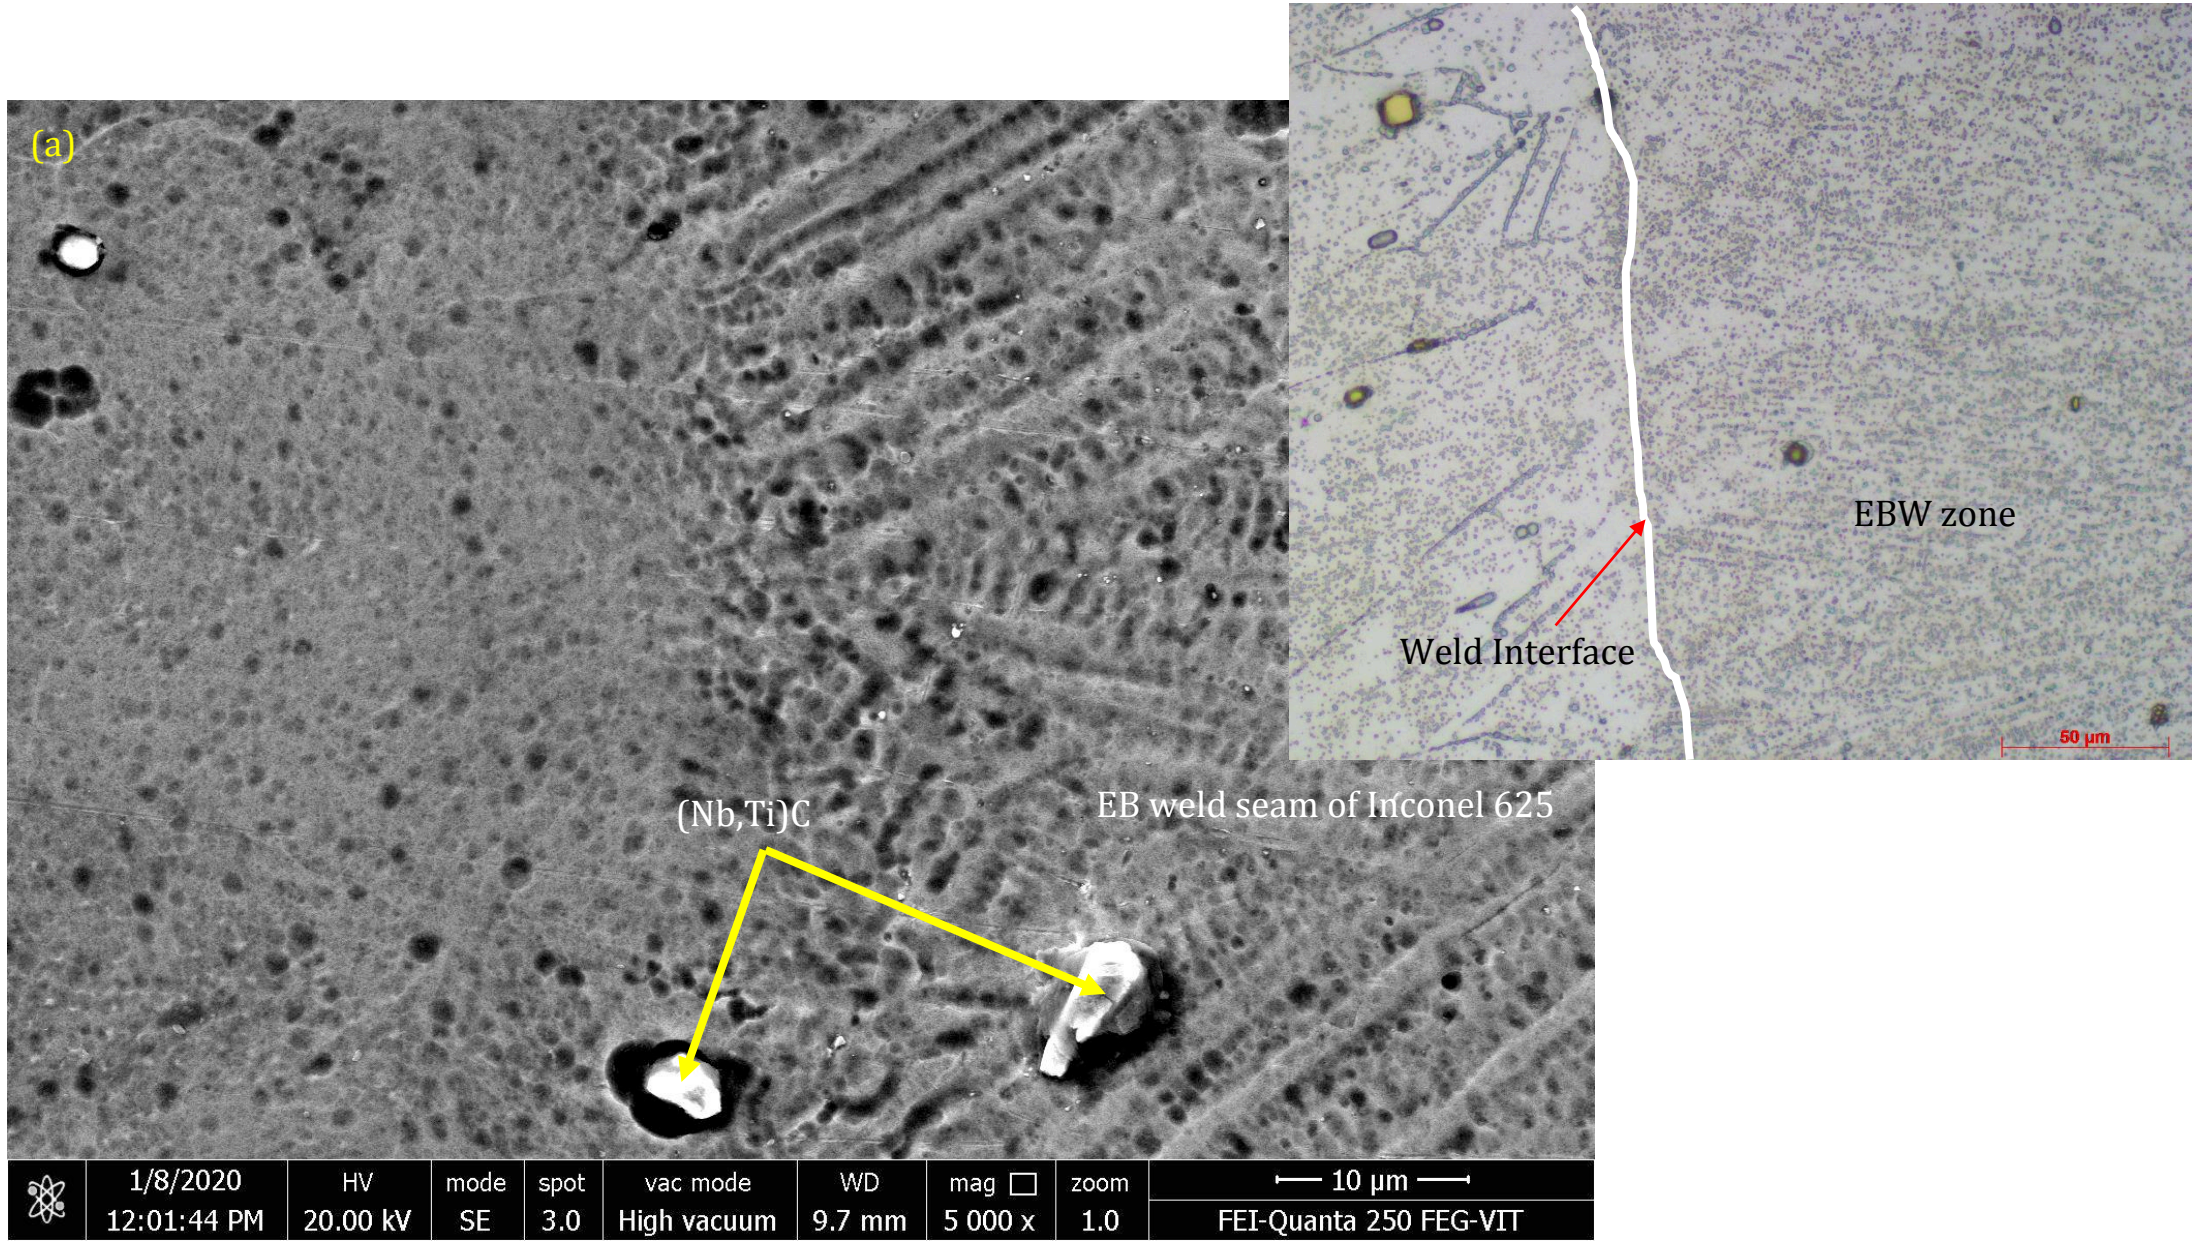
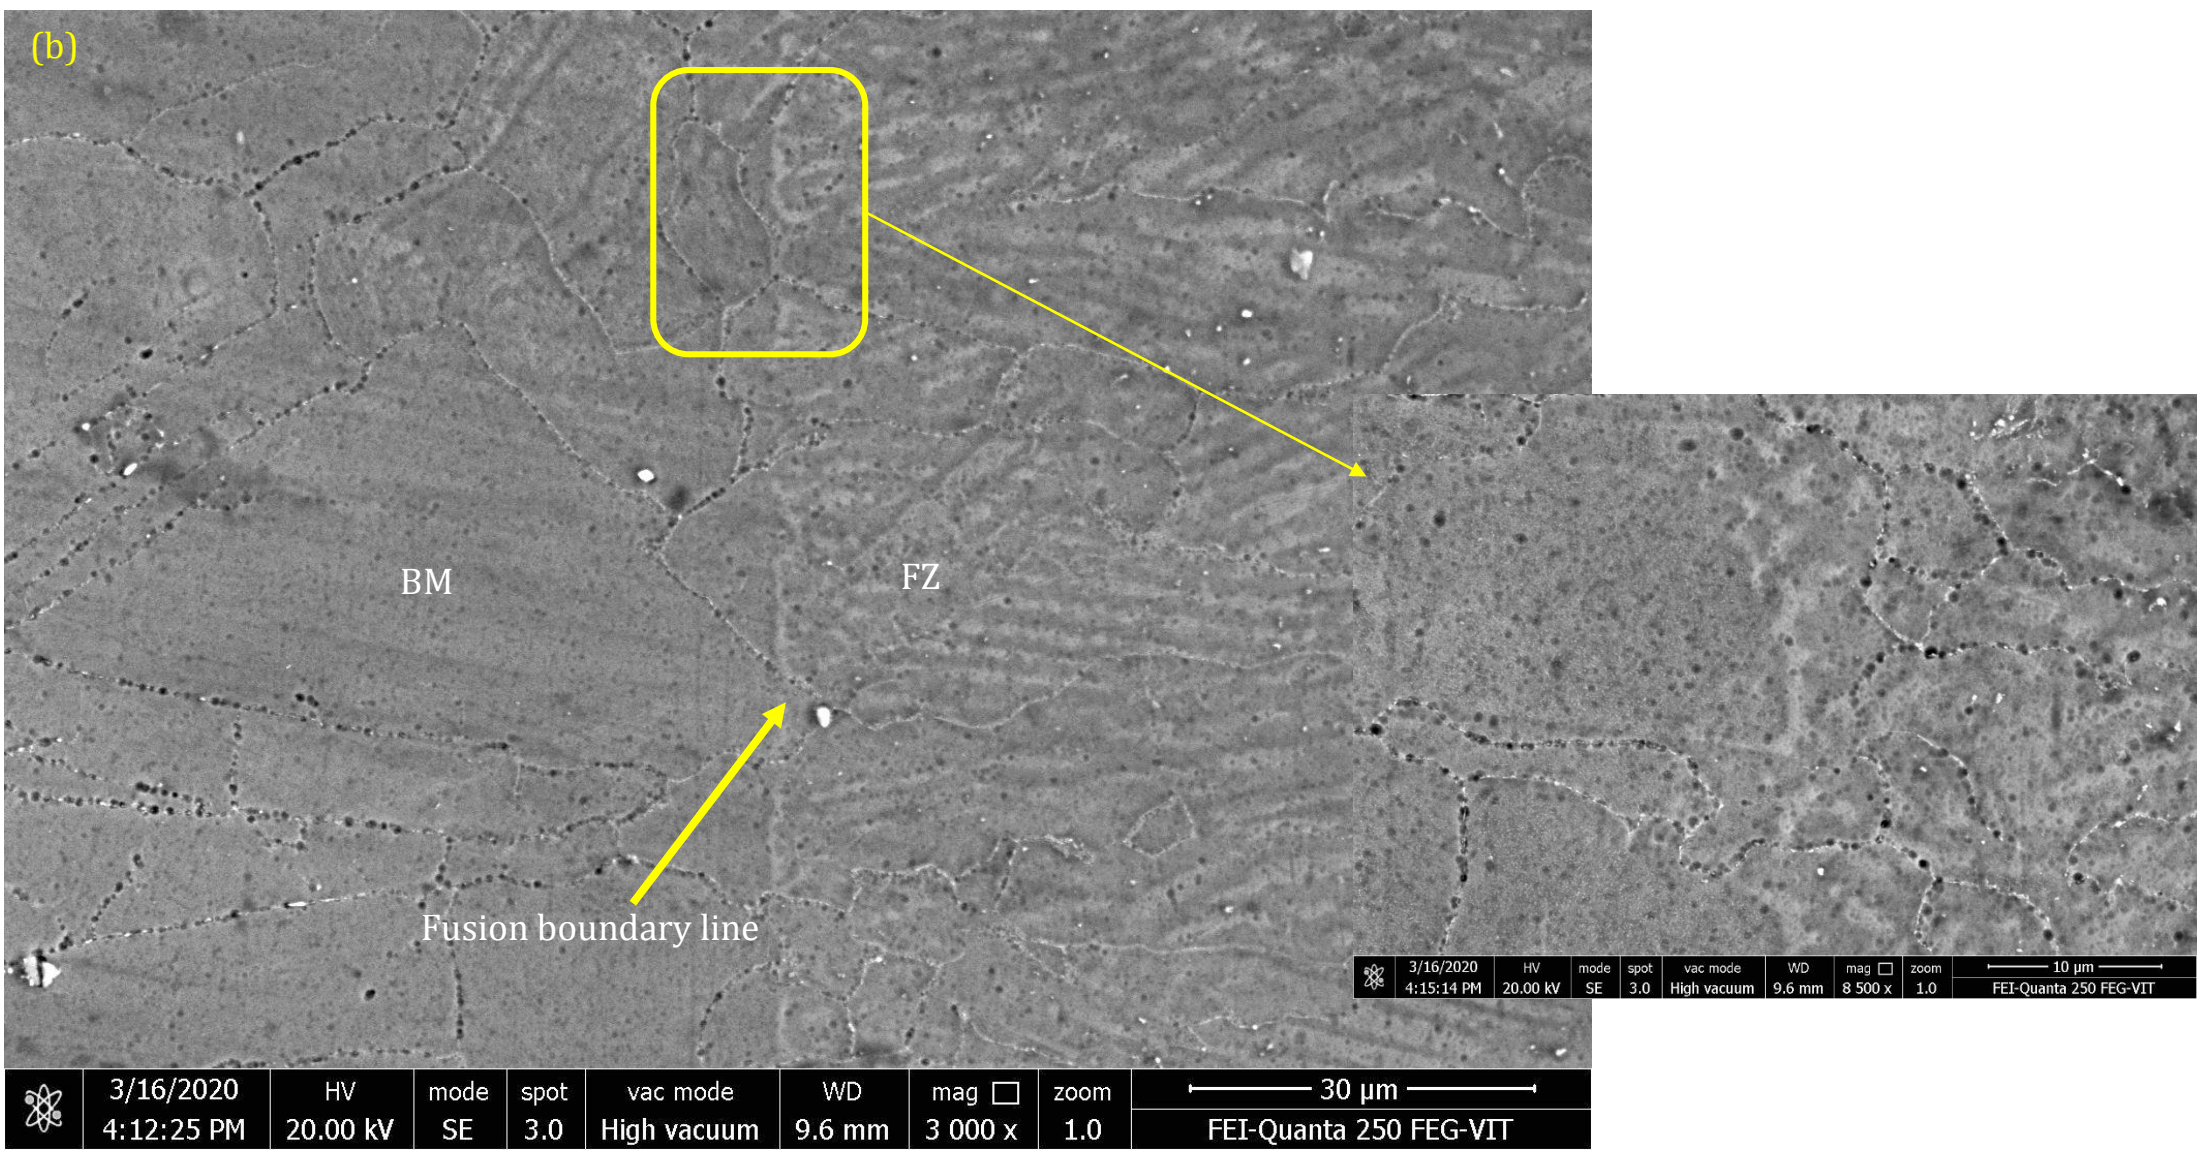
Fig. 3 SEM images showing the interface microstructures of EBW seams of Inconel 625 in the (a) as-welded and (b) direct aged conditions

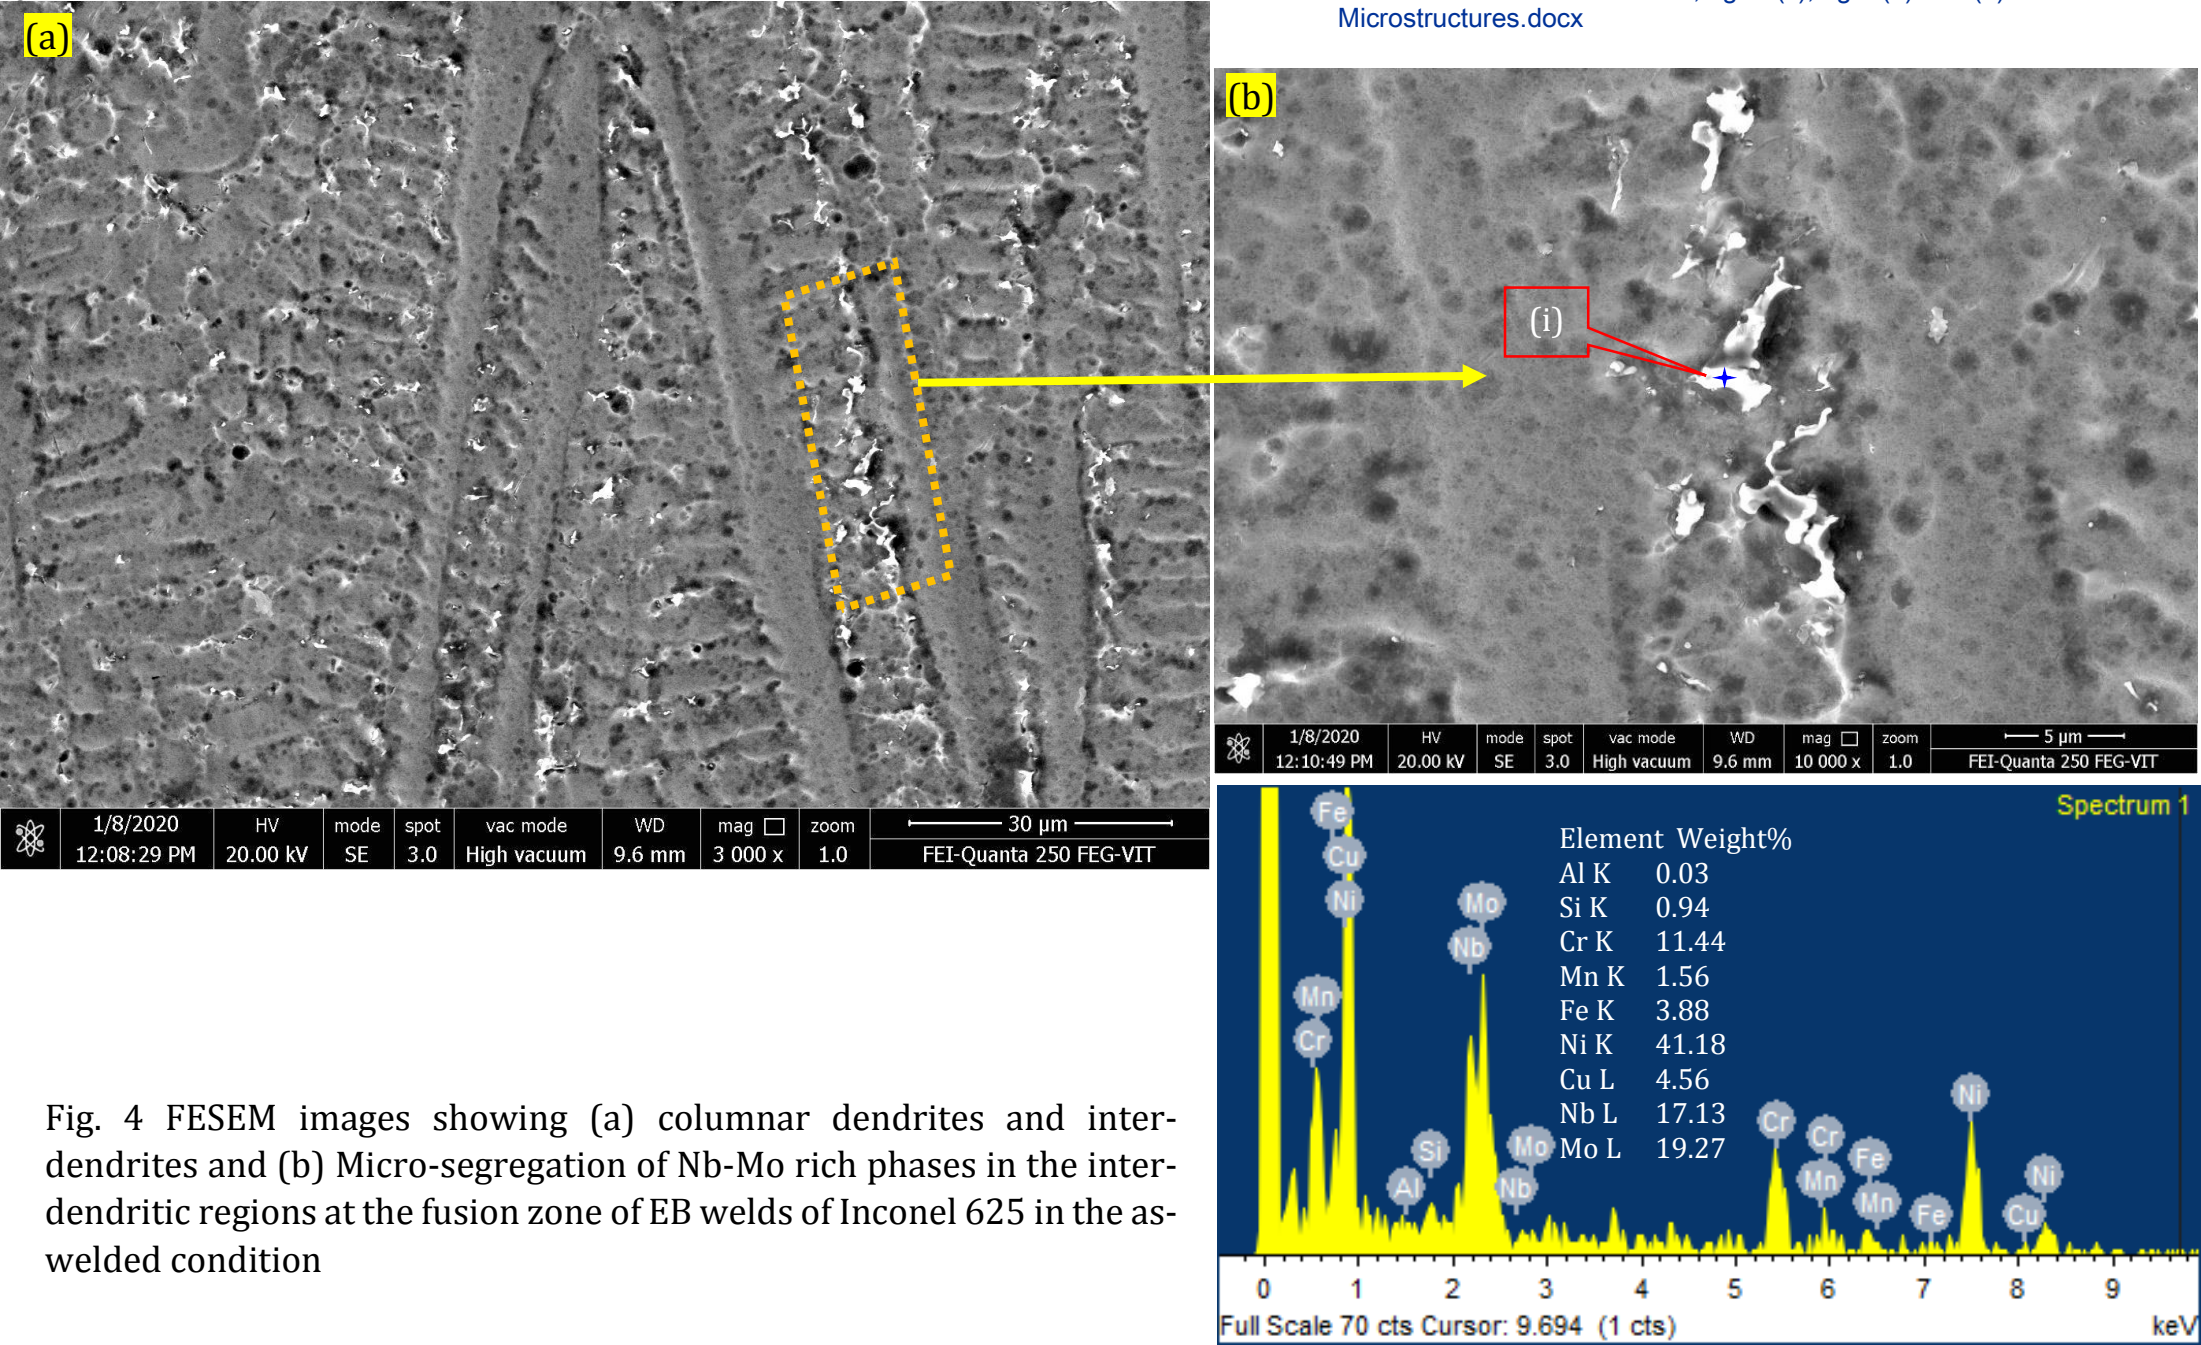
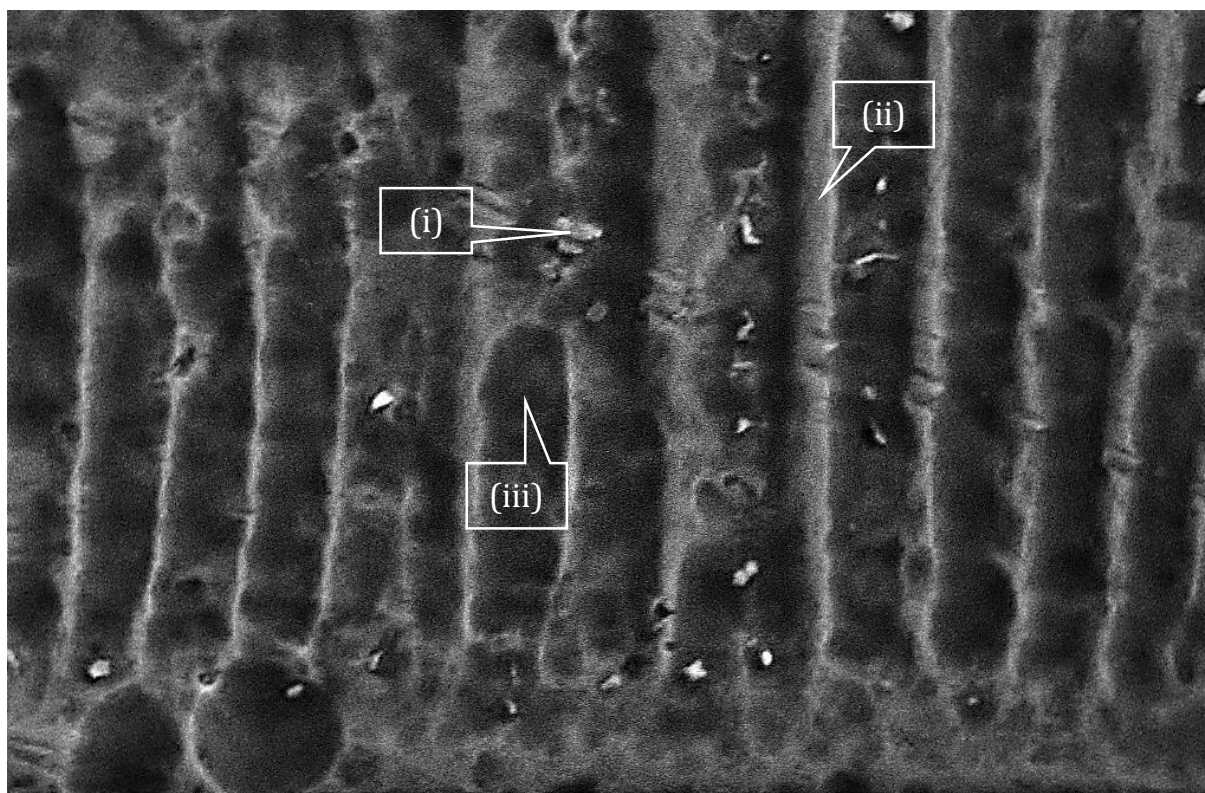
Fig. 4 FESEM images showing (a) columnar dendrites and inter-dendrites and (b) Micro-segregation of Nb-Mo rich phases in the inter-dendritic regions at the fusion zone of EB welds of Inconel 625 in the as-welded condition

Columnar dendrites were observed in the FZ of EBW joints along with the micro-segregation in the inter-dendritic zones as evident from the EDS analysis depicted in Fig. 4(a). The compositional changes across the dendrite and inter-dendritic zones of the EBW joints in the AW conditions could be observed clearly from the EDS data provided in Fig. 4(b). Further, it is revealed from the EDS spectra that these segregated precipitates are richer in Nb, Mo, and Si and lean in Fe, Cr compared to the composition of the base alloy. These richer elemental constituents in the segregate indicate the occurrence of the Laves phase and  $\sigma$  phase in the AW conditions. It is opined that the Nb segregation is essential for the occurrence of the solidification phase and there is very limited segregation of Ti to the Laves phase. The results are in agreement with Chen et al. [16].

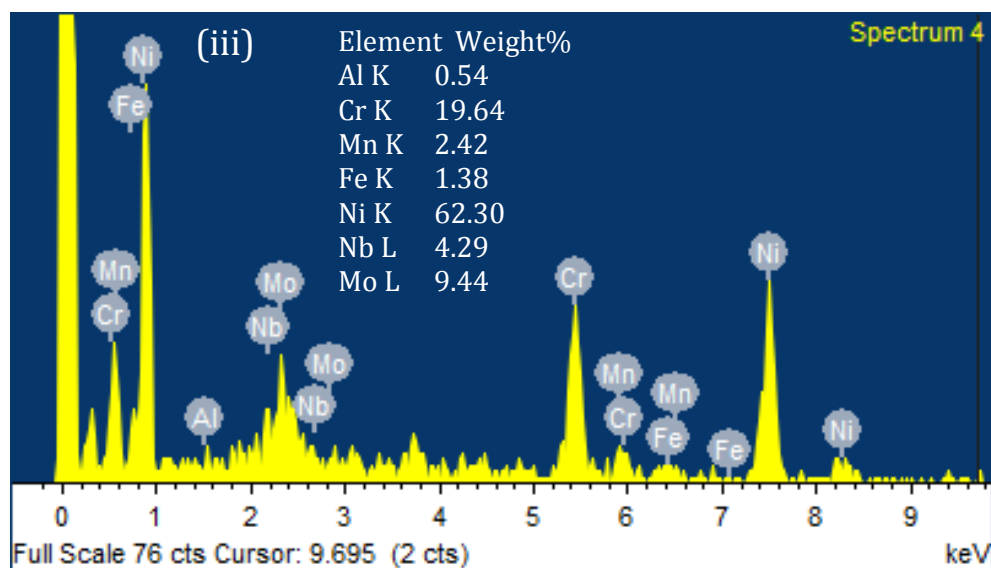
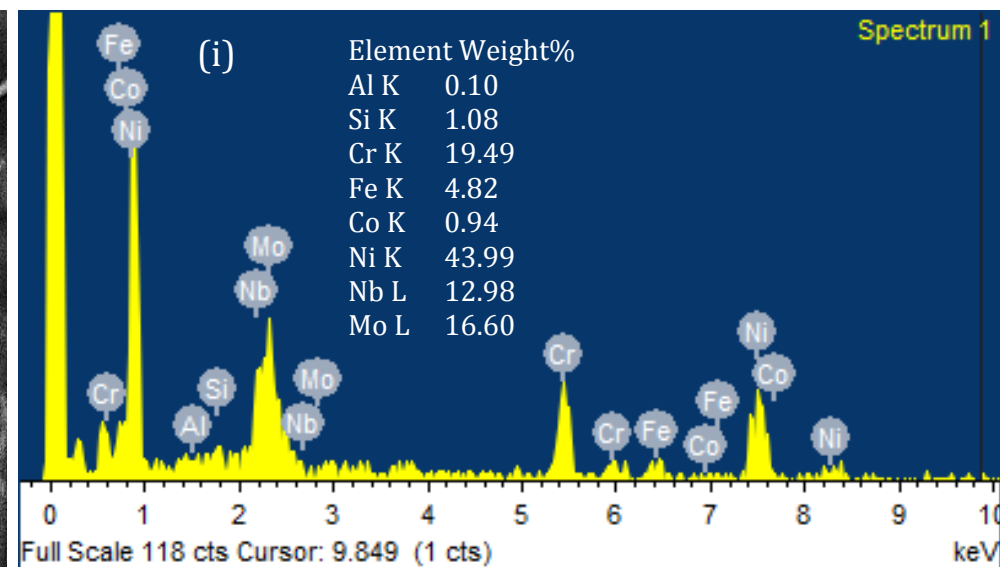
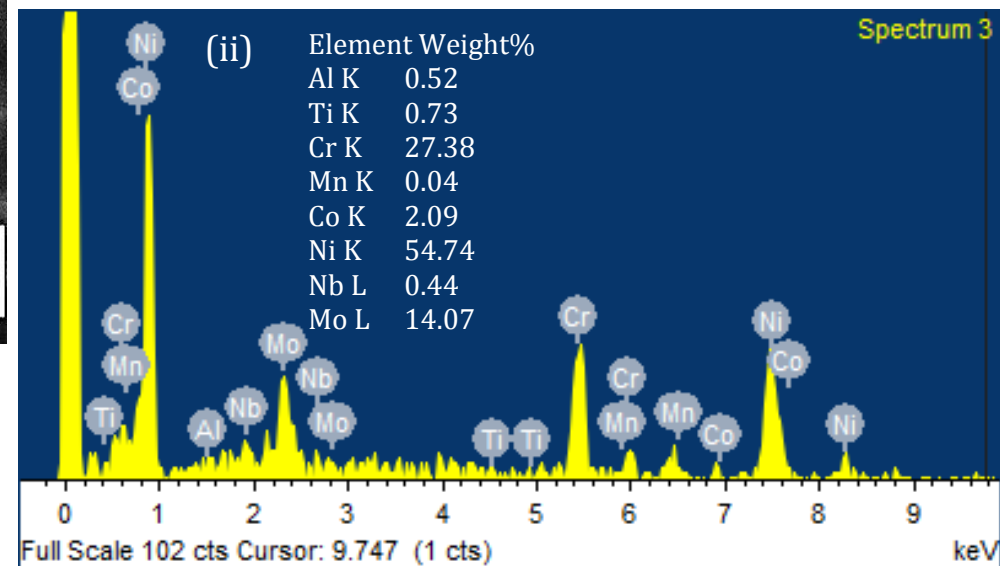
Fig. 4(b) EDS analysis showing the elemental composition at different spots in the fusion region of EB welded Inconel 625 in the as-welded condition

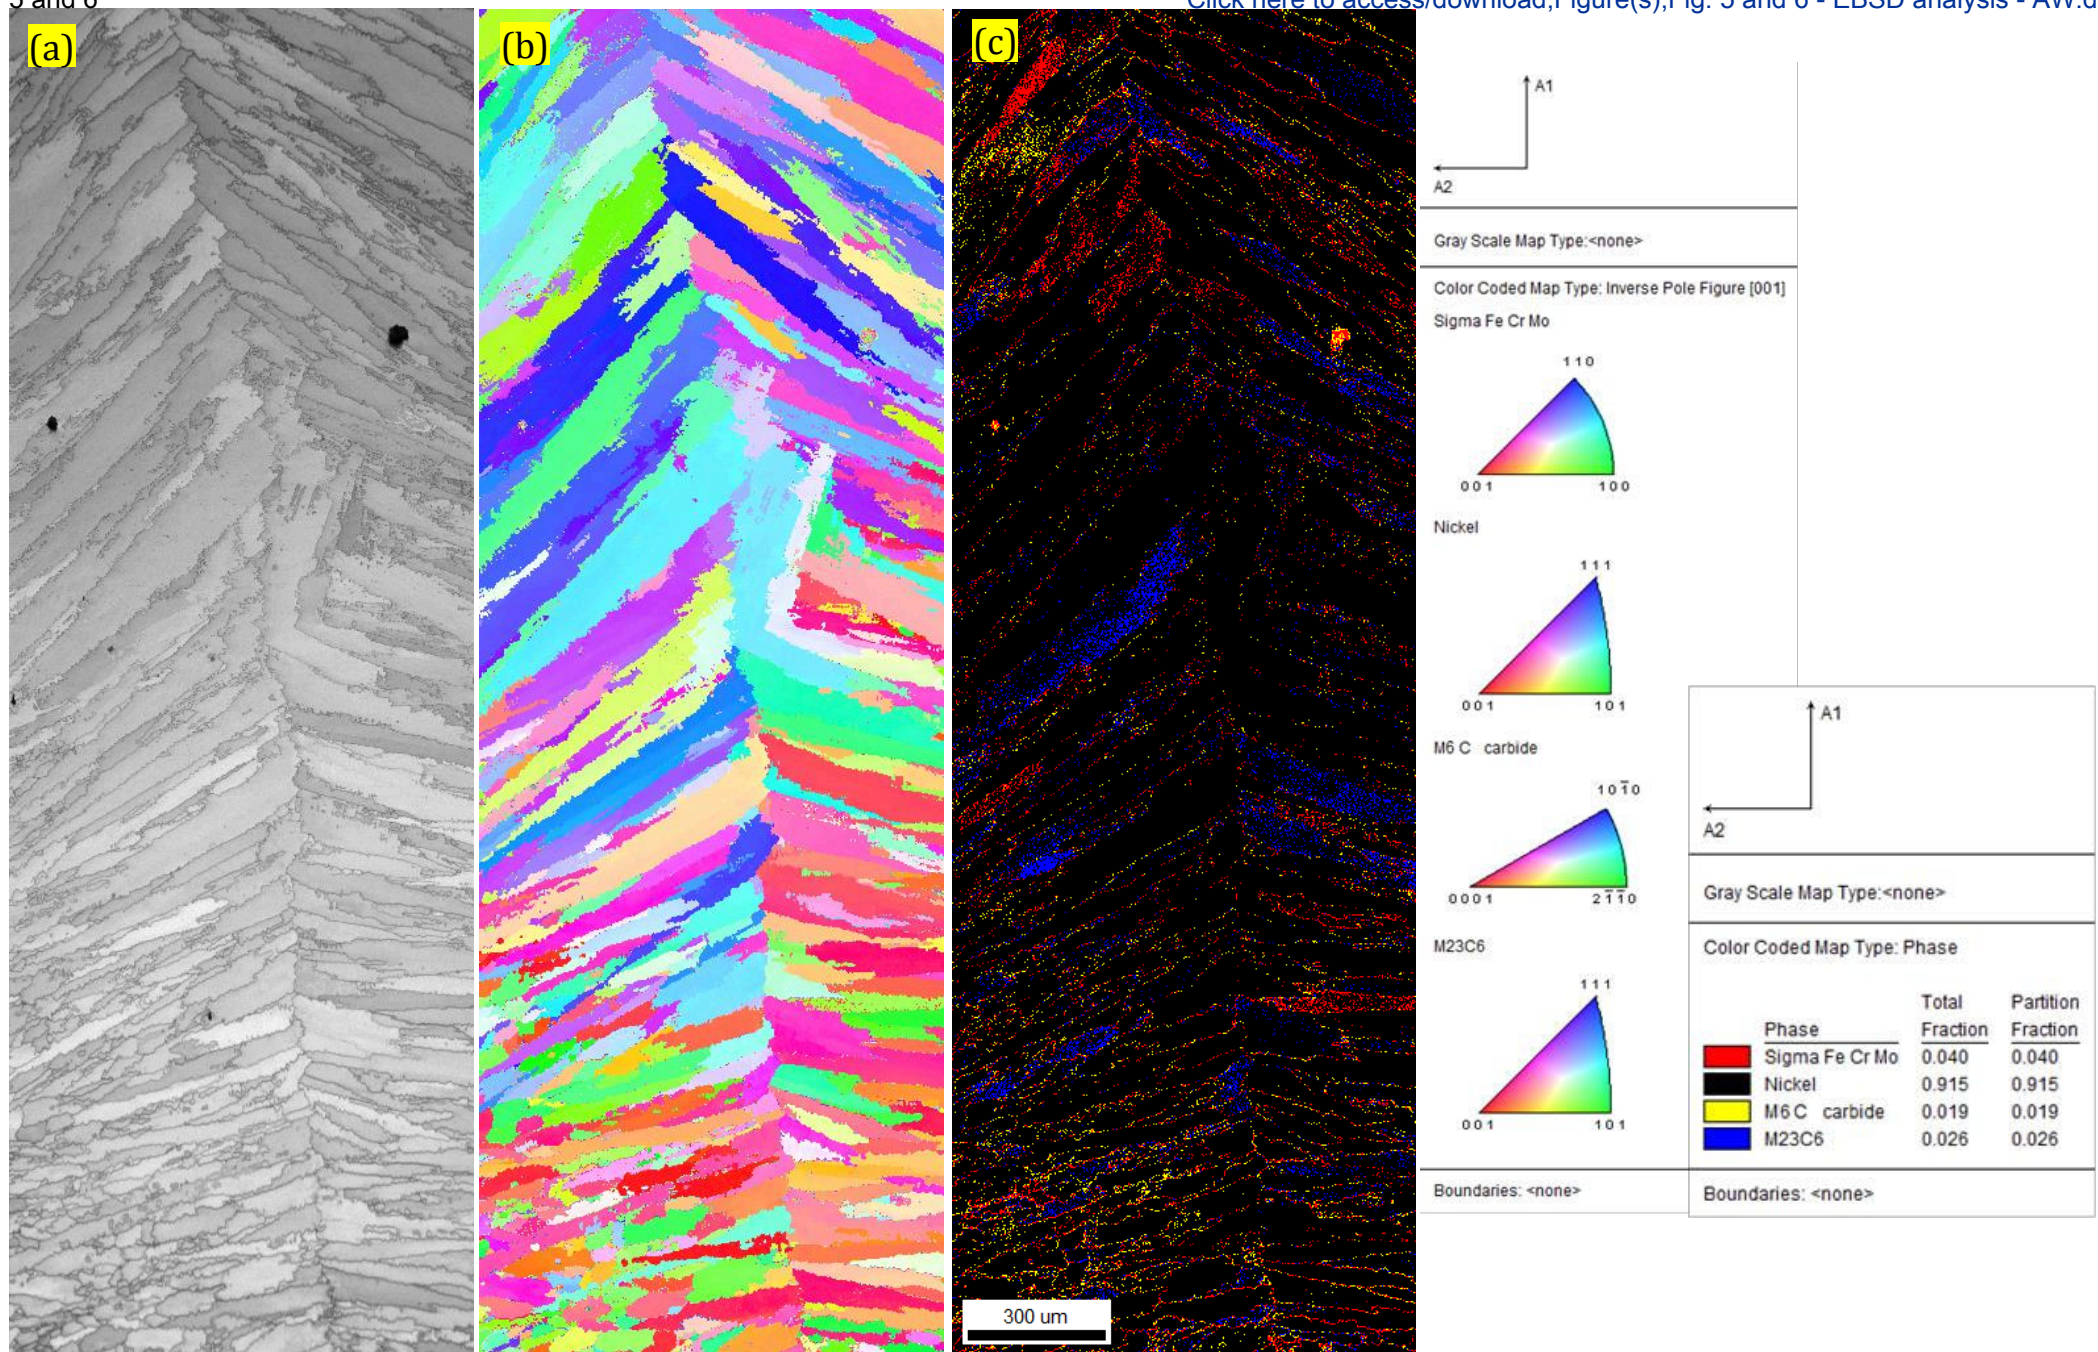
Fig. 5 EBSD analysis depicting (a) Original (b) IPF and (c) Phase map on the weld region of Incoloy 625 joints in the as-welded condition
