## Effect of grain boundary precipitation on the mechanical integrity of EBW joints of Inconel 625

The precipitation effects on the mechanical behavior of electron beam welded joints of Inconel 625 in the as-welded [AW] and post-weld heat treatment [PWHT] conditions have been investigated in this research study. A PWHT comprising of direct aging [DA] treatment at 700 °C for 100 h in vacuum at a pressure of 10<sup>-5</sup> mbar was performed on the weld joints. The microstructure of the base alloy opined the precipitation of MC system carbides and  $\gamma''$  strengthening phase after subjecting to DA. Also, Nb-Mo rich precipitates and the Laves phase was noticed in the inter-dendritic arms of the fusion zone (FZ) of welded joints in the AW conditions. DA treatment has a notable effect on the weld mechanical characteristics of Inconel 625 joints. The precipitation of  $\gamma''$  strengthening phase is reasoned for the significant rise in the yield strength [YS] and tensile strength [TS] of the base alloy and EBW joints.

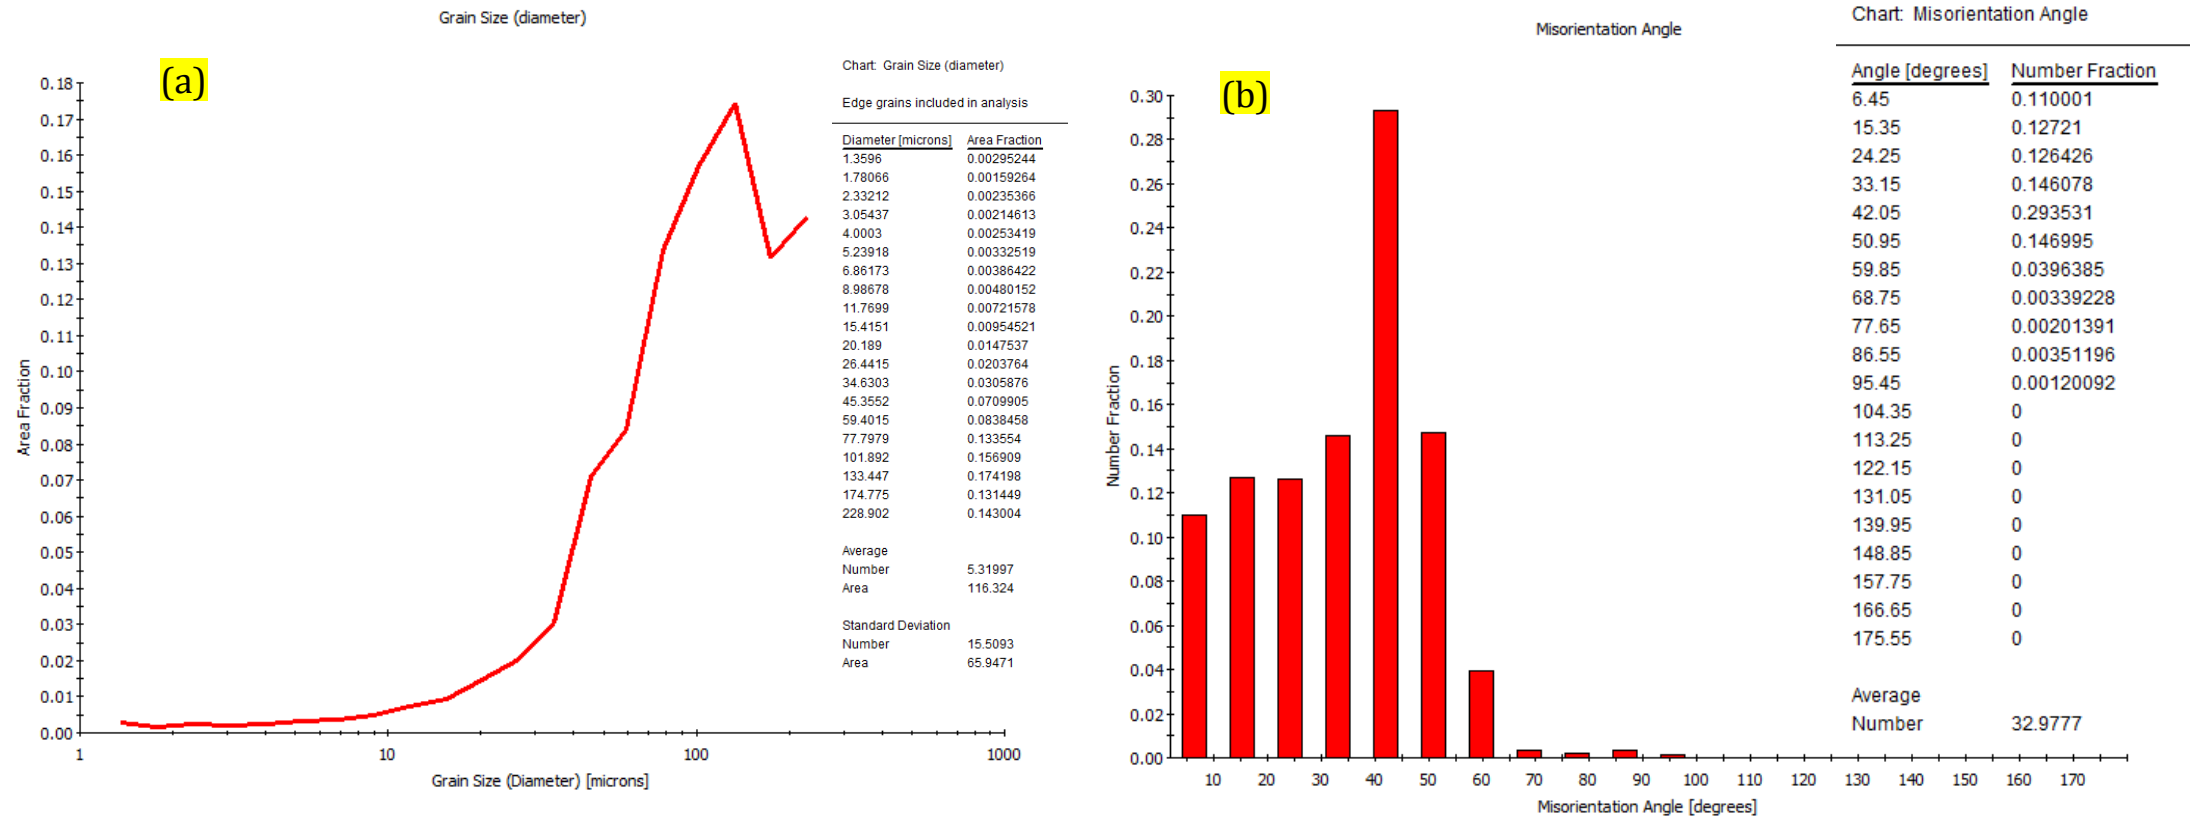
Fig. 6 EBSD analysis showing (a) average grain size and (b) misorientation angle distribution in the fusion region of EBW joints of Inconel 625 in the as-welded condition

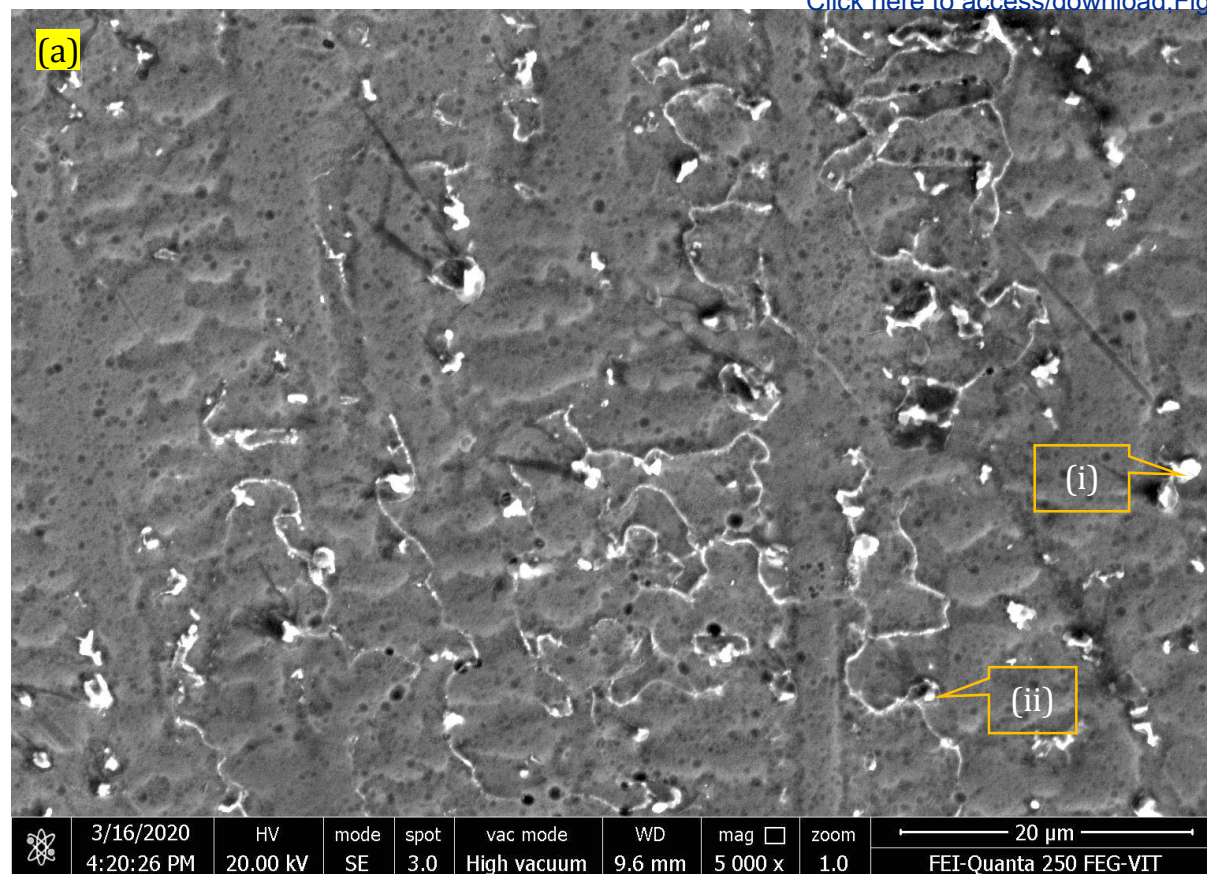
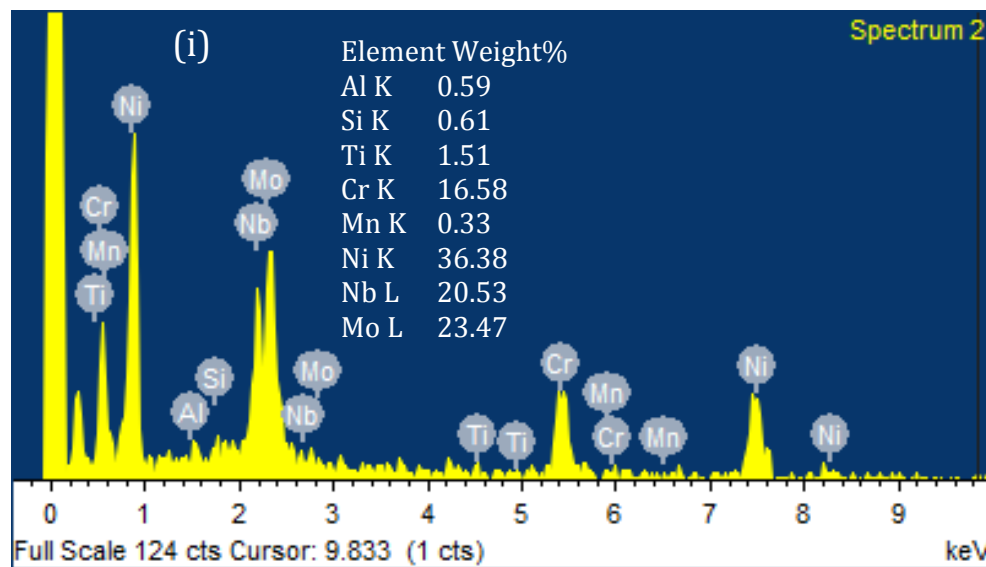
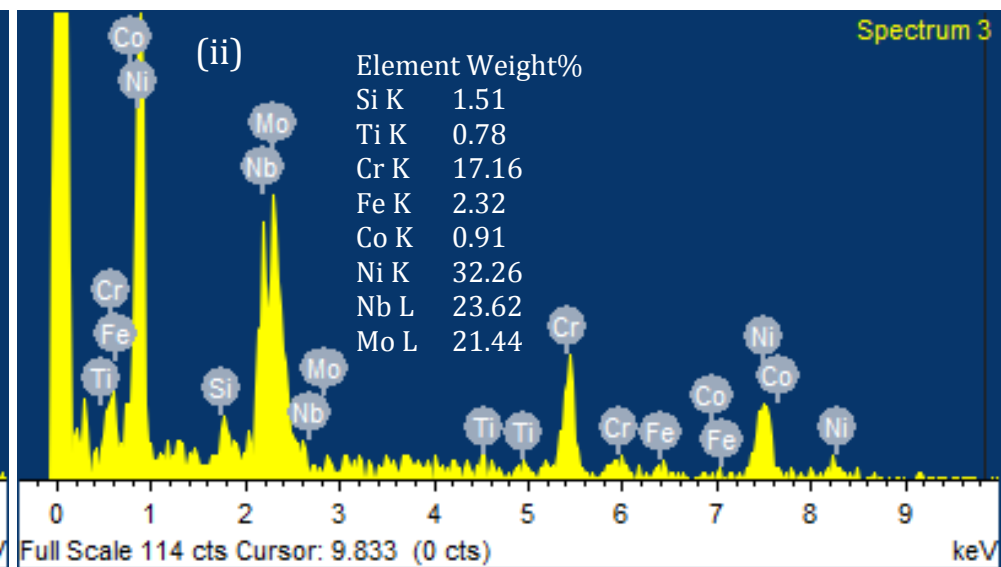
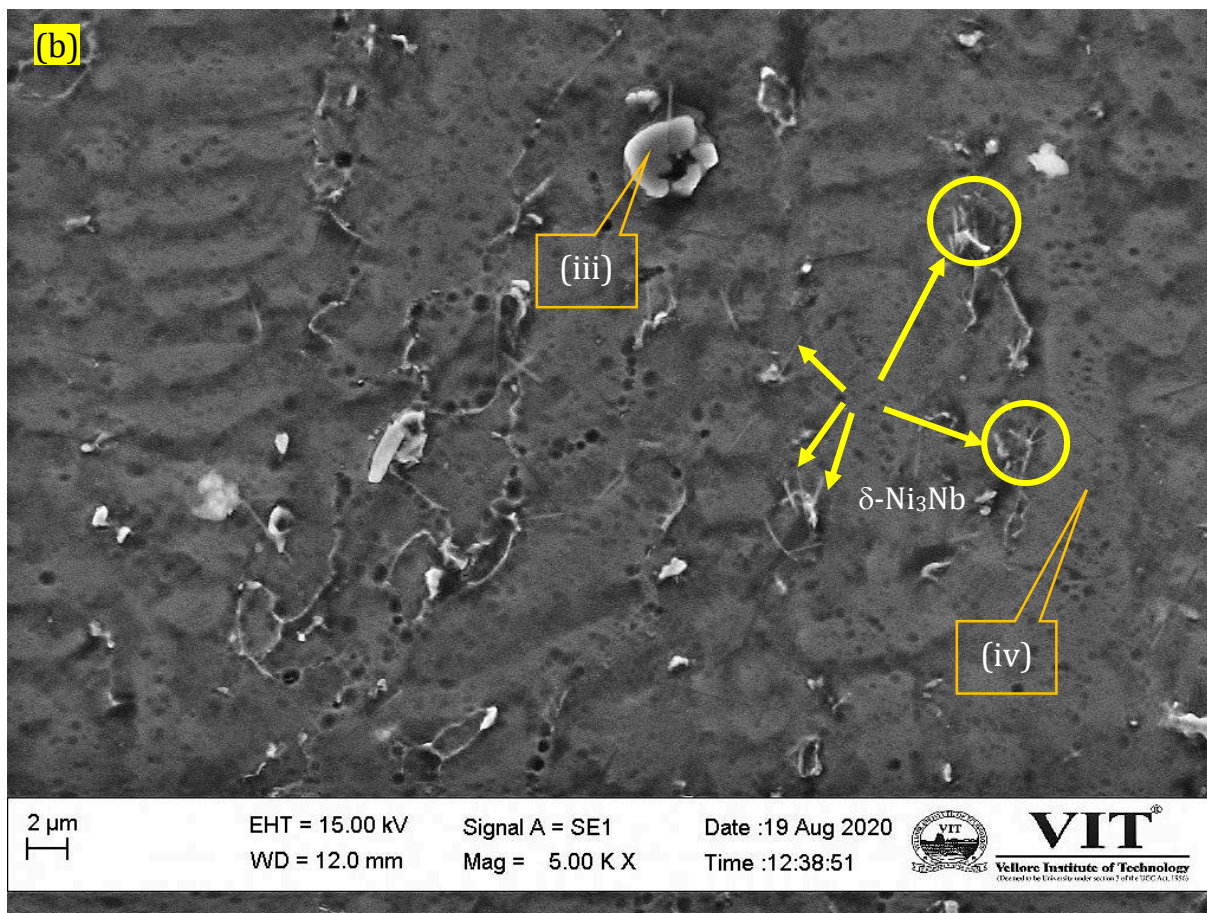
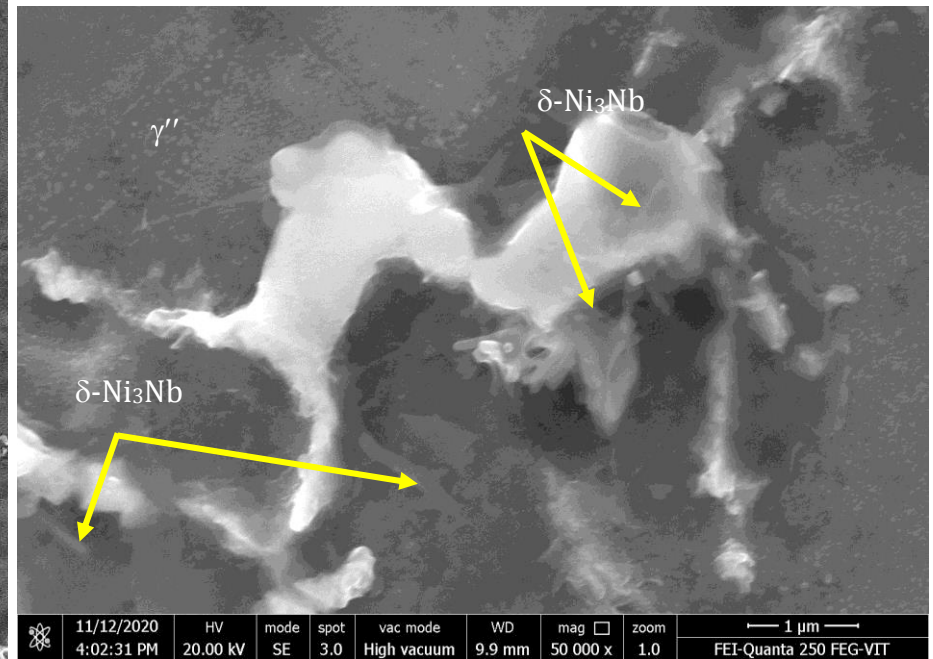
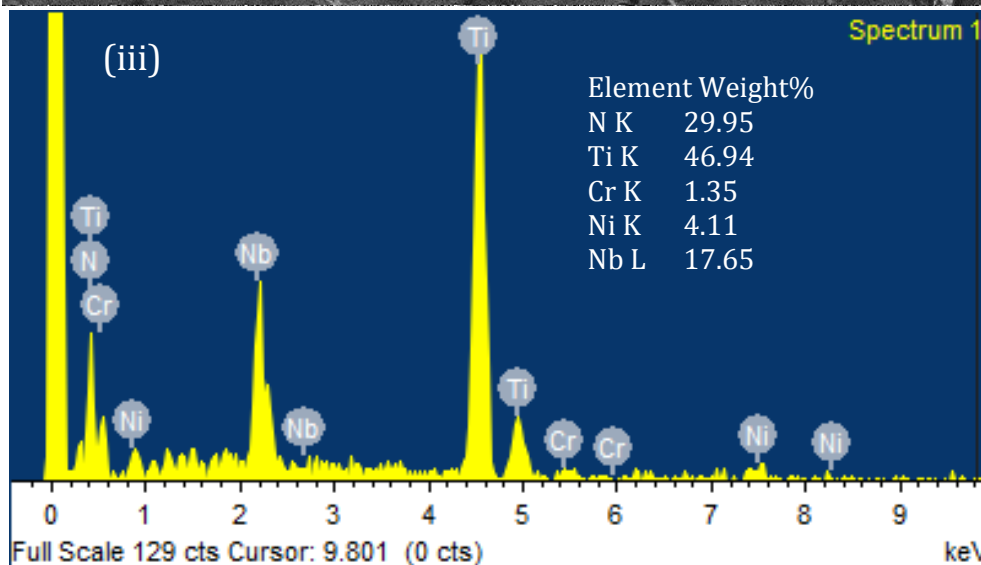
Fig. 7 SEM images and EDS analyses showing the elemental composition at different spots (a) nail head region and (b) weld centre of the EB welded Inconel 625 in the PWHT condition

It is noticed from Fig. 7(a) that the complete dissolution of the Laves phase has not occurred even after subjecting to a solutionizing and aging treatment for 700°C for 100 h. This is because the dissolution of the Laves phase is relatively hard to achieve on account of the poor diffusivity of Nb atoms as claimed by Janakiram et al. [19]. However, the aging temperature and time are found to be sufficient to achieve the

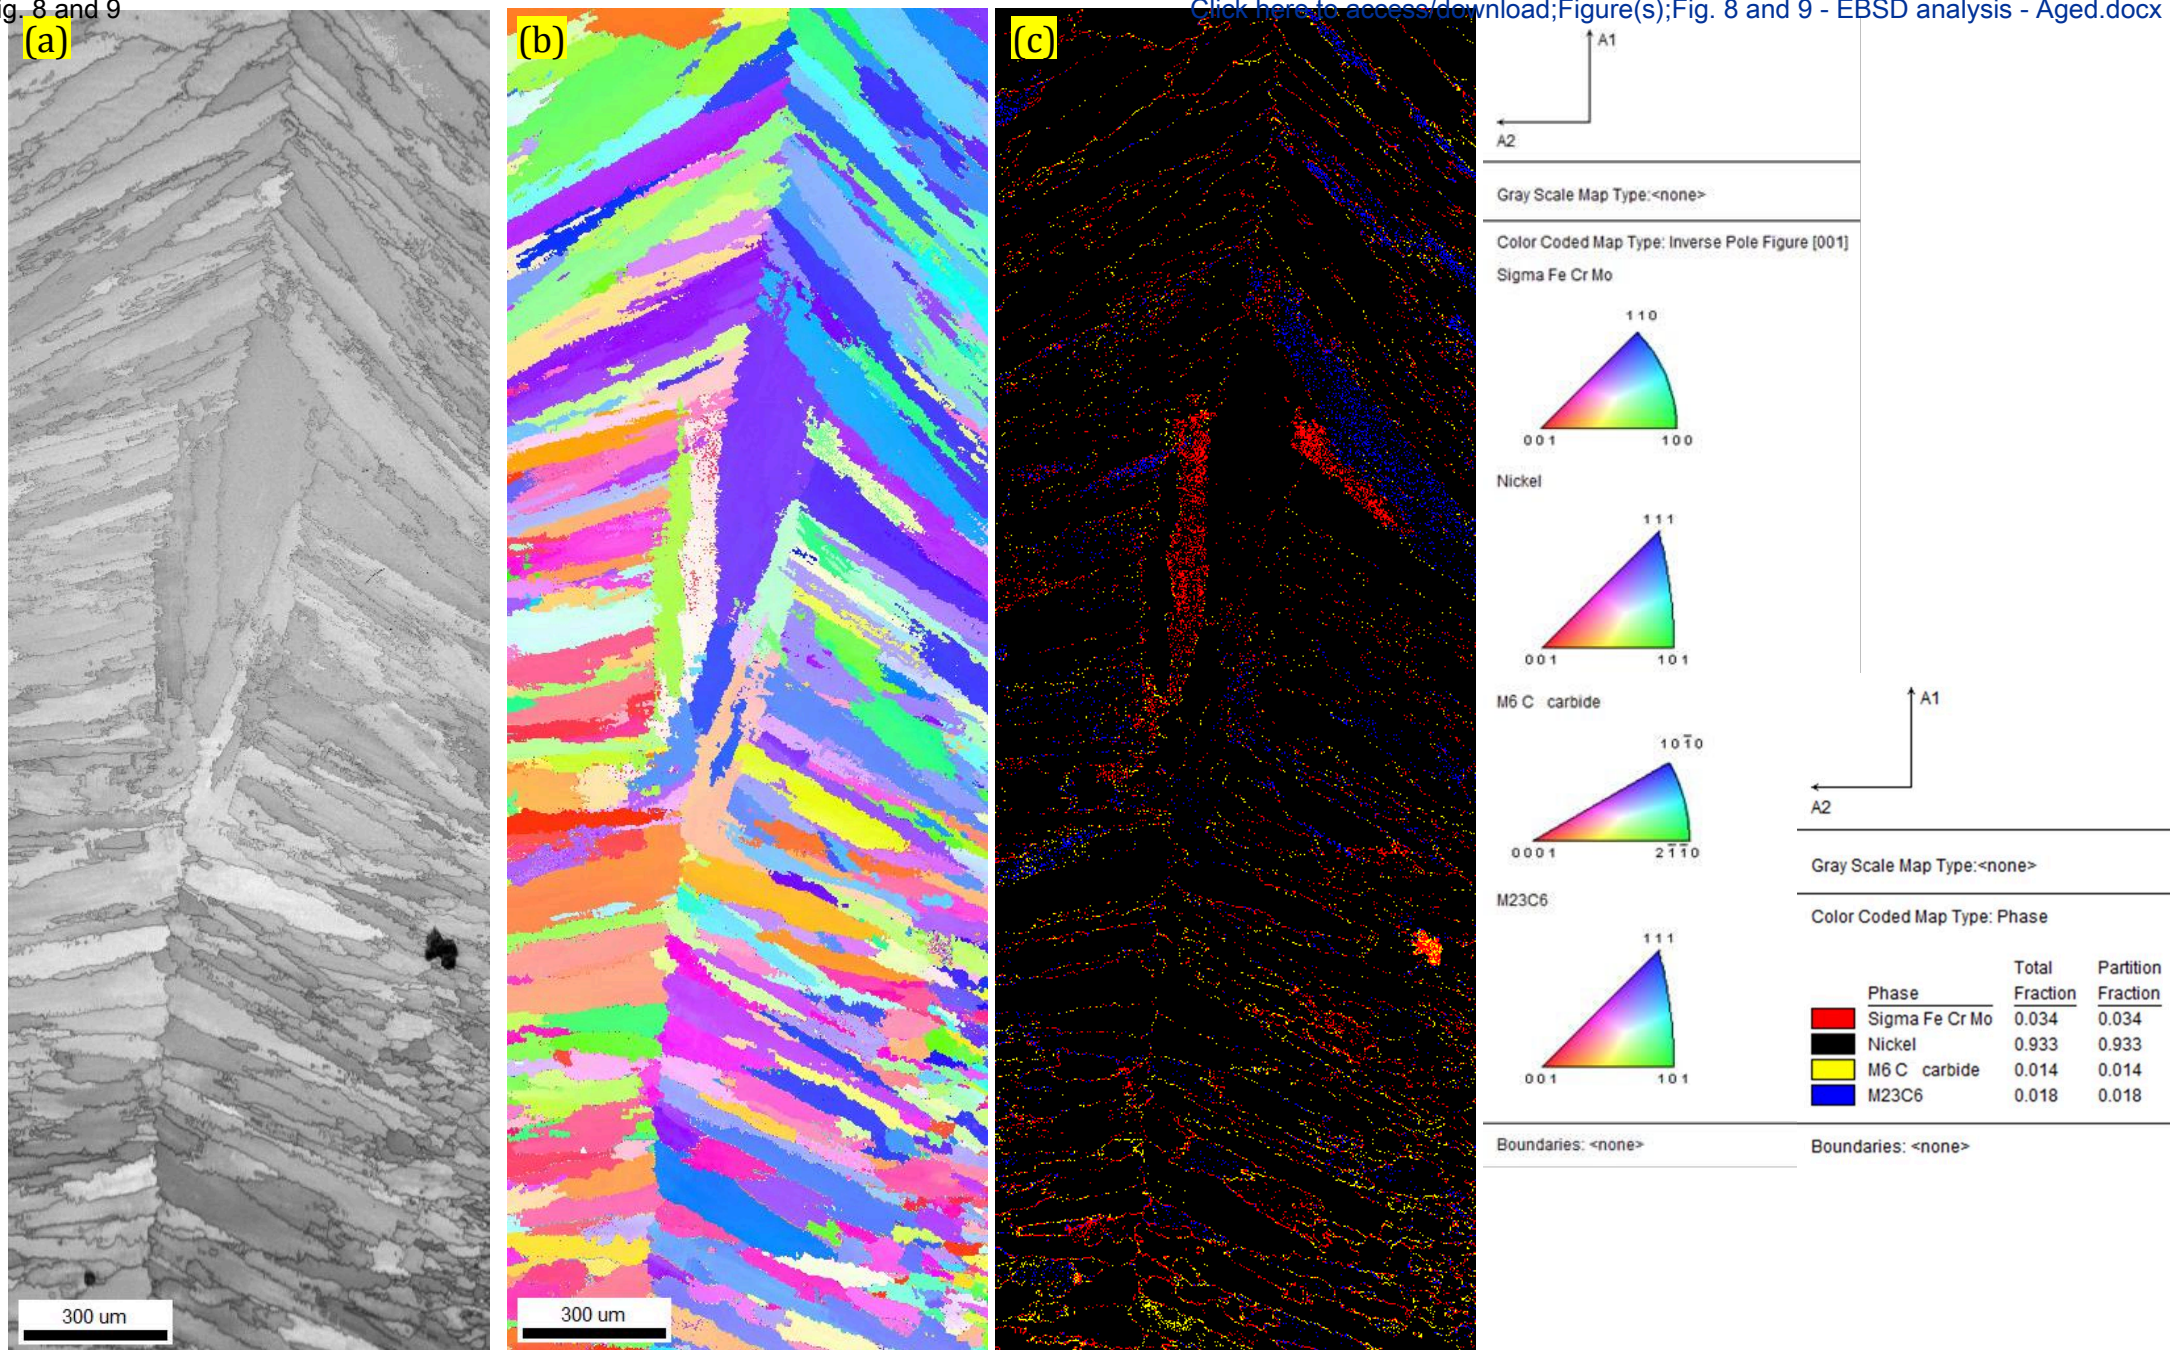
Fig. 8 EBSD analysis depicting (a) Original (b) IPF and (c) Phase map on the weld region of Incoloy 625 joints after ageing for 100 h

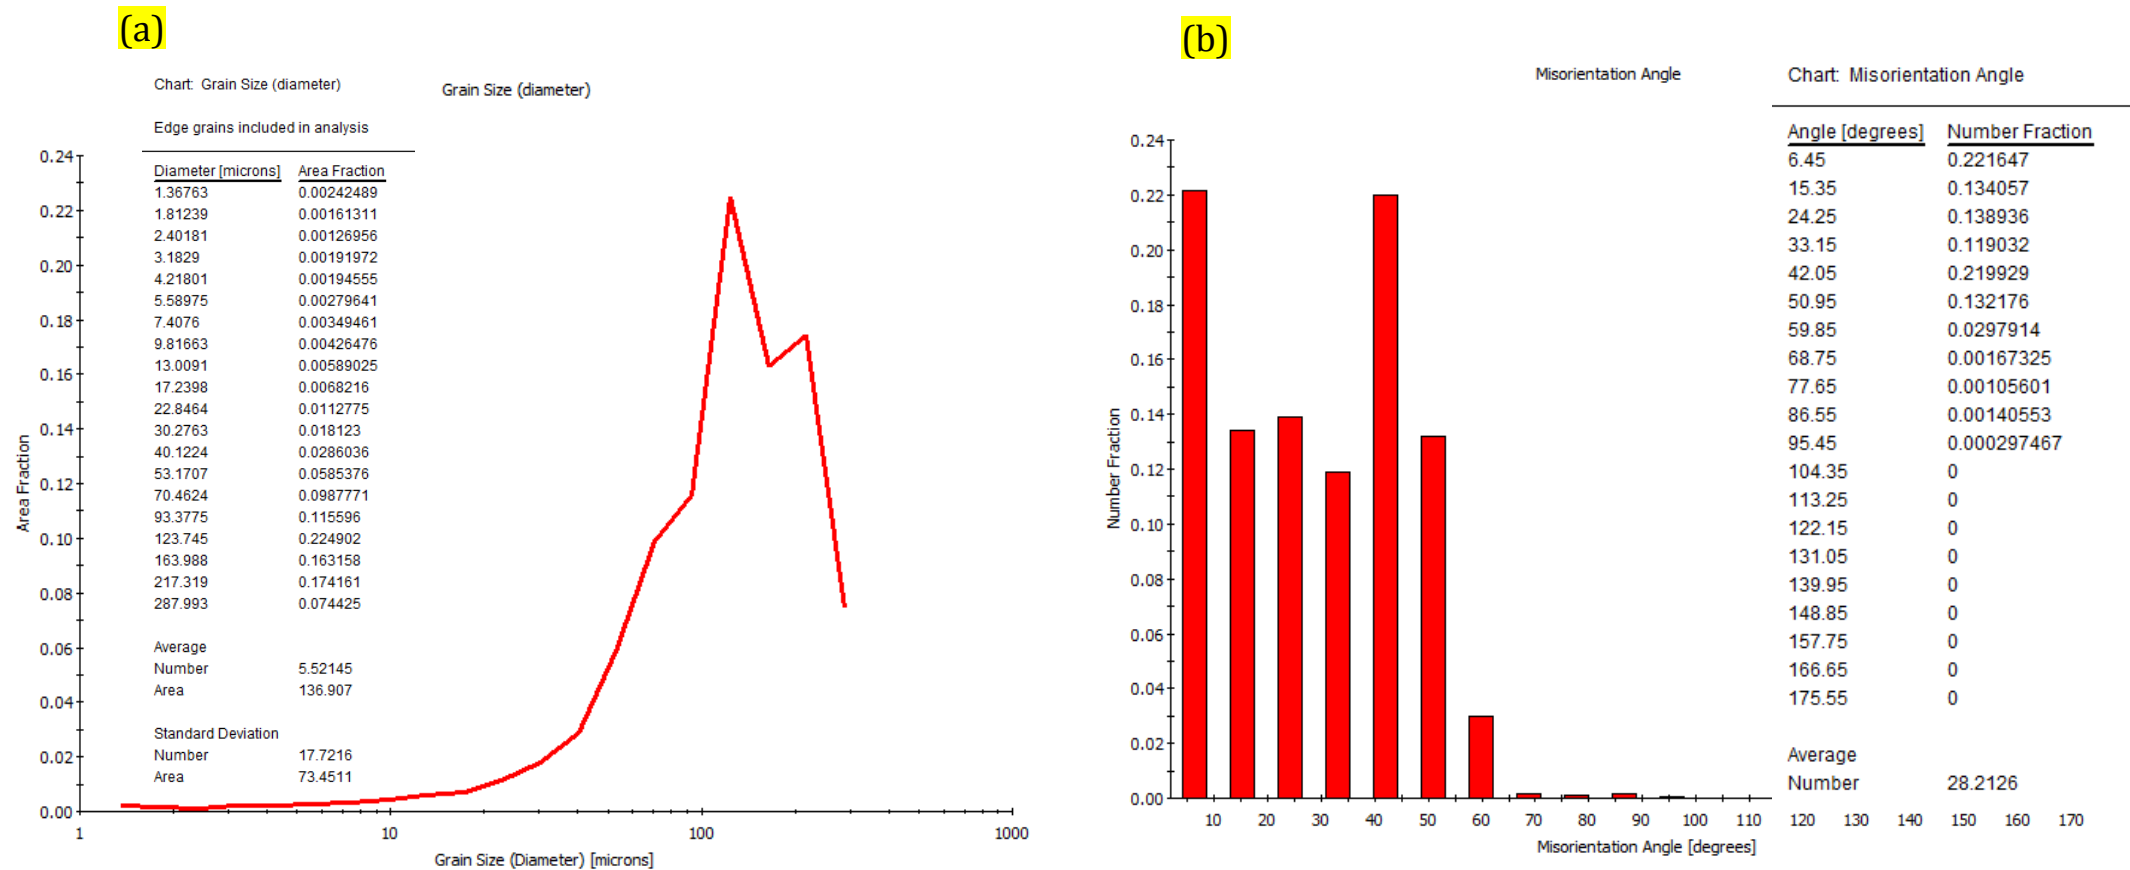
Fig. 9 EBSD analysis showing (a) average grain size and (b) misorientation angle distribution in the fusion region of EBW joints of Inconel 625 in the PWHT condition

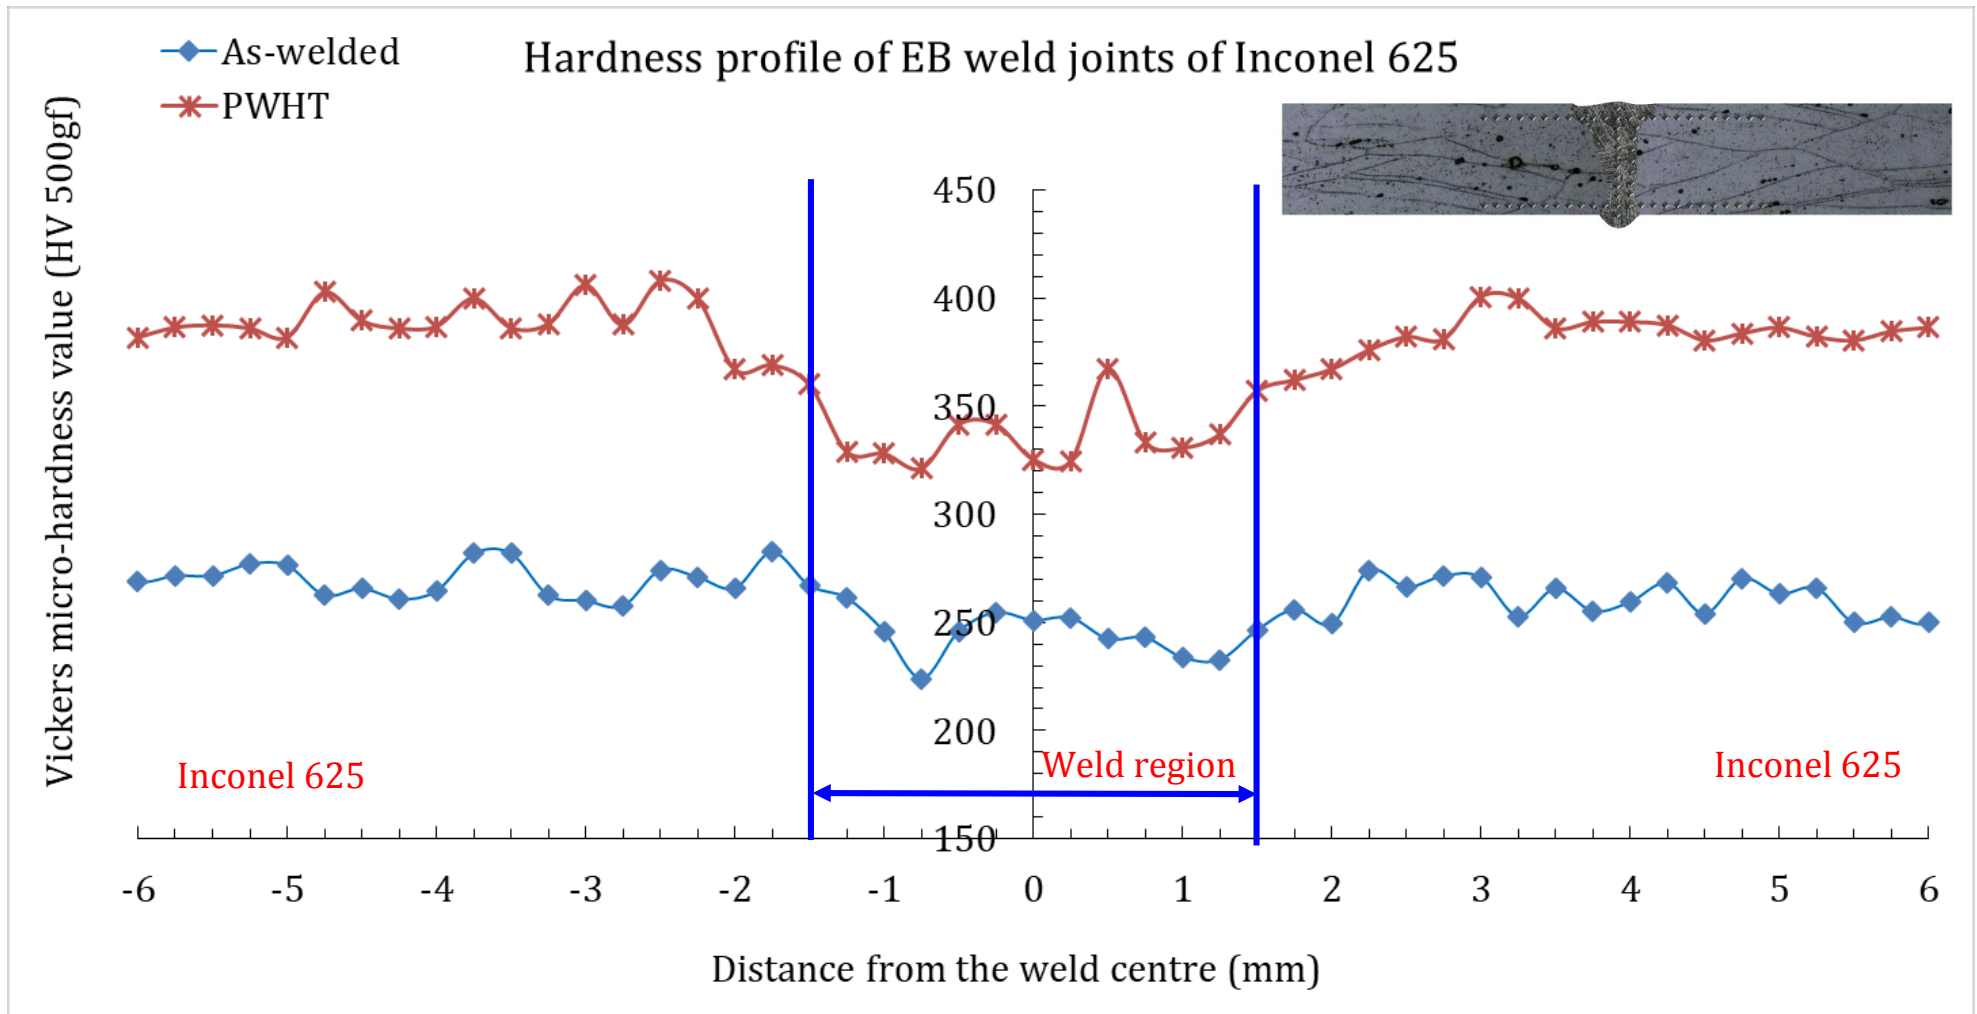
Fig. 10 Hardness profiles of EB weld joints of Inconel 625 in the as-welded and PWHT conditions

The changes in the micro-hardness values before and after direct aging are presented in Fig. 10 and Table 3. The average micro-hardness values of base alloy Inconel 625 side before and after direct aging was revealed to be 266 HV and 388 HV respectively. Similarly, the average hardness value of the EB weld zone was increased from 246 HV to 334 HV after subjected to direct aging treatment. The study attests that both the base alloy side and EB weld joints of Inconel 625 imparts a significant rise in hardness to 45.67% and 35.77% respectively after 100 h of aging treatment. The substantial increase

in the hardness of the base alloy after thermal aging could be reasoned to the precipitation of  $\gamma''$  strengthening phase. The formation of  $M_{23}C_6$ ,  $M_6C$  carbides have also been favored in increasing the hardness of the base alloy and weld region, which is attested from EBSD analysis. Similar hardness trends were noticed during the friction stir welding of Inconel 625 welds served by [Song and Nakata \[14\]](#). The convection phenomena of the weld zone along with the divergence in the supersaturation of strengthening elements Mo and Nb in the  $\gamma$ -matrix are attributing to the decline or scatter trend of hardness values in the FZ.

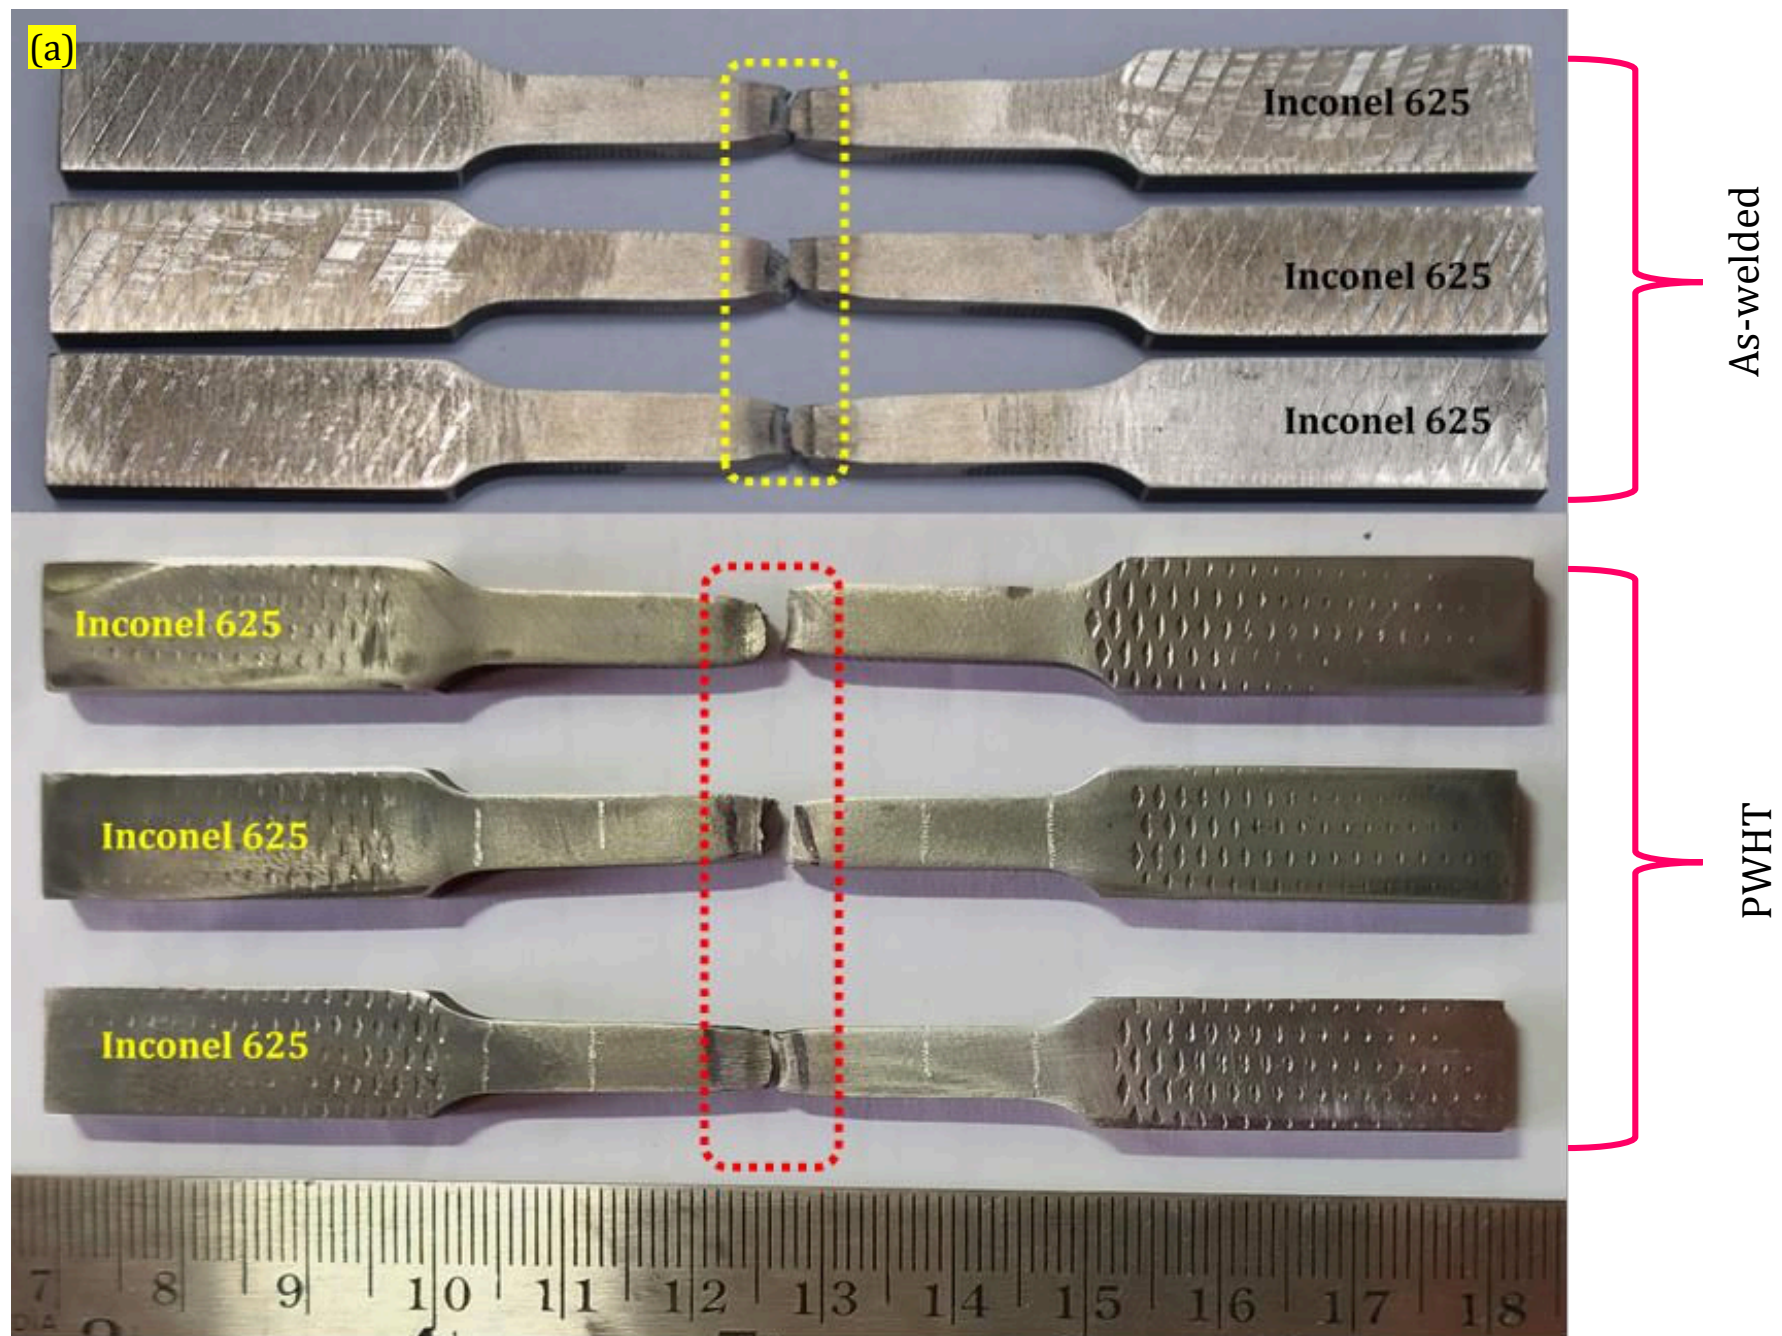
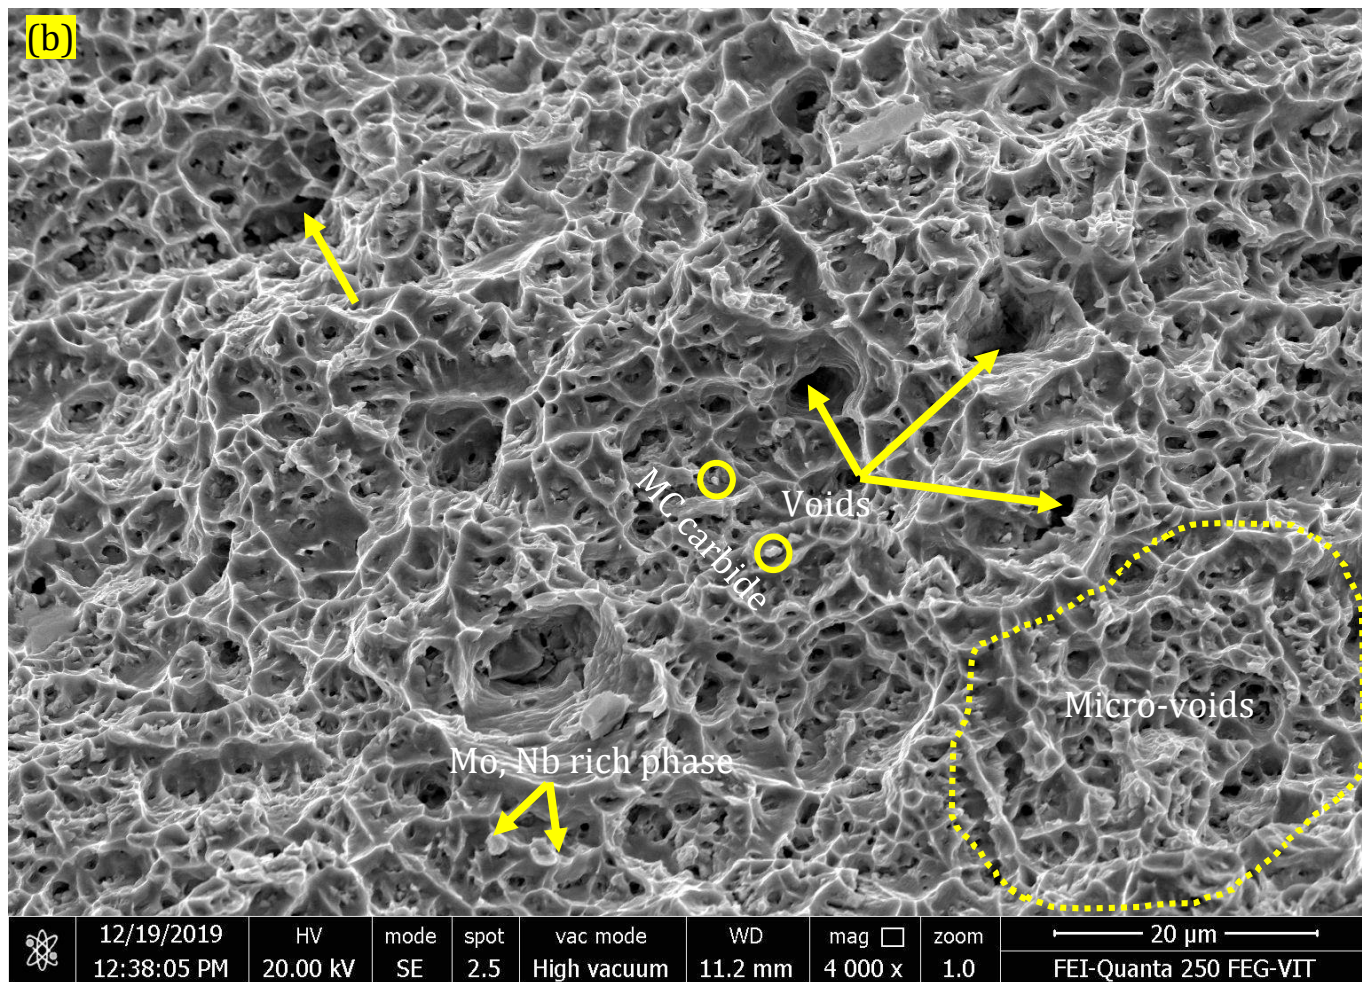
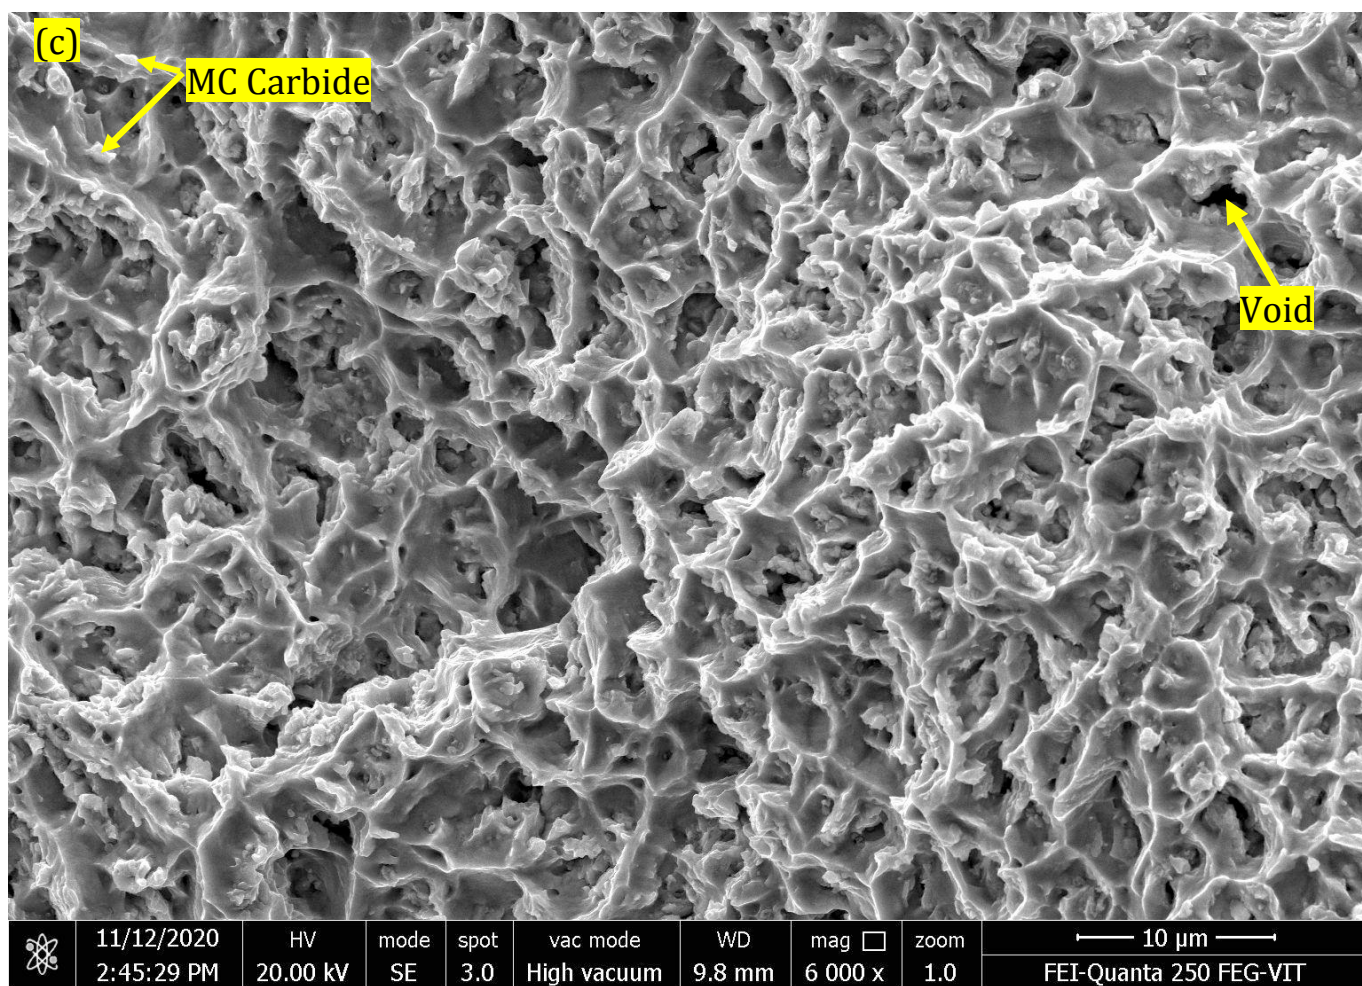
Fig. 11 (a) Tensile tested samples and (b), (c) SEM images showing the fractographic traits of tensile tested EB weld seams of Inconel 625 in the as-welded and PWHT conditions

Tensile test results of both the welded and aged EBW joints of Inconel 625 are shown in [Fig. 11\(a\)](#) and the data are listed in [Table 4](#). The tensile properties of the joints are following the hardness trends in both conditions. The base alloy Inconel 625 demonstrated a UTS of 879 MPa and 1111 MPa in the as-received and DA conditions respectively. The YS and TS of the base alloy were increased to 60.37% and 26.25% respectively after subjecting to direct aging. The increase in both strengths could be attributed to the precipitation of  $\gamma''$  strengthening phase in the base alloy. On the other hand, the tensile elongation was lowered from 53.5% to 34% after direct aging. The precipitation of grain boundary carbides  $M_6C$  and  $M_{23}C_6$  contributed significantly to the reduction in the tensile elongation of the base alloy. It is well acknowledged that  $M_{23}C_6$  carbide is highly brittle and there will be a lesser bond strength between the  $M_{23}C_6$  and matrix. Before subjecting to the aging treatment, the grains in the matrix are connected well through grain boundaries. However, the grains are parted by the coarse  $M_{23}C_6$  and MC system carbides after aging treatment. Hence during the tensile test, when the stress level reaches maximum, the carbide breaks first and cracks are generated at the grain boundaries. Similar trend in the tensile properties was observed by [Hu et al. \[23\]](#).

When subjecting to tensile loads, the failures emerged in the FZ of the EBW joints in both conditions. The tensile strength of the EBW joint was increased from 858 MPa to 1,011 MPa after exposed to DA treatment. The YS of the EBW joints was also considerably improved from 565 MPa to 671.5 MPa. A higher YS of the joints is mainly derived from the  $\gamma''$  strengthening phase and  $Ni_2(Cr, Mo)$  in the matrix while exposing in the elevated temperature, as stated by [Shankar et al. \[24\]](#). The joint efficiencies imparted by the EB weld joints of Inconel 625 are 97.53% and 90.99% in the AW and DA conditions respectively. In addition to the  $M_{23}C_6$  carbide precipitation, the occurrence of the Laves

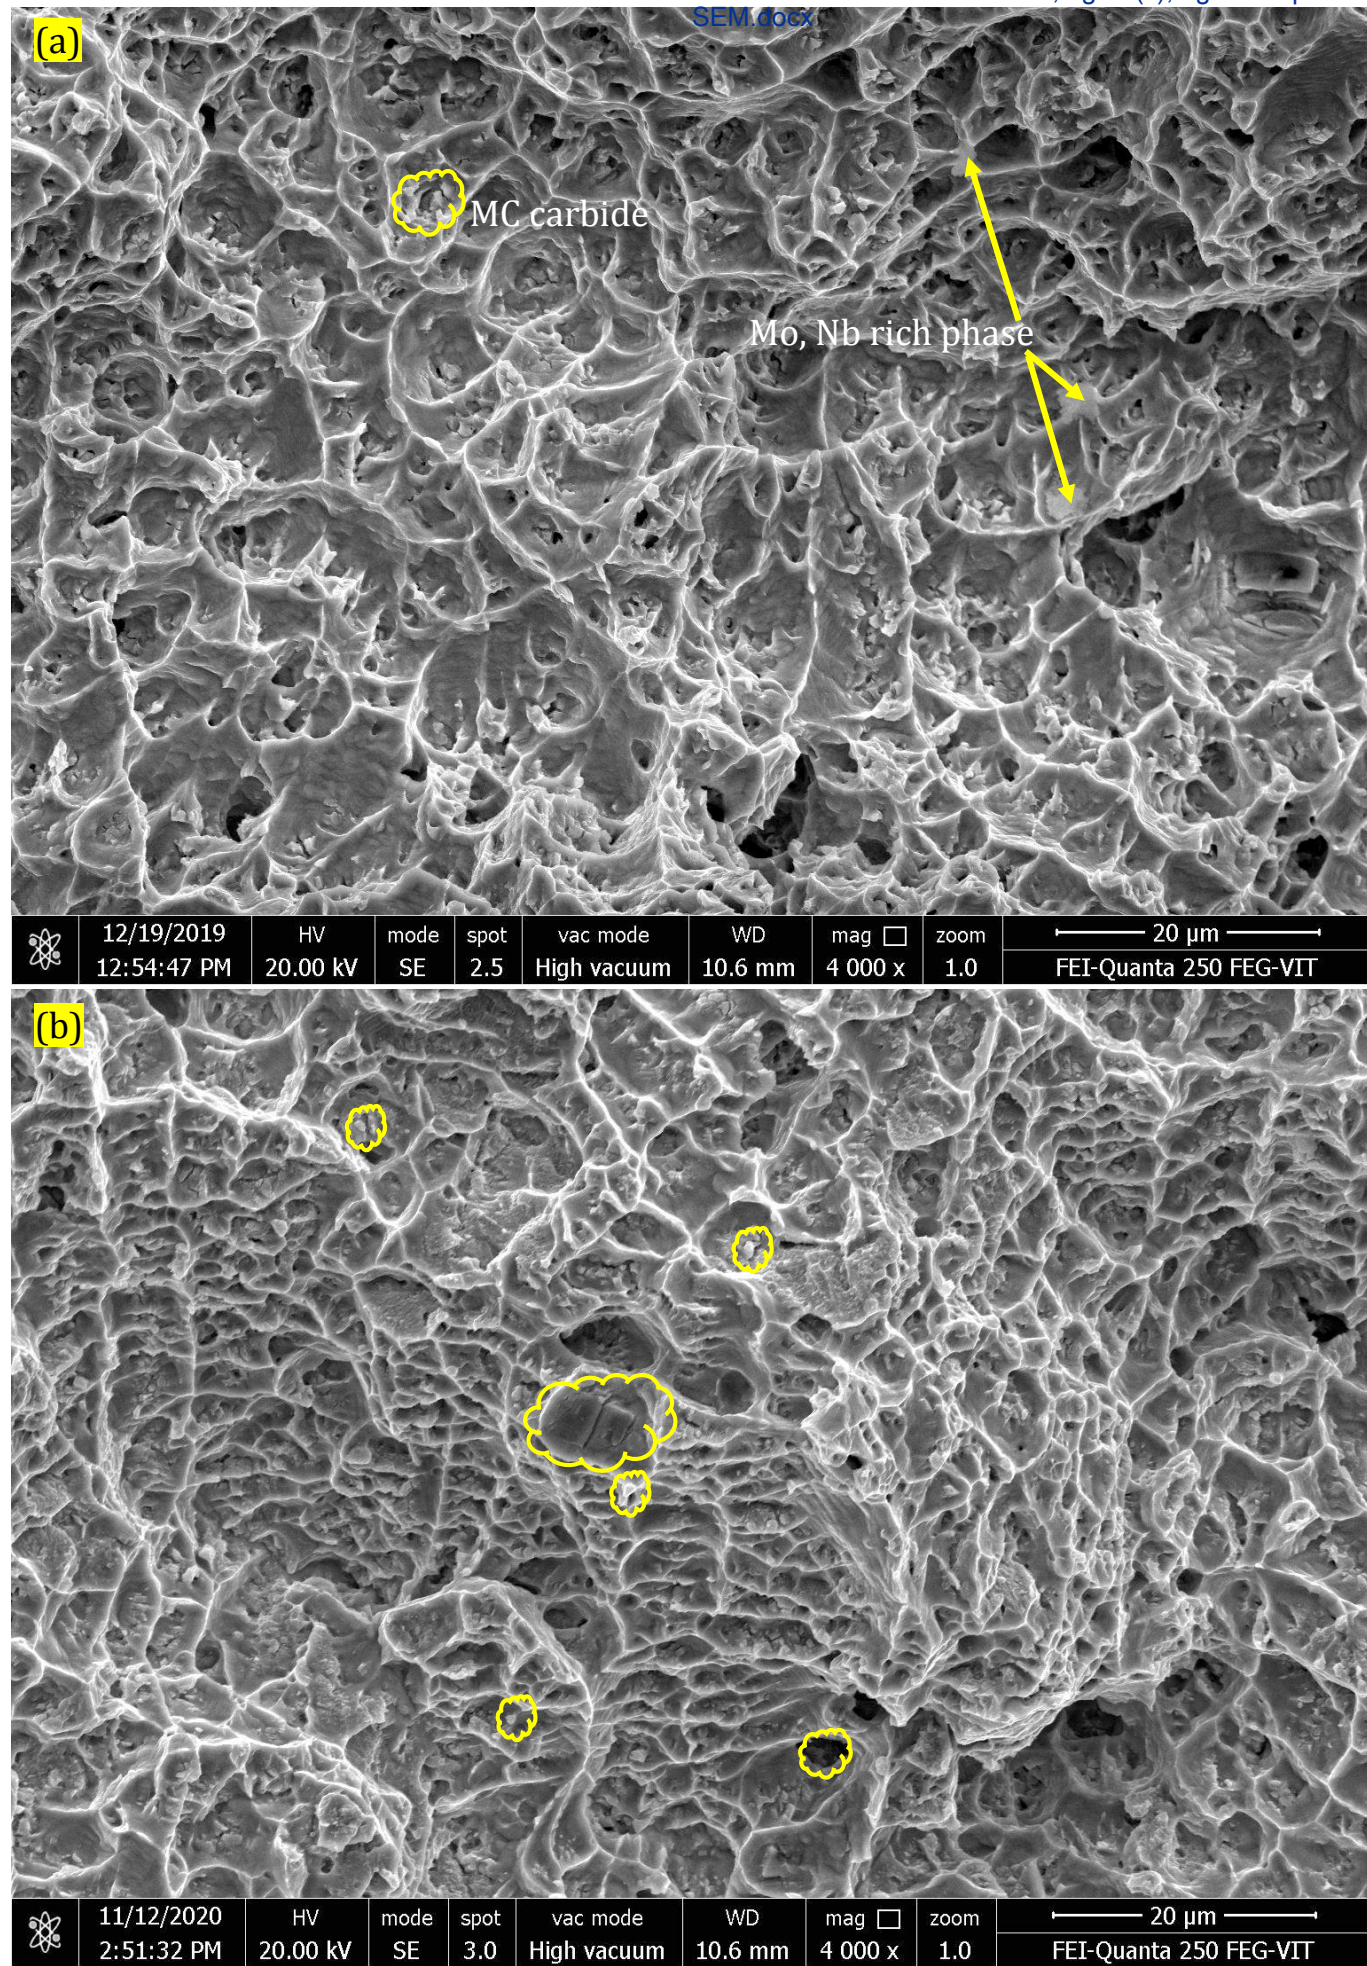
Fig. 12 SEM images showing the fractographic traits of notch impact tested EB weld seams of Inconel 625 in the (a) as-welded and (b) PWHT conditions

It is observed from the SEM fractography shown in Fig. 12(a) that a higher volume of Nb-Mo rich segregates/ Laves particles in the dendritic arms along which the crack has been propagated. In contrast, the precipitation of the strengthening  $\gamma''$  phase,  $\delta$  phase and MC carbides such as  $M_{23}C_6$ ,  $M_6C$  deteriorated the notch toughness of the EBW seams drastically as confirmed from SEM fractography shown in Fig. 12(b). The results are well in agreement with Köhler [26]. It is evident from all these tests that the DA treatment has a remarkable consequence on the mechanical traits of the EBW joints of Inconel 625.
