## Effect of grain boundary precipitation on the mechanical integrity of EBW joints of Inconel 625

The precipitation effects on the mechanical behavior of electron beam welded joints of Inconel 625 in the as-welded [AW] and post-weld heat treatment [PWHT] conditions have been investigated in this research study. A PWHT comprising of direct aging [DA] treatment at 700 °C for 100 h in vacuum at a pressure of 10<sup>-5</sup> mbar was performed on the weld joints. The microstructure of the base alloy opined the precipitation of MC system carbides and  $\gamma''$  strengthening phase after subjecting to DA. Also, Nb-Mo rich precipitates and the Laves phase was noticed in the inter-dendritic arms of the fusion zone (FZ) of welded joints in the AW conditions. DA treatment has a notable effect on the weld mechanical characteristics of Inconel 625 joints. The precipitation of  $\gamma''$  strengthening phase is reasoned for the significant rise in the yield strength [YS] and tensile strength [TS] of the base alloy and EBW joints.

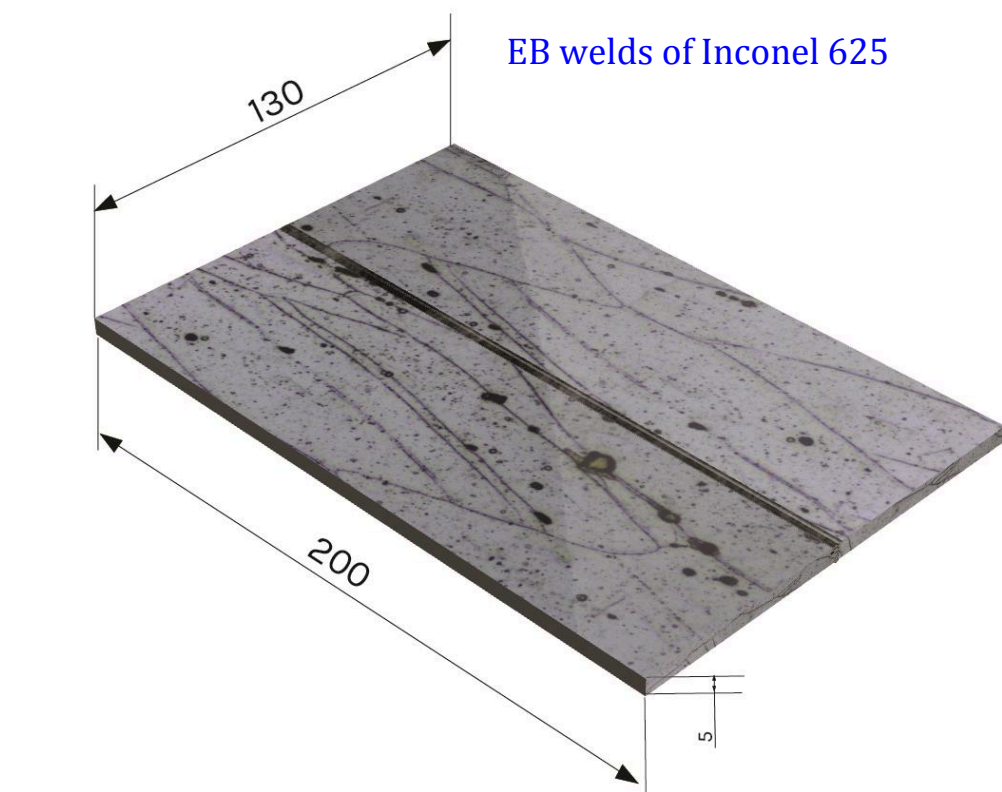
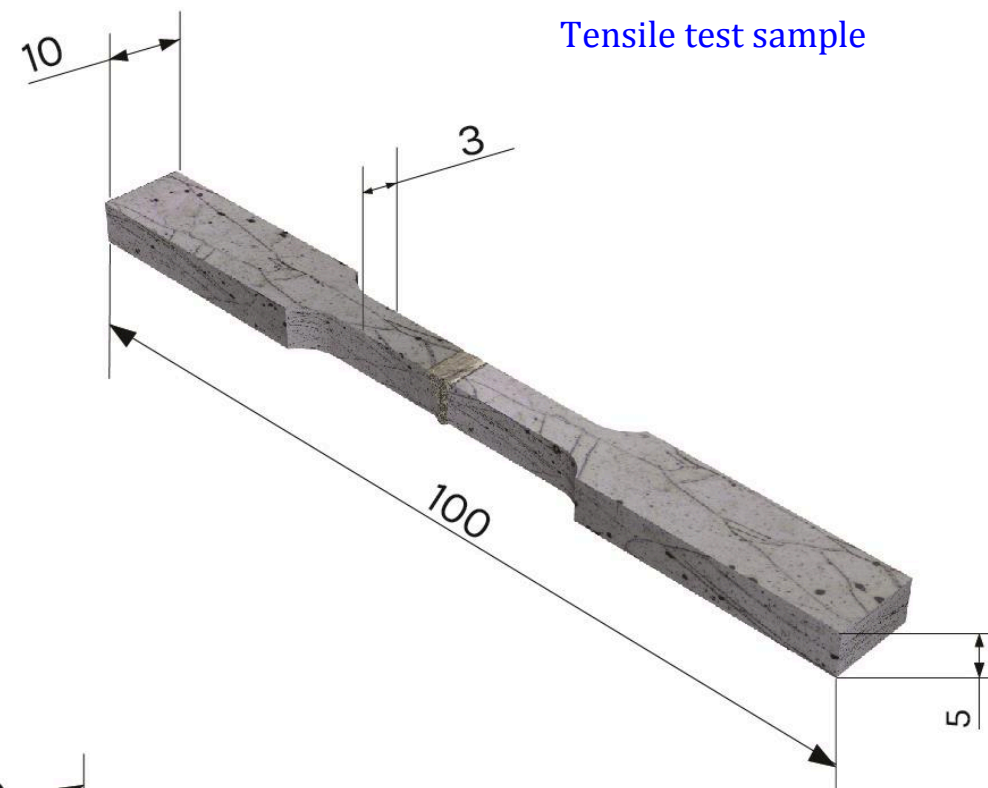
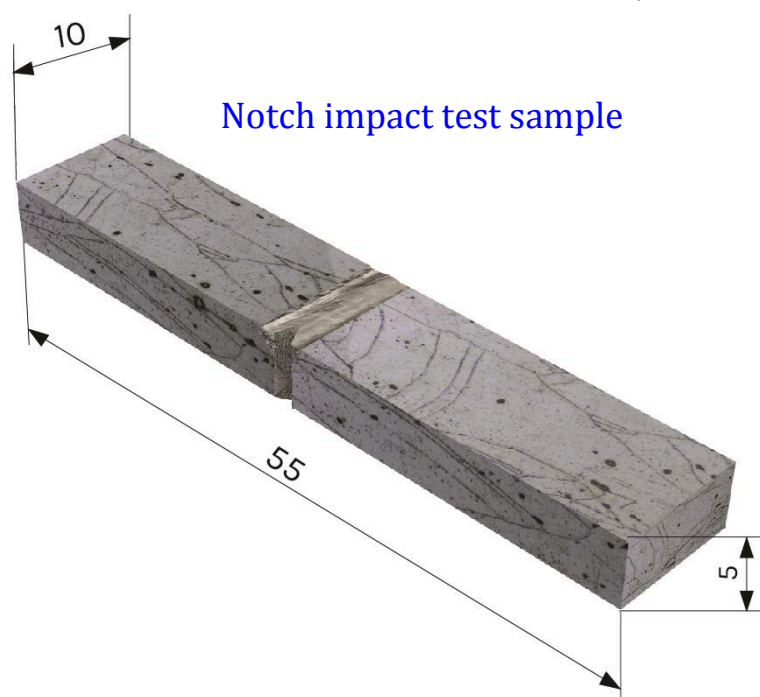
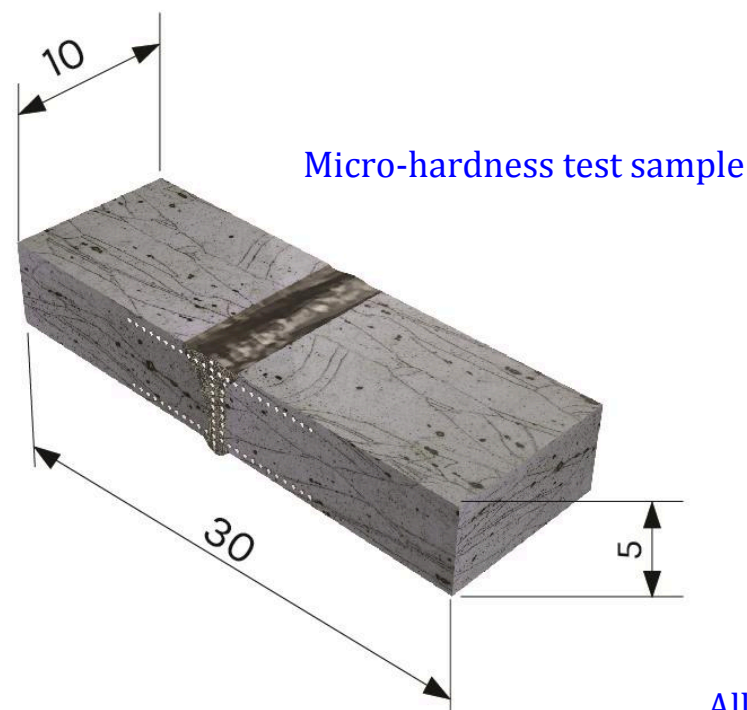
Fig. S1 CAD model depicting the samples extracted from EBW joints of Inconel 625 for analysing metallurgical and mechanical characteristics

Metallographic samples of dimensions  $28 \times 10 \times 5$  mm from the EBW joints were retrieved transversely concerning the direction of welding as provided in [Fig. S1](#). These samples in the AW and PWHT conditions were subjected to traditional metallographic practices for microstructural investigation. Samples were polished to obtain a mirror-like finish and then etched electrolytically with 10% oxalic acid using a 6 V DC supply for 15-20 s. The primary microstructural assessment on both the samples was examined using ZEISS Axio Vert A1 inverted microscope. Further, scanning electron microscopy (SEM) attached with energy dispersive X-ray analysis (EDS) was used to perform the detailed
