Hydrogen transport and embrittlement in 300m and aermet100 ultra high strength steels

D. Figueroa, M.J. Robinson

To appear in: *Corrosion Science*

## HYDROGEN TRANSPORT AND EMBRITTLEMENT IN 300M AND AERMET100 ULTRA HIGH STRENGTH STEELS

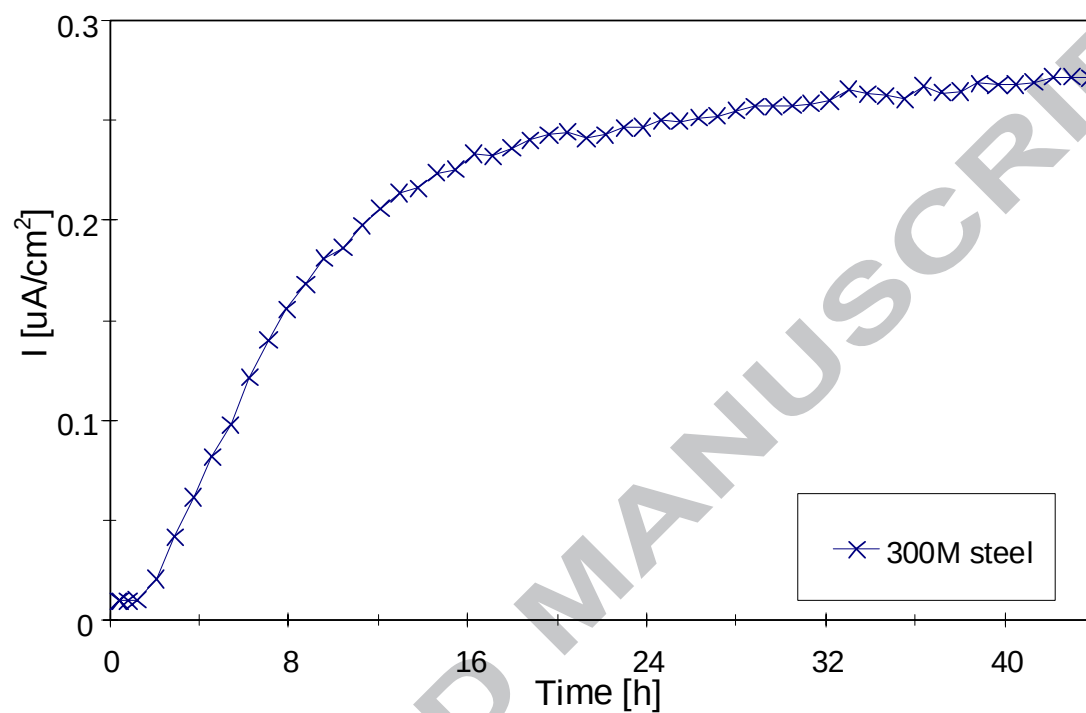
**Figure 1. Hydrogen permeation transient for 300M steel charged at -1.25 V (SCE) in 0.2M NaOH solution**

**Hydrogen permeation technique** The measurements were made using the double cell permeation technique of Devanathan and Stachurski [13]. A membrane of the steel, 1mm thick was polished to a 1 $\mu$ m diamond finish and held between two electrochemical cells with an exposed surface area of 50.3 cm<sup>2</sup> on each side. Both cells contained an electrolyte of 0.2 M NaOH solution. Prior to hydrogen charging, the membrane was depleted of residual hydrogen by holding the exit surface at a potential of -0.094 V (SCE) until the current density was lowered to 0.01 $\mu$ Acm<sup>-2</sup>. Charging was then carried out on one side only by maintaining the entry surface at a constant potential of -1.250 V (SCE) to promote hydrogen generation and uptake. The hydrogen that diffused through the membrane was oxidised and detected on the exit side. After an interval known as the breakthrough time,  $t_b$ , the oxidation current displayed a rising transient and eventually reached a steady state value,  $J_\infty$ .

In this case, the  $C_o$  value in the charging side of the membrane was not of interest as it was not required to determine  $D$ . Using a potential of -1.250 volts (SCE) and 0.2M NaOH electrolyte gave a high rate of hydrogen charging and avoided corrosion on the entry side of the steel membrane.

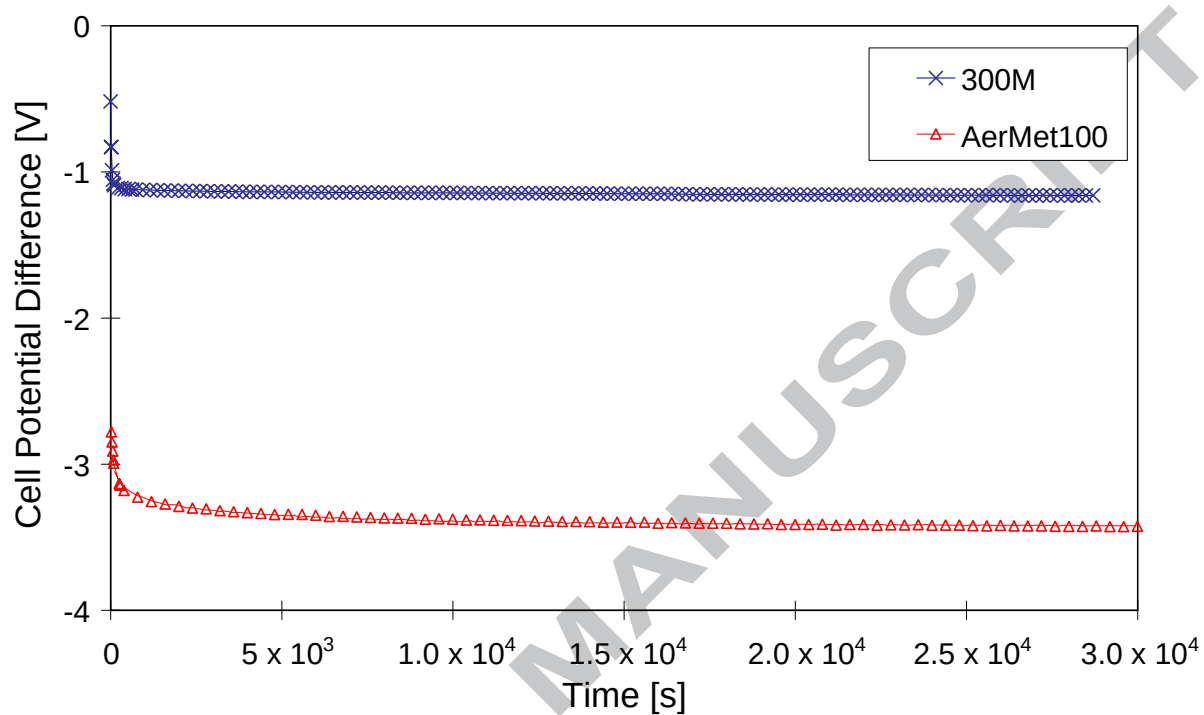
Figure 2. Graphs of cell potential difference versus time obtained for 300M and AerMet100 in the galvanostatic method

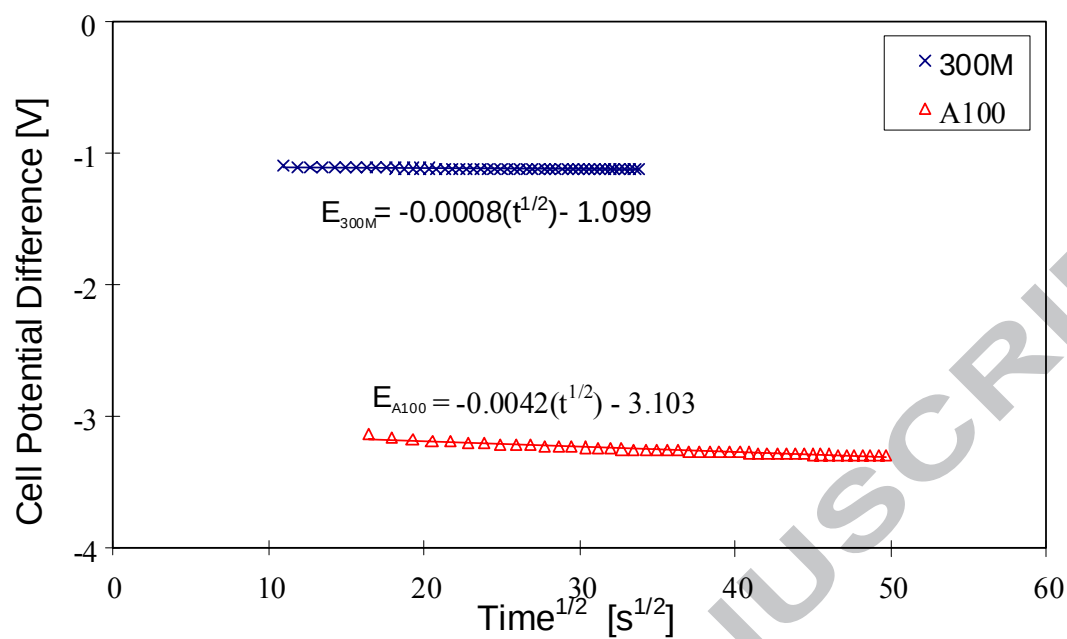
**Figure 3. Linear plots of cell potential difference against (time)<sup>1/2</sup> for 300M and AerMet100 over short charging times ( $t \ll L^2/D$ )**

4, respectively and their gradients were used to calculate the hydrogen diffusion coefficients from equation (8).

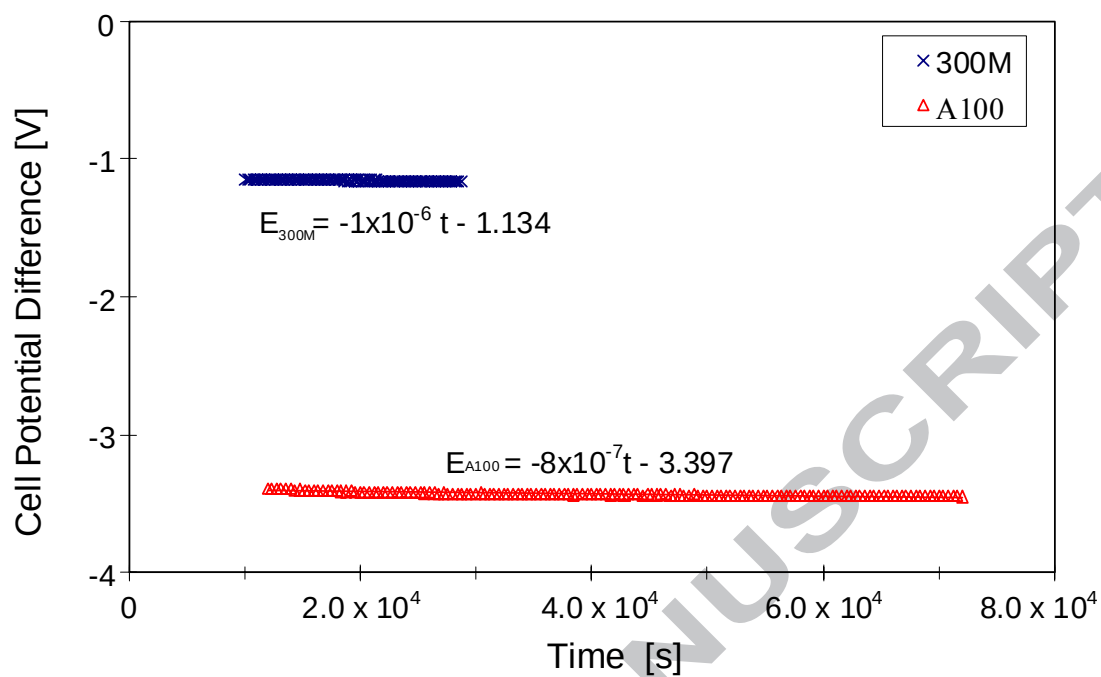
Figure 4. Linear plots of cell potential difference against time for 300M and AerMet100 at long charging times ( $t > L^2/D$ )

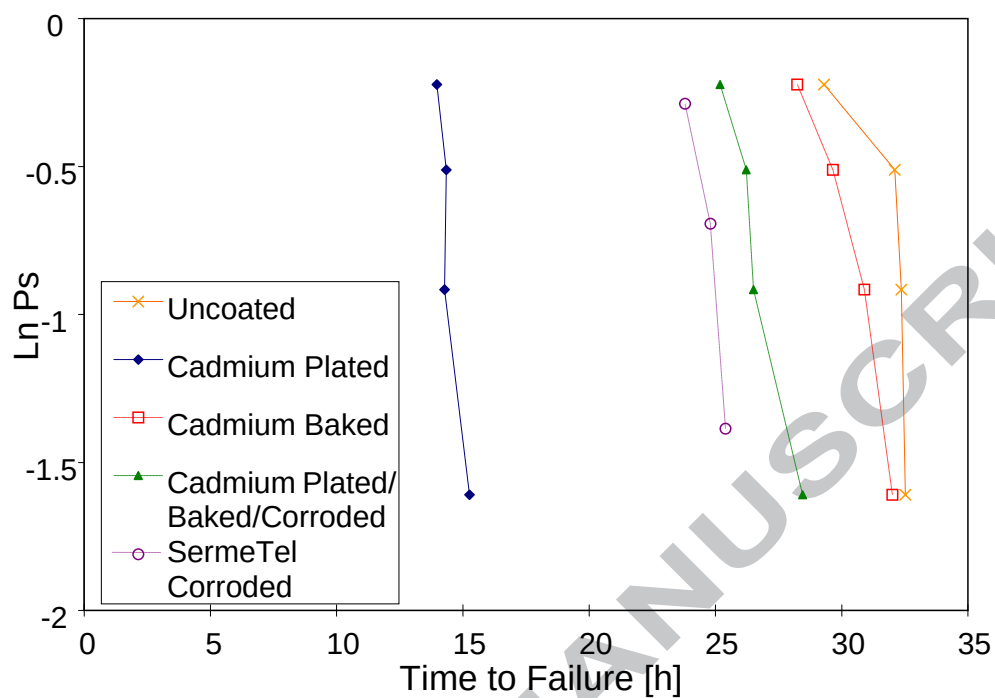
**Figure 5. Weibull plots for 300M showing the effects of direct embrittlement from cadmium plating and re-embrittlement from corrosion of cadmium and SermeTel 1140/962 coatings**

**Slow strain rate tests** The slow strain rate test results for 300M and AerMet100 specimens, tested in air and when cadmium coated and exposed to 3.5% NaCl solution, are shown in Figures 5 and 6. The mean failure times for the four replicate specimens in each condition and the corresponding embrittlement indices are compared in Table 3. 300M displayed much more direct embrittlement than AerMet100 and when electroplated with cadmium its embrittlement index, EI, was 0.54, compared to only 0.05 for AerMet100. Post-plating baking the cadmium plated specimens at 200°C was effective in removing hydrogen from the microstructure and the mechanical properties were almost completely recovered to give an EI for 300M of 0.04. Corrosion of the cadmium coating in 3.5% NaCl solution caused significant re-embrittlement of 300M and an EI of 0.16. However, AerMet100 displayed no re-embrittlement in 3.5% NaCl solution. Its lower susceptibility was attributed to the distribution of phases in its microstructure, as discussed in a later section.

The results for the re-embrittlement tests on the aluminium-based SermeTel 1140/962 coated specimens are also shown in Figures 5 & 6. The open circuit potential of SermeTel 1140/962 in 3.5% NaCl solution (-0.76 V (SCE)) was very close to that of electrodeposited cadmium (-0.75 V (SCE)) yet it led to greater re-embrittlement of 300M, with an EI of 0.27. The structure of the coating is believed to be an important factor affecting hydrogen uptake, in addition to its electrochemical potential [4]. In contrast, AerMet100 specimens showed no reduction in failure times when tested in 3.5% NaCl solution. In fact, there was a small increase in the mean failure time, as shown in Table 3, which resulted in a negative value for the calculated embrittlement index. It is possible that the baking treatment at 315°C to cure the coating may have slightly affected the mechanical properties of the steel. However, this temperature was well below the tempering temperature of the material (485°C for 5h) and the Student-t test showed, with a 95% confidence level, that the coated and uncoated AerMet100 specimens could not be considered to belong to different statistical populations.

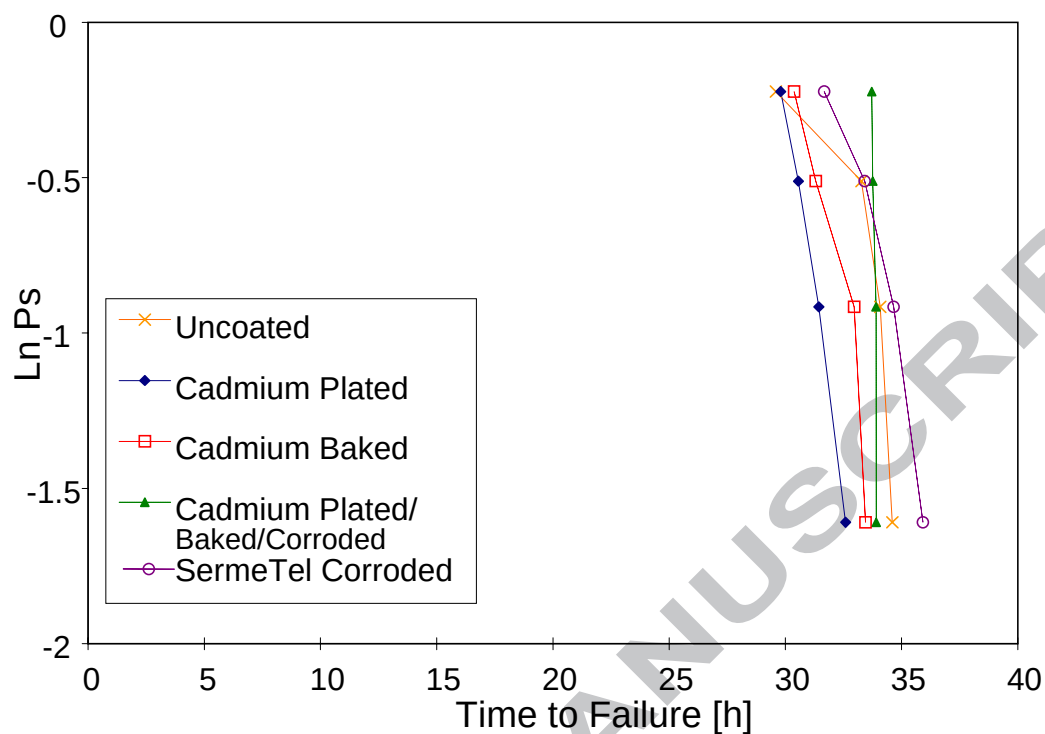
**Figure 6. Weibull plots for AerMet100 showing low levels of direct embrittlement from cadmium plating and re-embrittlement from corrosion of cadmium and SermeTel 1140/962 coatings**

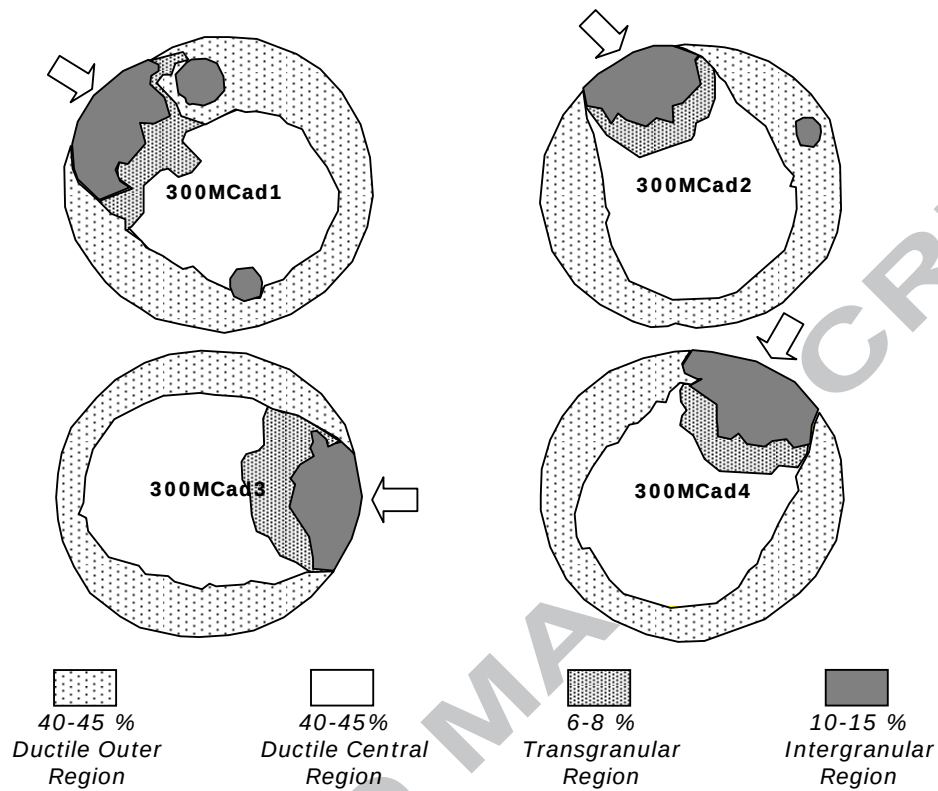
**Figure 7. Schematic illustration of different failure modes on the fracture surfaces of four replicate 300M tensile specimens**

After the SSR tests, the fracture surfaces were examined in a scanning electron microscope. The different failure modes were carefully mapped across the surfaces and are shown schematically for each material in Figures 7 and 8. The 300M specimens had very little reduction in area due to their high level of embrittlement, whereas the AerMet100 fractures were more ductile and necking had occurred. In 300M, a brittle fracture had initiated at a single point at the edge of each specimen and

propagated inwards until the stress on the remaining section exceeded the UTS, whereupon it then failed in a ductile manner by microvoid coalescence. The mean depth of brittle fracture was 1.0mm. The initial brittle fracture was intergranular, suggesting that the applied stress had been relatively low [22], and this changed to a transgranular cleavage mode as the crack grew in length and the stress increased (Figure 9). In contrast, all the regions of brittle fracture in AerMet100 specimens were transgranular cleavage. They had initiated from many sites around the circumference but had propagated only a short distance (mean depth of 0.13mm) before the final ductile failure occurred.

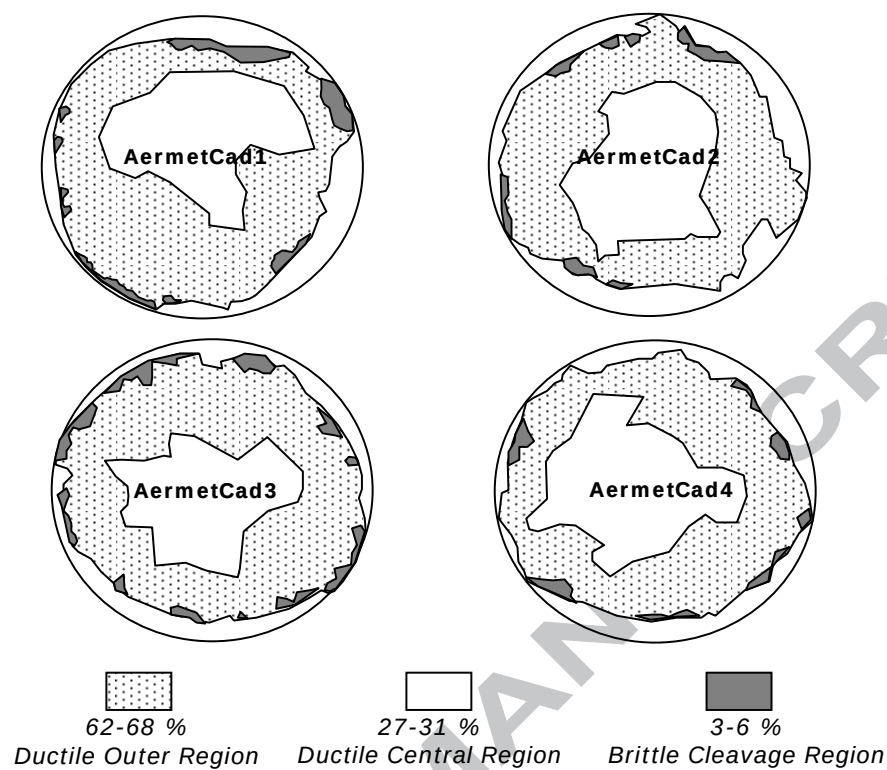
**Figure 8. Schematic illustration of different failure modes on the fracture surfaces of four replicate AerMet100 tensile specimens**

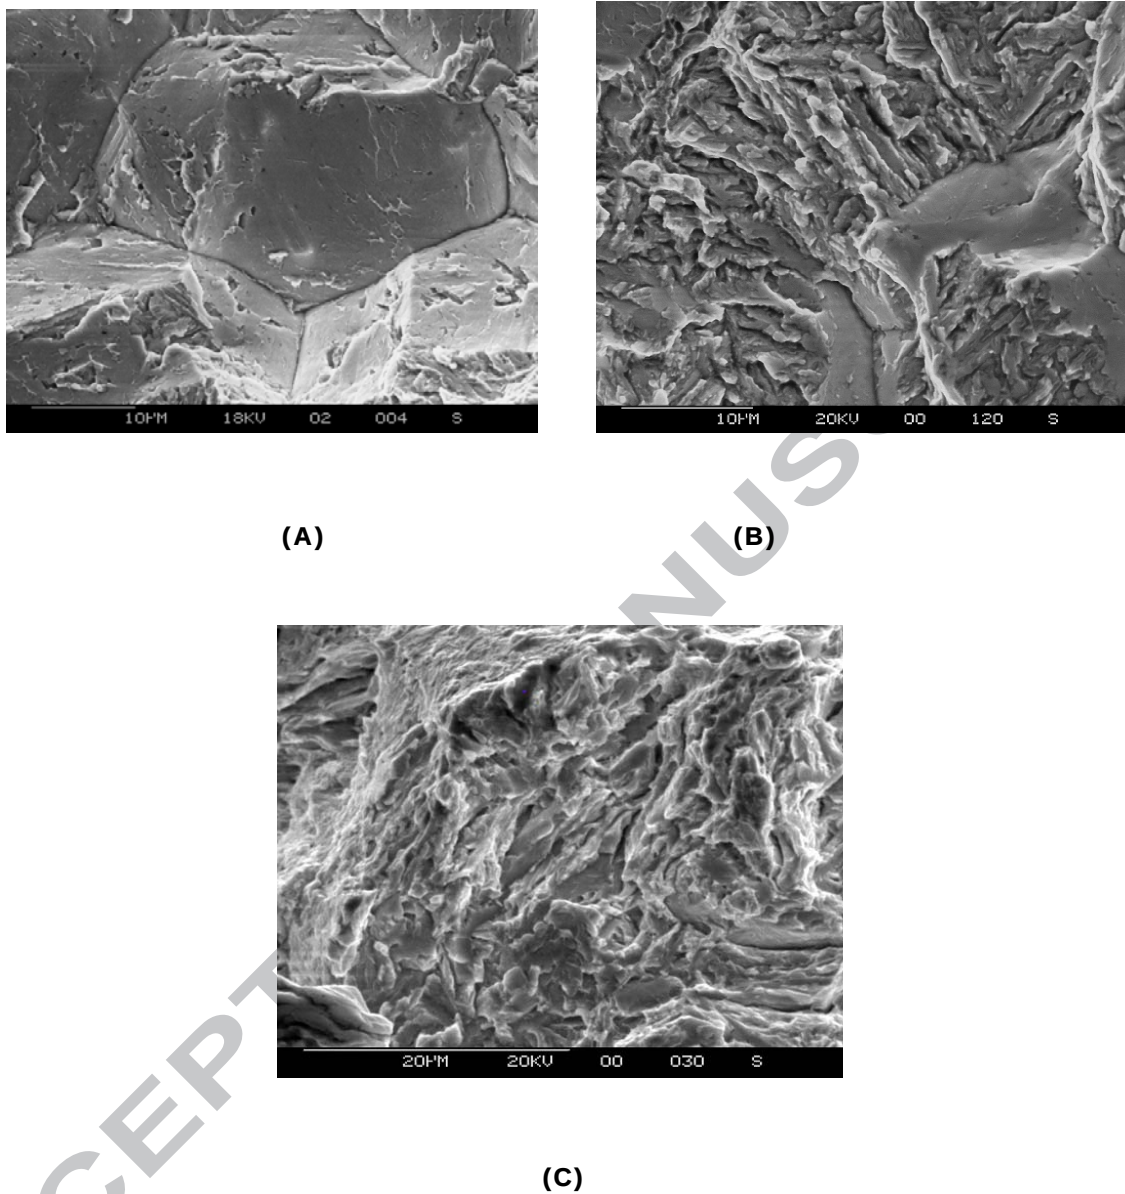
**Figure 9. SEM Micrographs showing fracture surfaces of cadmium plated slow strain rate specimens. A) brittle intergranular fracture of 300M at prior austenite grain boundaries, B) transgranular fracture of 300M, C) transgranular fracture of AerMet100**

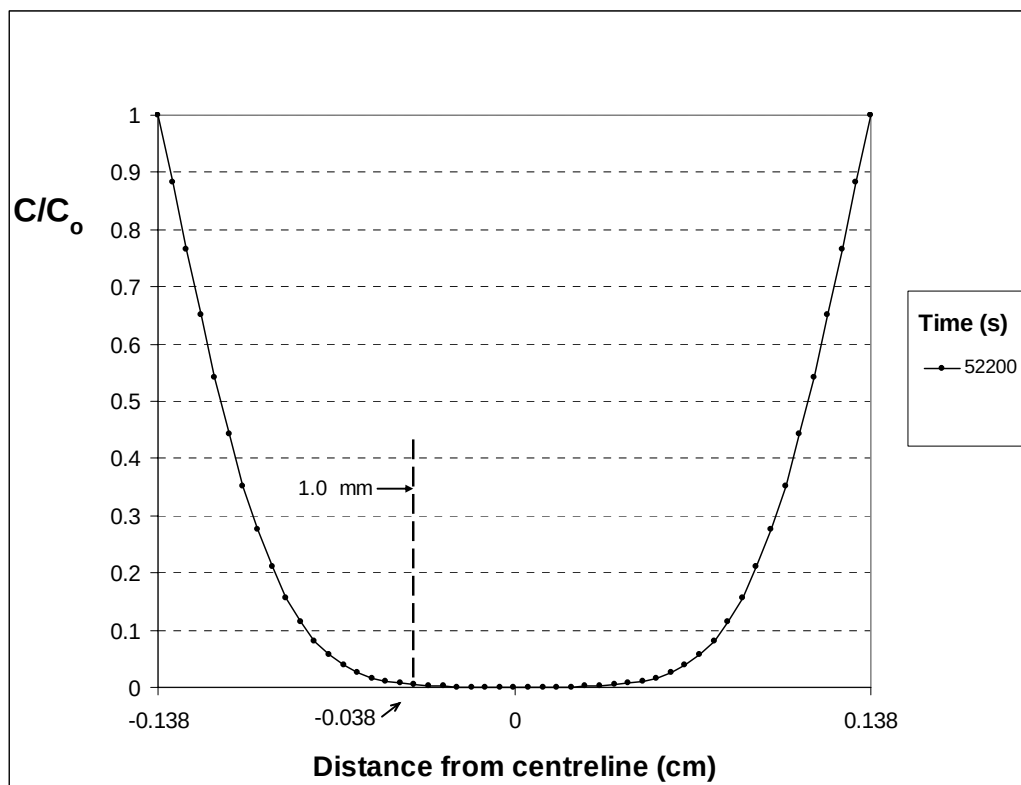
Figure 10. Hydrogen distribution in 300M at the failure time of 14.5h for a diffusivity,  $D$ , of  $1 \times 10^{-8} \text{ cm}^2 \text{ s}^{-1}$

Figure 10 shows the least depth to which hydrogen could have penetrated into the cadmium plated, but unbaked, 300M SSR specimens in the mean failure time of 14.5 hours, to explain the observed failures. The graph represents the hydrogen concentration,  $C$ , as a proportion of the surface concentration,  $C_0$ , across the 2.75mm diameter of the specimen, when charged from both sides. In evaluating the series in equation (17), the hydrogen diffusion coefficient has been adjusted so that hydrogen just reached a depth of 1.0mm, which was the mean depth of the embrittled region on the four replicate 300M specimens. For this condition to be satisfied, the diffusion coefficient would need to be  $1 \times 10^{-8} \text{ cm}^2 \text{ s}^{-1}$ , compared to  $8.0 \times 10^{-8} \text{ cm}^2 \text{ s}^{-1}$  measured using the galvanostatic method.

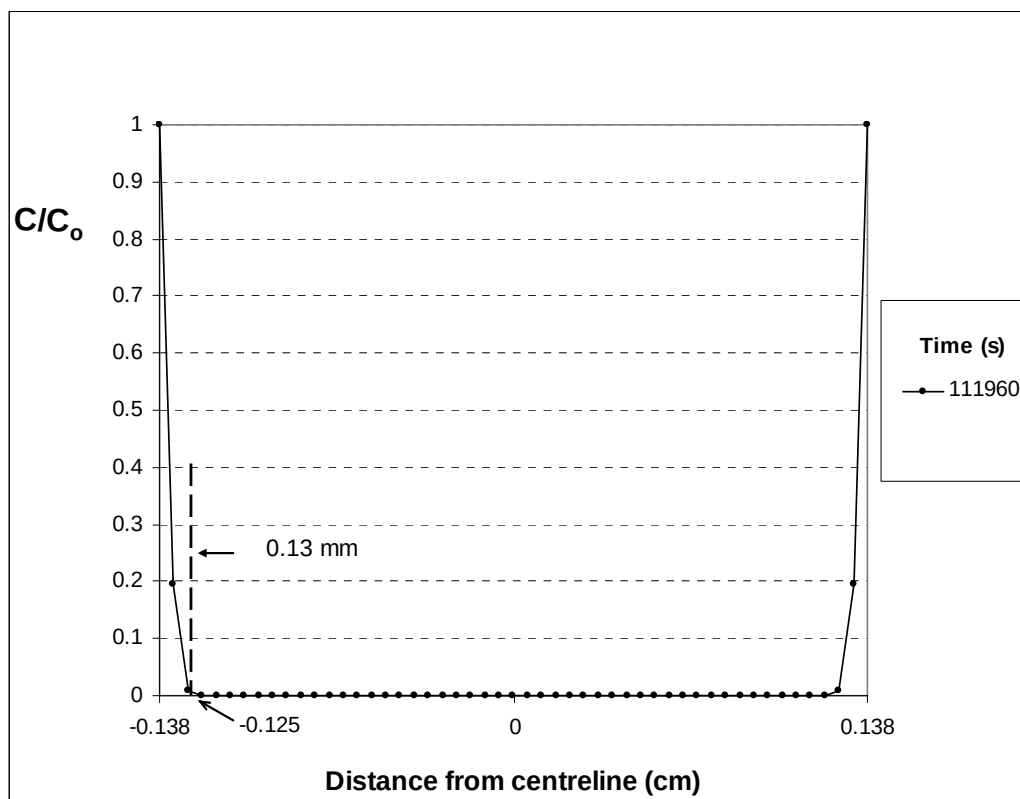
Figure 11. Hydrogen distribution in AerMet100 at the failure time of 31.1h for a diffusivity,  $D$ , of  $8 \times 10^{-11} \text{ cm}^2 \text{ s}^{-1}$

Similar calculations were carried out for AerMet100 such that hydrogen just penetrated 0.13mm from the surface; the mean depth of the embrittled region in cadmium plated specimens of this alloy, as shown in Figure 11. In this case,  $D$  needed to be  $8 \times 10^{-11} \text{ cm}^2 \text{ s}^{-1}$ , whereas the measured value was  $1 \times 10^{-9} \text{ cm}^2 \text{ s}^{-1}$ . As the measured diffusion coefficients were the higher values in both steels, it appears that at the time of failure hydrogen had diffused further than the embrittled region, indicating that a significant hydrogen concentration was required at the crack tip for the brittle fracture to propagate.

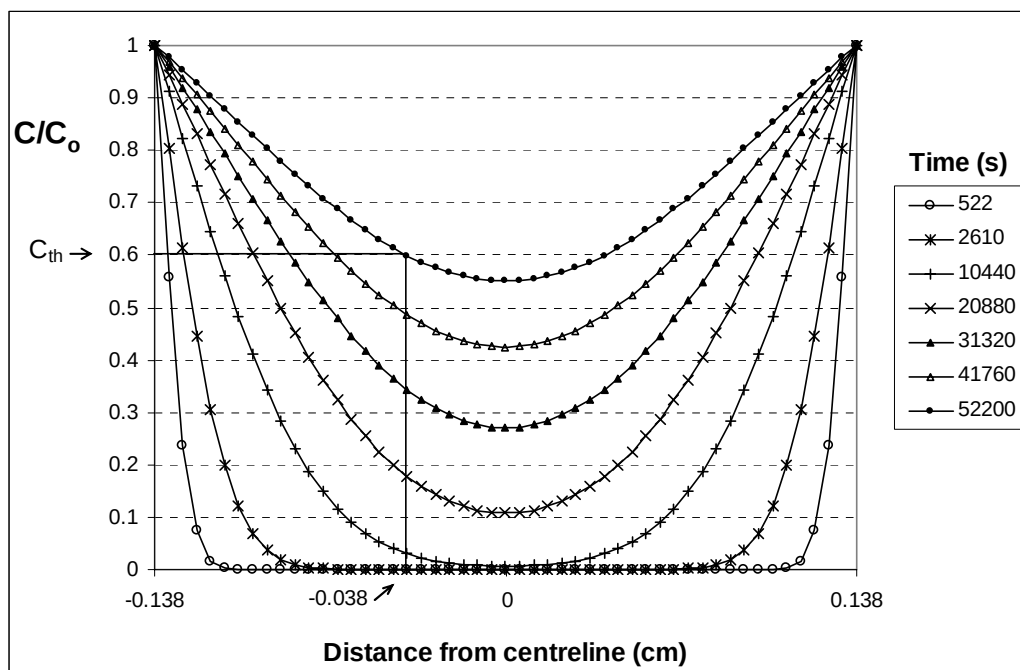
Figure 12. Predicted hydrogen distribution in 300M at the failure time of 14.5h for the measured diffusivity,  $D$ , of  $8 \times 10^{-8} \text{ cm}^2 \text{ s}^{-1}$

Figures 12 and 13 show the hydrogen distribution for each alloy that would be predicted from its failure time and measured diffusion coefficient. For 300M (Figure 12) distributions are shown for a range of times up until failure occurred. For example, at 10440s hydrogen had just penetrated from each side of the specimen to reach the centre (the breakthrough time  $t_b = 0.04L^2/D$ ). At failure (52200s), the hydrogen concentration,  $C/C_o$ , at a depth of 1.0mm was predicted to be 0.6. That is to say, the concentration was 0.6 of that at the surface due to hydrogen charging from the cadmium coating. This value represents the threshold hydrogen concentration for embrittlement in 300M.

A comparison of the threshold hydrogen concentrations,  $C_{th}$ , required to propagate a brittle crack (Figures 12 and 13) might suggest that AerMet100 was slightly more susceptible than 300M ( $C/C_o$  of 0.4 for AerMet100 and 0.6 for 300M). However, this difference is not thought to be particularly significant. Both steels have tempered martensite in the microstructure and embrittlement of this phase is expected to be similar in each case. In addition, due to the steepness of the hydrogen distribution profile in Figure 13, a small difference in the measured depth of embrittlement in AerMet100 would result in a large difference in the predicted  $C/C_o$  value. However, there are features of the microstructure of AerMet100 that explain both its low embrittlement susceptibility and the low hydrogen diffusion coefficient.

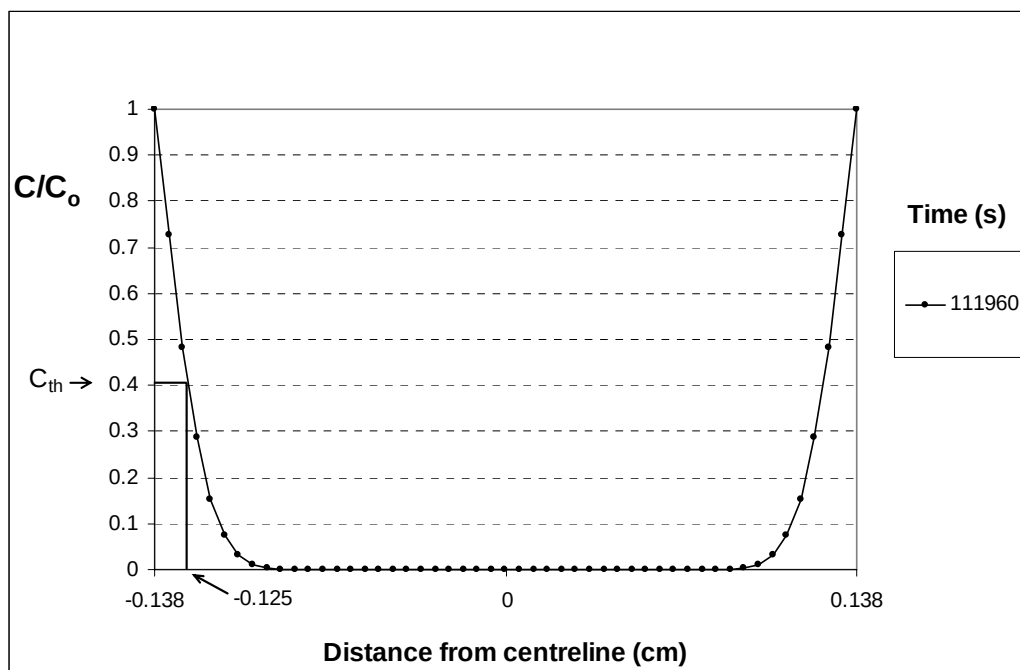
**Figure 13.** Predicted hydrogen distribution in AerMet100 at the failure time of 31.1h for the measured diffusivity,  $D$ , of  $1 \times 10^{-9} \text{ cm}^2 \text{ s}^{-1}$

The corresponding hydrogen distribution for AerMet100 at the failure time of 111960s is shown in Figure 13. At the mean embrittlement depth of 0.13mm, the hydrogen concentration is predicted to be 0.4  $C/C_o$ .

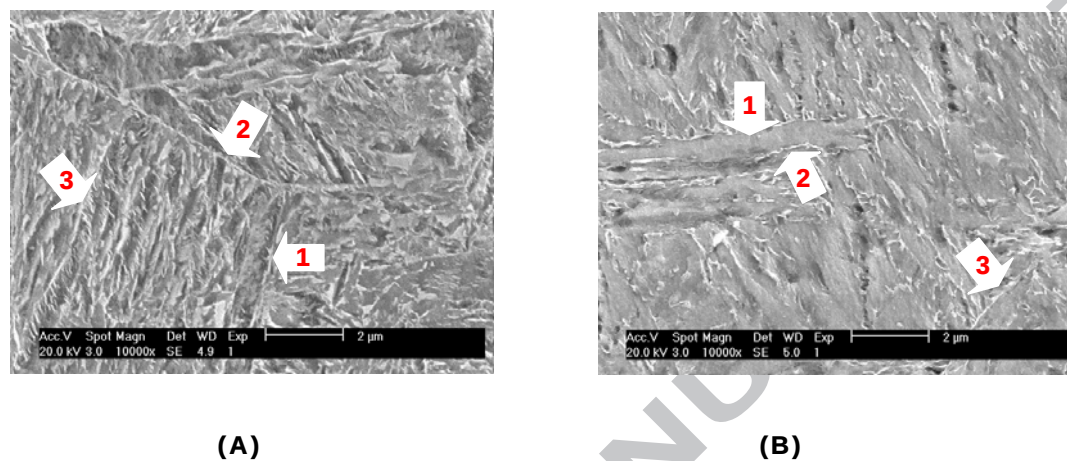
**Figure 14. SEM micrographs showing A) retained austenite at prior austenite grain boundaries in 300M and B) reverted austenite at lath boundaries (1,2) and at prior austenite boundaries (3) in AerMet 100**
