The Fourth International Conference on Through-life Engineering Services

## Review of Non-destructive Testing (NDT) Techniques and their applicability to thick walled composites

MR Jolly\*, A. Prabhakar, B. Sturzu, K. Hollstein, R. Singh, S. Thomas, P. Foote &amp; A. Shaw

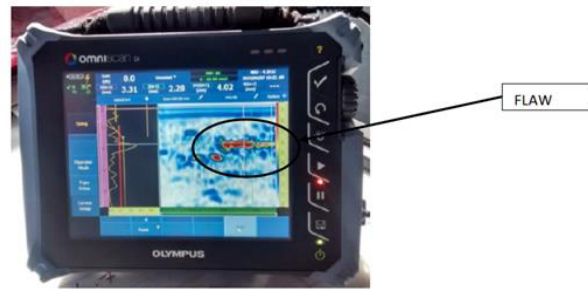
The experiment with 5MHz frequency probe detected back wall echo of material. At the same time with a 2MHz frequency probe echo signal received with larger amplitude. However, the known flaw's present in material was not noticed. There was another flaw, which was detected in C-Scan and flaw characterization shows a crack of length (figure 5).

Fig. 5. Result of experiment and analysis of sample showing flaw characteristics.

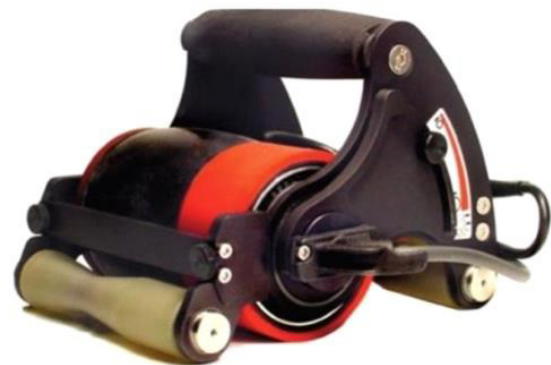
Fig. 6. Sonatest RadiusWheel Probe. [14]

The front wall echo was visible on the scanner screen. There was too much attenuation due to surface feature of the sample. The back wall echo was not detected on the screen. There could be several reasons for the lack of penetration. This could be failure of proper contact between RadiusWheel probe and flywheel due to geometry of part. The use of water as a coupling agent might have proved to be ineffective due to low viscosity and hence less adherence in between two surfaces. These factors could have led to large attenuation that were shown as near surface flaws.

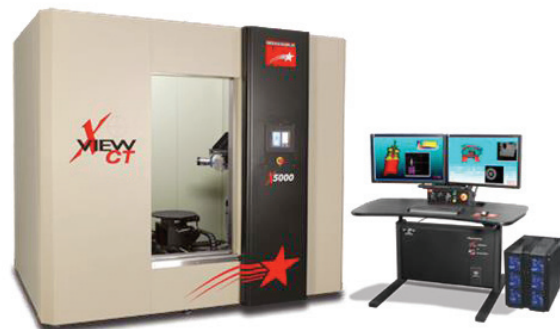
Fig. 9. North Star Imaging X5000 CT scanning system with workstation. [16]

will be presented below. Most of the companies recommended to use cabinet systems for an industrial production environment (like the one shown in figure 9). All products are state-of-the-art machines and are already used in the manufacturing industry. The price for CT scanning machines ranges from £200k to £600k, depending on precise requirements and resolution.
