## Professional Practice Report

# An assessment of a non-destructive magneto-optical imaging technique for the recovery of laser engraved marks from steel plates and firearm components

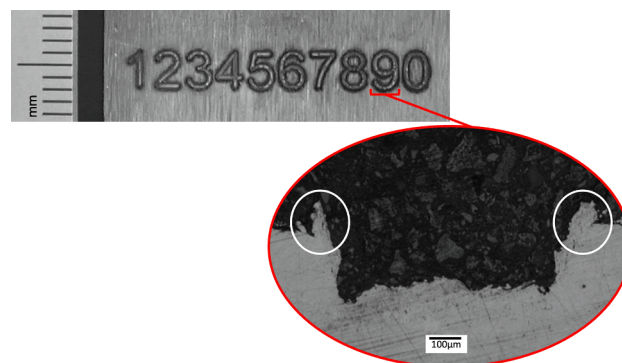
Fig. 1. One laser engraved serial number on a steel plate (left) and a cross section of the highlighted character (×50 magnification), showing the depth of the laser engraving (230 µm) (right). The lipping of the metal is circled.

20 CR4 grade mild steel plates, with a mean Vickers hardness of 135 HV, had a microstructure composed of ferrite and pearlite. Each 60 mm × 100 mm × 2 mm plate was laser engraved using a 30-watt BWM-30F Fibre laser marking machine. These plates were used to simulate firearms with a laser engraved serial number, while maintaining consistent and known material properties. For the purposes of this study, a "character" is any single letter, number, or symbol. Each steel plate was engraved with twenty marks of ten characters (1234567890) to allow for increased recovery areas for sampling. The average depth of the engraving on the steel plate was obtained by cross-sectioning an engraved area and measured using a calibrated Olympus SC50 microscope at 50x magnification to 230 µm ± 10 µm. One of the 20 sample plates is shown in Fig. 1, showing an aerial view of the engraving, as well as a cross section of a laser engraved digit. In total, two characters from each steel plate were sampled to obtain the average depth. Fig. 1 also shows cross section of a single digit, mounted in a black polymer mounting medium. At the edges of the engraved digit, material can be seen lipping up and outward on both edges of the engraving, and the uneven surface at the bottom of the digit.

Fry's reagent was made using 5 g of copper chloride in 25 ml of ethanol and 40 ml of hydrochloric acid in 30 ml of distilled water [22]. The solution was heated to 30 °C and brushed on to the surface of each sample using cotton buds inside a fume hood. This process was repeated until a mark was revealed, or depth of material removed exceeded the depth of the laser engraved markings observed in the cross-section of Fig. 1.

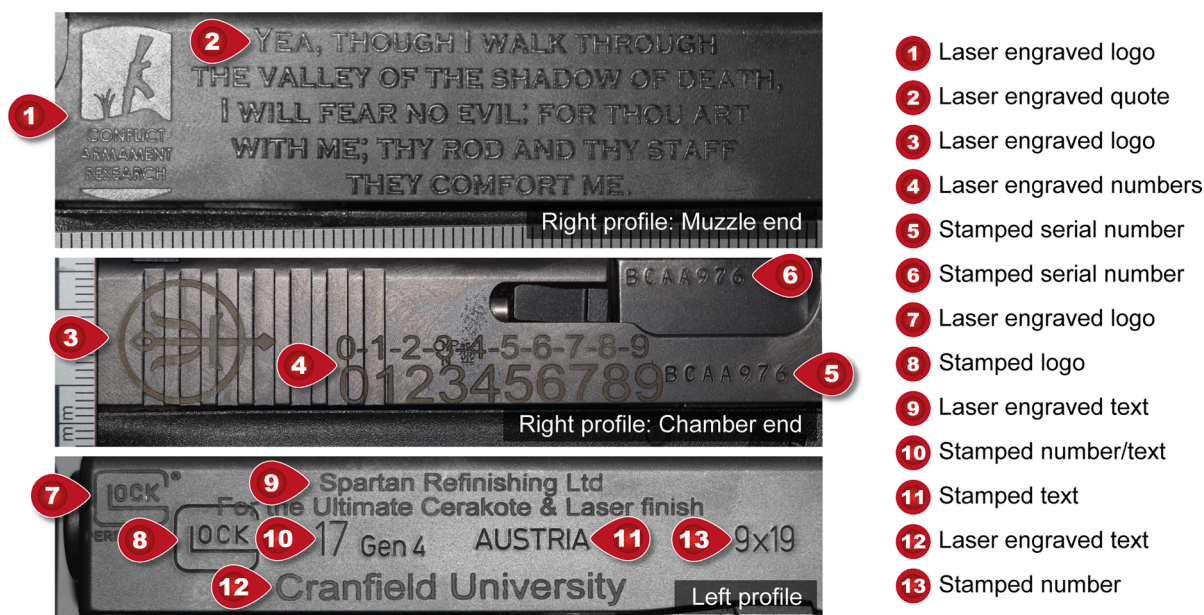
Fig. 2. The laser engraved and stamped marks removed from the right profile (top, middle) and left profile (bottom) sides of the pistol slide. Image authors own.

To compare the results of standardised steel plates, true firearm components were also used in this work. A steel Glock pistol slide (18.6 cm × 2.55 cm × 2.55 cm) was also laser engraved using the same BWM-30F Fibre laser marking machine. This was in addition to the pre-existing manufacturer stamped marks. The average depth of the marks applied post-manufacturing with the laser were 550 µm ± 10 µm, while the stamped manufacturing marks was 840 µm ± 10 µm. The depth of these marks was measured using a Vernier caliper, sampled in six locations on each item. Fig. 2 shows both the marks stamped during manufacturing and those added for the purpose of this study. In total, there were six original stamped marks, and seven applied laser engraved marks.

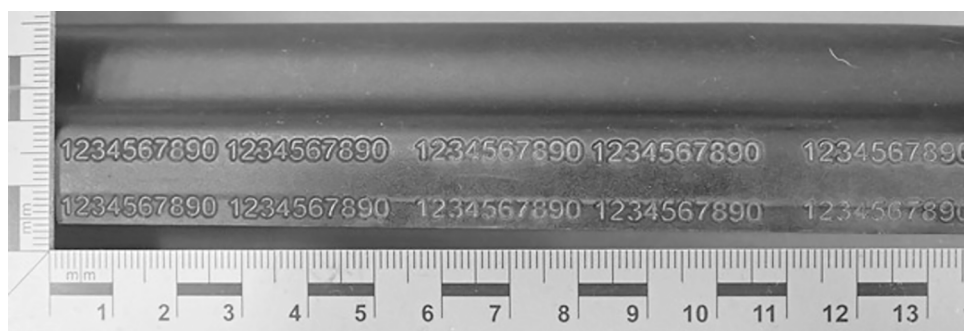
Fig. 3. The left side of an AK-pattern rifle top cover, with ten laser engraved marks (“1234567890”).

(Fig. 3). In addition to the ten pictured on the left side, one was applied to the backface of the cover, and an additional six marks were engraved on the right side. There were no original stamped marks on these items.

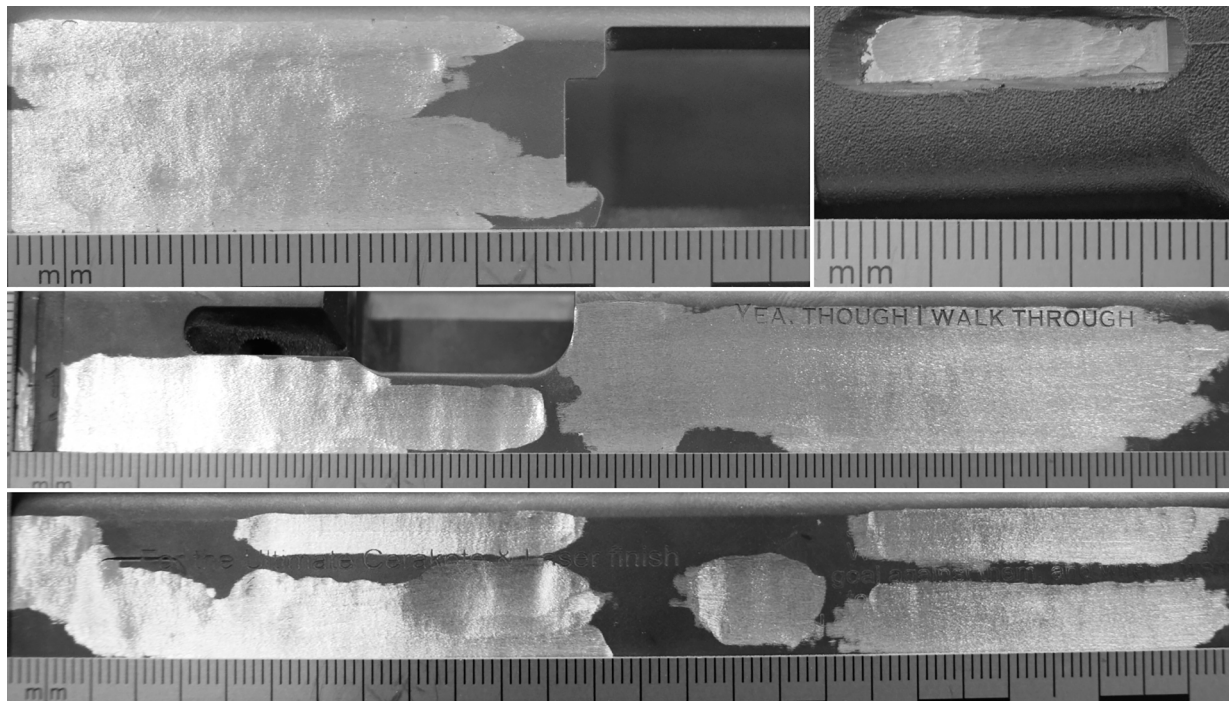
Fig. 4. Each side of the pistol slide (top, middle) and the backface of a top cover (bottom) after the marks were removed with a Dremel®.

Due to the size of the weapon components (pistol slide and AK covers), a Dremel® rotary tool with a grinding bit was used to remove the manufacturer stamped marks and additional laser engraved marks. This was conducted by one operator to a depth where the marks were no longer visible to the naked eye. The original surface was maintained to ensure a datum point remained for measuring the obliteration depth. Fig. 4 shows the pistol slide and a top cover post-obliteration, where the

obliteration depth was measured at  $1200 \mu\text{m} \pm 10 \mu\text{m}$  ( $n = 10$  measurements across all samples). To ensure the orientation of the recovery scans some features (small amounts of laser engraved text) left unobliterated, which can also be seen in the figure.

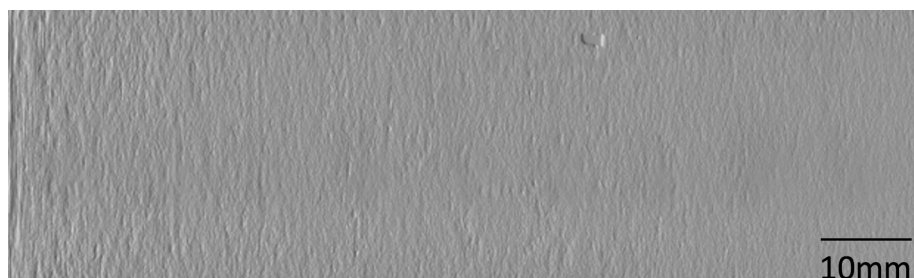
Fig. 5. The clearest magneto-optical image of the obliterated steel plate microstructure.

0 % ( $n = 400$ ) of the laser engraved marks were recovered from the steel plates using the ECK technique. From this method the clearest magneto-optical image was obtained at an amplitude level 8 (Fig. 5), showing the microstructure of the steel without any residual markings from the laser engraving. There are shadows on the image, however those are attributed to the magnetic tape.

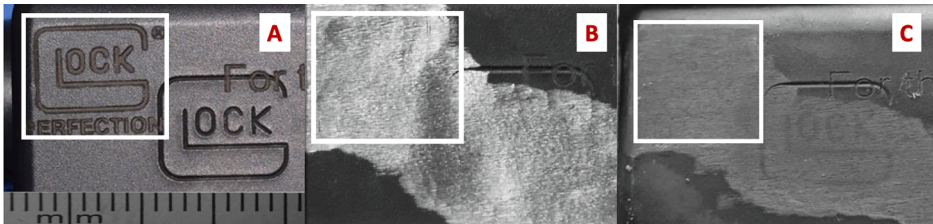
**Fig. 7.** The front left side of the pistol slide. (A) the marks before obliteration, (B) the marks after obliteration, and (C) the stamped “Glock” logo was recovered using Fry’s reagent, and the laser engraved logo was not recovered (boxes). Note; additional laser engraved text was not obliterated and can be seen overlapping the Glock logo.

Fry's reagent successfully recovered all ( $n = 6$ ) of the stamped marks from the slide, and did not recover any of the seven laser engraved marks. Fig. 7 shows an example of the Fry's reagent recovery of a stamped mark and highlights one area where the laser engraved marks were removed, but not recovered. Also included in Fig. 7 are the marks before removal, for visual comparison.

The non-destructive ECK was employed first, to preserve the integrity of the samples for later testing. As previously described, the ECK detects structural differences in the microstructure of the steel and visualises it through magneto-optical digital images. As shown in the example (Fig. 7 above), all stamped marks ( $n = 6$ ) were recoverable with clear results. This is an expected result for stamped marks based on continuous, proven use in forensic laboratories, relying on the plastic deformation to the microstructure of the steel below the original mark. The total laser engraved characters ( $n = 509$ ), were not recovered via ECK (also pictured in Fig. 8), demonstrating that the microstructural alteration in the steel by laser engraving are insufficient to allow for recovery using this technique.

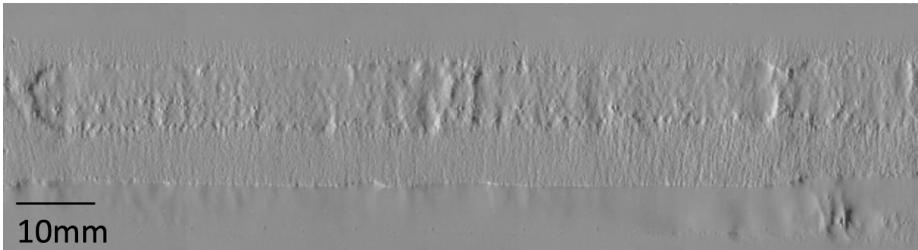
**Fig. 8.** The electromagnetic recovery image showing the microstructure of the AK-pattern rifle top cover, where the laser engraved marks were removed by hand using a Dremel® rotary tool.

None of the 102 characters were visible in the electromagnetic image following recovery from the ECK, or when using the Fry’s reagent. Fig. 8 shows the electromagnetic image of the eddy current scan, where the microstructure disturbance is clear, however, no characters are discernable.
