# Observation of Damage Initiation for Trans-laminar Fracture Using in situ Fast Synchrotron X-ray Radiography and ex situ X-ray Computed Tomography

Xiaodong Xu<sup>1</sup> · Nathanael Leung<sup>2</sup> · Urangua Jargalsaikhan<sup>2</sup> · Evi Bongaers<sup>3</sup> · Tan Sui<sup>2</sup>

Trans-laminar fracture is an important topic for engineering composites. In this study, trans-laminar fracture initiation in quasi-isotropic carbon/epoxy laminates made of non-crimp fabrics was examined using in situ fast synchrotron X-ray radiography and ex situ X-ray computed tomography. The maximum split lengths were measured by in situ radiography and were compared with the predicted values in a detailed FE model using cohesive elements. Ex situ computed tomography scans were also conducted to confirm that no fibre breakage occurs before the final load drop in the experiments. In situ and ex situ observations are complementary for the understanding of damage initiation.

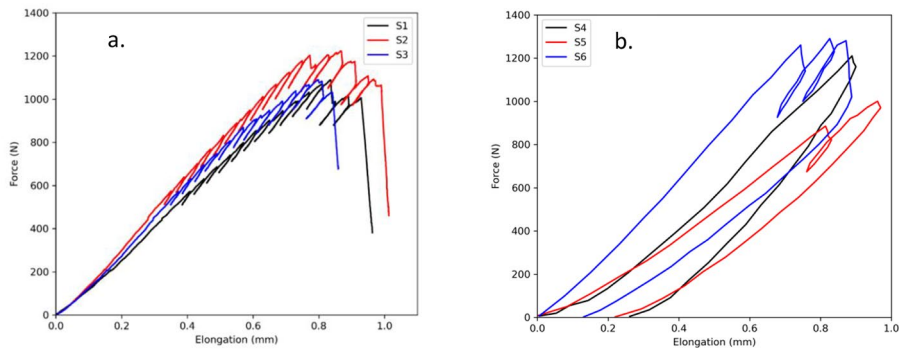
**Fig. 2** Deben Force-elongation curves for **(a)** S1, S2 and S3 during in situ radiography experiments; **(b)** S4, S5 and S6 during interrupted experiments before X-ray CT

A Deben MT5000 Microtest rig (Microtest, Deben Ltd., Suffolk, UK) was used to perform an elastic compliance technique on the compact tension specimens whilst continuous radiography scans were acquired. The load-displacement graph obtained from the in situ radiography experiment performed on the three specimens can be seen in Fig. 2a. Overall, 13 cycles, 15 cycles, and 12 cycles were achieved for in Specimen 1 (S1), Specimen 2 (S2), and Specimen 3 (S3), respectively.

Prior to the ex situ CT scanning, three interrupted tests were performed involving three different load-unload regimens for each specimen as shown in Fig. 2b. In the first specimen (S4), the specimen was loaded until a load drop was observed at 1200 N. In the second specimen (S5), the specimen was loaded until a load drop occurred, at which point the specimen was partially unloaded and then loaded again until a second load drop was observed at 1000 N. Finally, for the third specimen (S6), the specimen was loaded and unloaded until three load drops were observed with the last load drop at 1280 N. The measured displacements from the interrupted tests in Fig. 2b are not used for any assessments. After the three interrupted tests, S4, S5 and S6 were scanned using the NeoScan S80 CT scanner with a 5  $\mu\text{m}$  pixel size.

ous measurements of splitting during trans-laminar fracture initiation before fibre fracture occurs. In Fig. 2a, the load-displacement curves from the in situ radiography experiments show consistent trends for all three specimens. Fig. 6 shows the presence of fibre fracture after the last load drop in Specimen S6 (1280 N), but no fibre breakage was observed in S4 (1200 N) and S5 (1000 N). Therefore, it is not expected to have fibre failure in Specimens S1 to S3 under 1200 N.

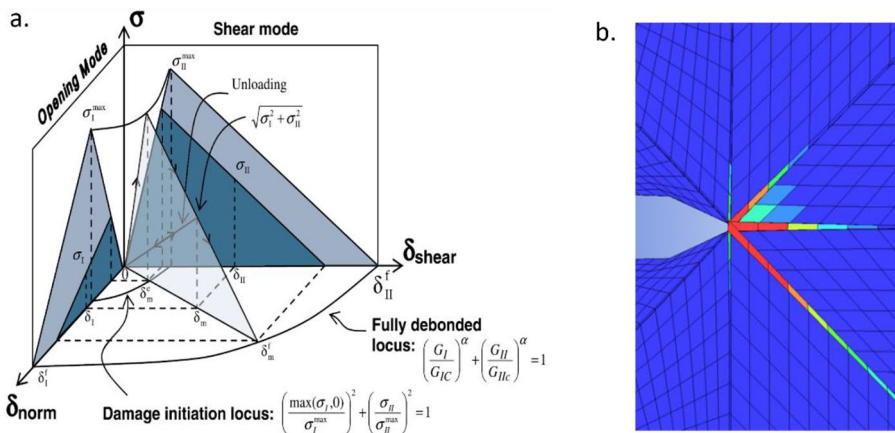
**Fig. 3** A detailed FE method for predicting damage initiation using cohesive elements with (a) Traction-separation relationship [18]; (b) Failed cohesive elements in red

Xu et al. [15] developed a detailed ply-by-ply FE model with a sharp notch in LS-Dyna using cohesive elements for intralaminar splitting and interlaminar delaminations. The traction-separation law for cohesive elements is shown in Fig. 3a. The input properties used were  $G_{IC} = 0.2$  N/mm,  $G_{IIc} = 1$  N/mm,  $\sigma_I^{\max} = 60$  MPa and  $\sigma_{II}^{\max} = 90$  MPa.

It was found that the  $0^\circ$  splits increase linearly with strain energy release rates without considering fibre failure. By revisiting the previous model [15], new results are extracted for all splits represented by the failed cohesive elements as shown in Fig. 3b. The predicted maximum split length is in the surface  $45^\circ$  plies. The predicted maximum split lengths at different strain energy release rates are compared against the experimental results.

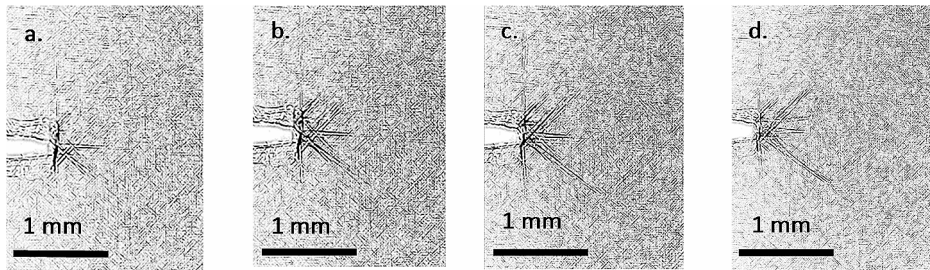
**Fig. 4** Representative radiograph images taken from S3 during the in situ radiography experiment (cycle 1, 5, 9, 13) at (a) 585 N; (b) 754 N; (c) 958 N; (d) 1074 N

In situ radiography offered continuous examination and a good resolution. This is preferable when studying splitting also because the specimen is loaded so the cracks are open. The multiple matrix crack propagation near the crack tip was successfully visualized. Fig. 4 shows the typical radiographic images at different loads during an in situ test. These radiographic images show the overall damage zone including 0°,  $\pm 45^\circ$  and 90° splits in all plies, but no obvious fibre failure by 1074 N. The maximum split length in the specimen can be measured which is in the 45° plies.

Compared to the CT scan images in Fig. 5 from the interrupted tests, the in situ X-ray radiographic images in Fig. 4 provide sufficient phase contrast and resolution for continu-

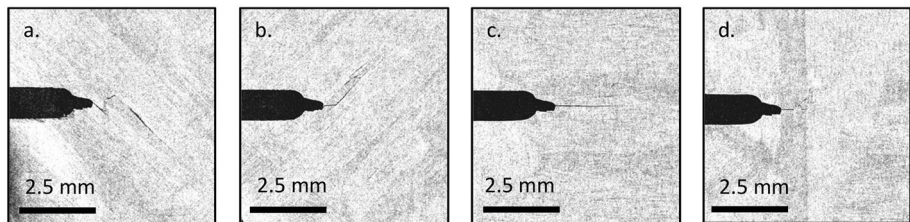
**Fig. 5** CT images showing damage from S6 after the peak load at 1280 N in (a) 45° ply; (b) -45° ply; (c) 90° ply; (d) 0° ply

While in situ radiography provided continuous examination of overall damage evolution, ex situ CT scanning was also done to show the cracks at different depths (plies) through the specimen thickness. This is difficult to observe in in situ radiography images because the damage in all plies is overlapped. Typical CT scan images in Fig. 5 show the damage states in different plies of Specimen S6 interrupted after 1280 N. It shows that fibers broke in the  $\pm 45^\circ$  and 0° plies at the final load drop, but further examination prove that fibers did not break at the first load drop in S4 and the second load drop in S5 as shown in Fig. 6. Splitting is visible in Fig. 5 except for the 0° ply in Fig. 5d. This is because the splitting was closed when the specimen was scanned after being unloaded.

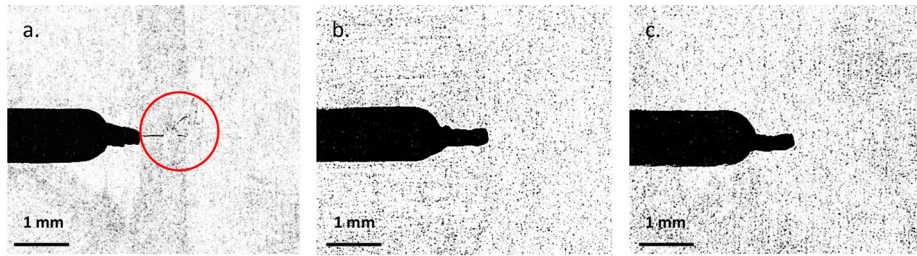
**Fig. 6** CT images showing fibre breakage circled in the  $0^\circ$  plies in (a) S6, and lack of fibre breakage in (b) S5 and (c) S4 after peak loads

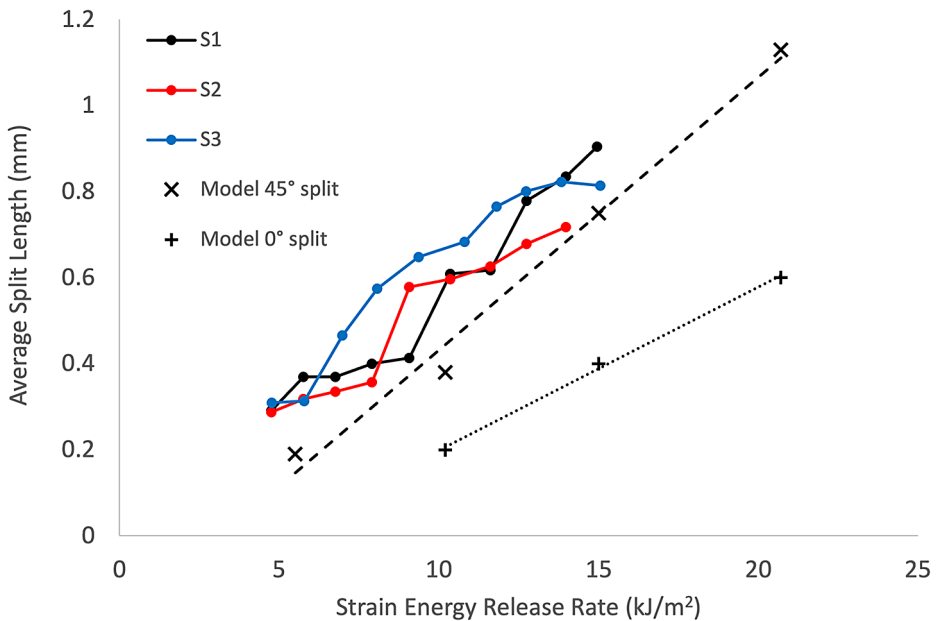
**Fig. 7** Maximum split length – strain energy release rate graph from in situ radiography experiments and FE model

The strain energy release rate of each specimen is determined by the initial crack length according to Eq. 1 to 3. Therefore, the maximum split length of three specimens (S4, S5 and S6) in relation to strain energy release rate is established as shown in Fig. 7. Among all the splits, the  $45^\circ$  splits are the longest and the most prominent in the images, so they are measured for comparison. The results show that the maximum split lengths grow approximately linearly with strain energy release rates.

Another recent detailed numerical study of trans-laminar fracture [19] was mainly focused on the prediction of R-curve behaviour during fracture propagation, which followed an earlier numerical work on fracture process zone development [15]. In Fig. 7, the currently measured slope is similar to that for the maximum splits predicted using the detailed model [15]. This suggests that the maximum splitting is driven by the same strain energy. The independent in situ radiography results in this work can confirm the findings of the detailed FE results. It is noted that the current slope for the maximum splitting in Fig. 7 is different from the previously reported slope for the  $0^\circ$  splitting, with the former being steeper.
