Cone cracking in human bone: A CT case review series

Angi M. Christensen, PhD, D-ABFA<sup>a</sup> (corresponding author)

John M. Rickman, PhD<sup>b</sup>

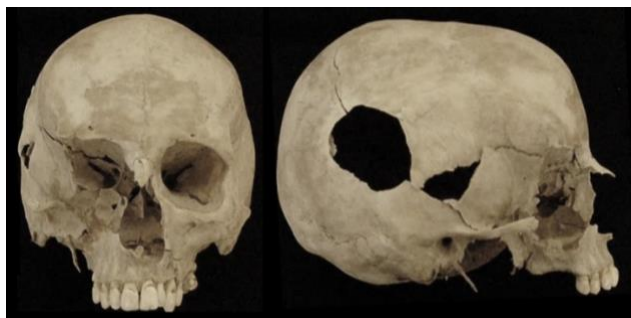
The cranium was received as multiple portions including most the cranium and several vault fragments which were temporarily reconstructed using adhesive (Fig. 6). Two primary areas of alteration are revealed, one consisting of a roughly circular alteration in the right cranial vault (further reviewed here) and one consisting of missing and fractured bone in the right facial region. The circular alteration is an internally beveled cone crack (Fig. 7) involving the right parietal and part of the right temporal squama. There are three primary radial cracks; one extending antero-inferiorly through the right temporal squama (bisecting the temporal squama and resulting in a dislodged fragment), one extending antero-superiorly through the right parietal toward the coronal suture, and one extending postero-superiorly through the right parietal, crossing the sagittal suture and terminating in the left parietal. There is no corresponding exit opposite the beveled perforation, and the overall pattern is consistent with blunt trauma. In this case CT imaging was especially beneficial in identifying the presence of beveling, which may not have been suspected based on the ectocranial trauma pattern, and is best visualized in endocranial and cross sectional views.

Figure 6: Largest of the cranial portions from Case 2, as received, in anterior (left) and right lateral (right) views

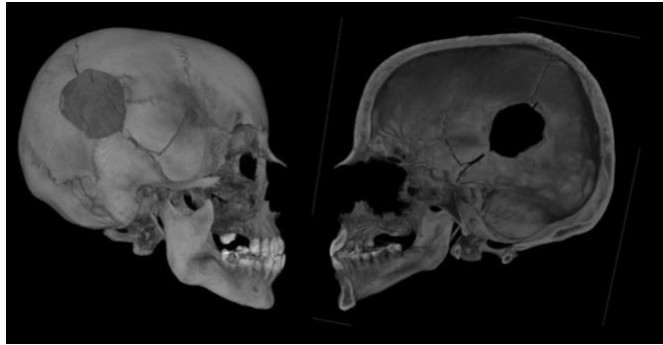
Figure 7: CT imaging of the cone crack in Case 2, including cutaway/slice view showing internal beveling (right)

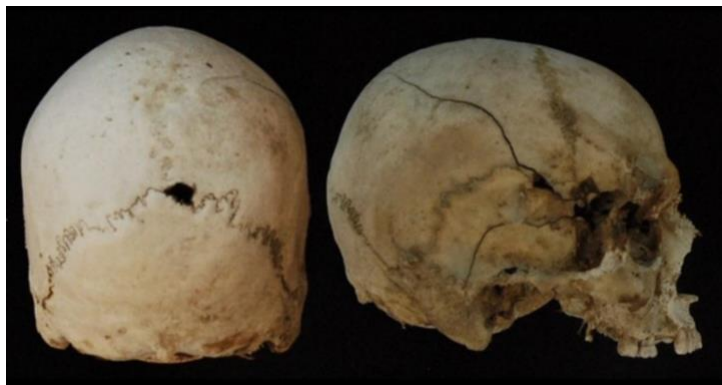
One of the crania (reviewed here) was received largely intact, and displays an irregular perforating defect along the right lambdoidal suture, just adjacent to lambda (Fig. 9). This location (combined with the irregular shape of the perforation) necessitates differential diagnosis from a missing sutural ossicle. When viewed externally, this taphonomic alteration can mimic projectile trauma very effectively, particularly when associated with additional fractures potentially representing the region of exit [19].

Figure 9: Cranium from Case 3, as received, in posterior view (left) showing the perforation, and right lateral view (right) view showing the alterations to the right temporal region

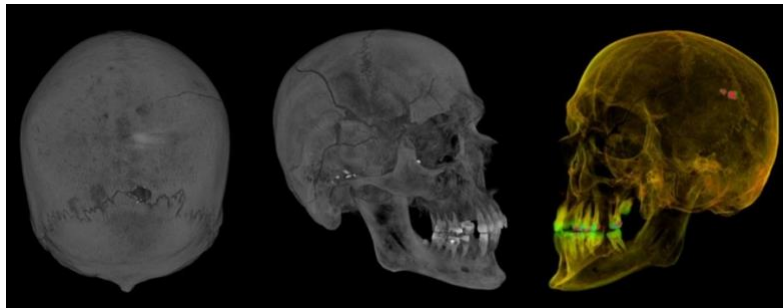
There are no radial or circumferential cracks associated with the perforation in this case, and radiodense debris can be seen on the margins in the CT imaging (Fig. 10). There is also a region

of missing, fractured, and hinged bone affecting the right temporal squama, sphenoid, frontal, and zygomatic. Two primary radial cracks emanating posteriorly from this region, one extending into the right parietal, terminating prior to the sagittal suture, and a second extending through the squamous portion of the right temporal and terminating superior to the mastoid process. A third radial crack extends across the right side of the frontal bone, branching above the right orbit. CT imaging also reveals the presence of an apparent projectile remnant adjacent to the perforation. At the time of the anthropological examination, this material was removed and referred for metallurgy analysis and determined to have a similar alloy composition to recovered cartridges.

Figure 10: CT imaging of Case 3 showing radiodense debris around the perforation (left), frontal bone fractures (middle), and projectile remnant (right)

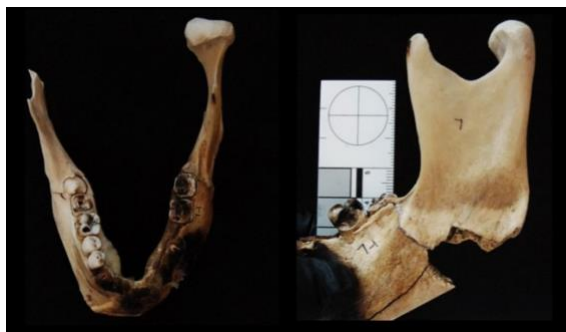
Thermal alteration of skeletal material was noted to primarily affect the left side of the body while some bones exhibited no thermal alteration. The cranium and mandible were highly fractured, and due to thermal alterations and the extent of missing bone, the trauma assessment of the cranium was inconclusive. The mandible (further assessed here) was reconstructed from five fragments, with discoloration representing thermal alteration focused on the anterior and left lateral mandibular body (Fig. 16). The mandible exhibits two perforating defects, one on the right inferior mandibular body and involving part of the right gonial angle, and one on the left inferior mandibular body just anterior to the gonial angle (Figs. 16-17). The right perforation is irregular in shape and exhibits one radial crack extending antero-superiorly across the oblique line. The left perforation is roughly circular superiorly, flaring outward inferiorly, and exhibits two radial cracks, one extending superiorly to the region of the extra-molar sulcus and one extending antero-inferiorly along the corpus. This left perforation is a cone crack exhibiting external bevelling, indicative of a medial to lateral impact direction, an interpretation consistent with a projectile entry on the right side and exit on the left side.

Figure 16: Case 5 mandible fragments as reconstructed (left) and showing perforation of the left mandibular body (right)
